# Service Problems with Steel Bins

R.A. Russell, Australia

## Summary

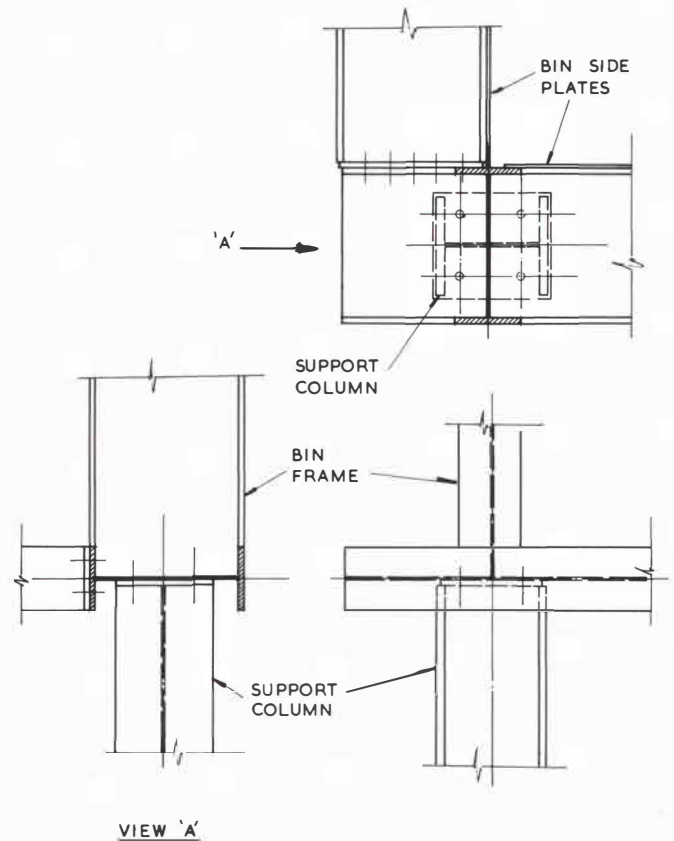
Fig. 1

In another case the partial failure at support column connections allowed a bin and dump truck bridge structure to settle approximately 30 mm.

The design of the particular connection required large concentrated loads to be transmitted through the webs of universal beam and column sections which were separated only by a thin steel plate (Fig. 1).

Fabrication of a stiffened connection stool between these two members would have avoided this failure.

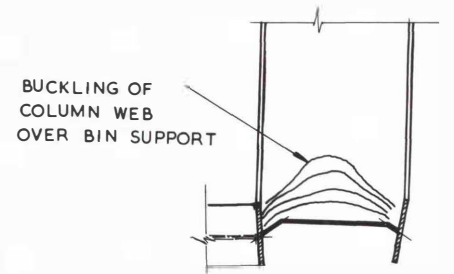
Fig. 1a

Buckling of the web of the vertical member attached to each corner of the bin allowed the bin and road bridge to drop by up to 30 mm maximum (Fig. 1a).

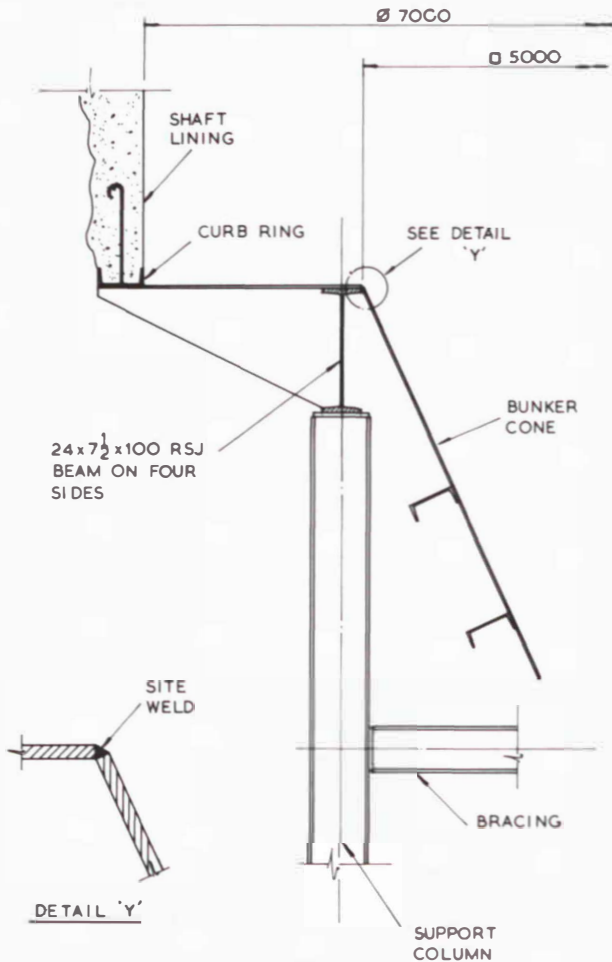
Fig. 2

The failure of an underground run-of-mine coal storage bin cone section was found to be at a joint which had been site welded.

This joint was located at the upper edges of the cone plate where it met a heavy steel support beam (Fig. 2).

When the bin was placed in service this joint was buried under coal and was exposed to maximum flexural stresses as the hopper was filled and emptied.

Examination of the welded joint indicated that a large portion of it had been cracked for a considerable period of time before the hopper failed.

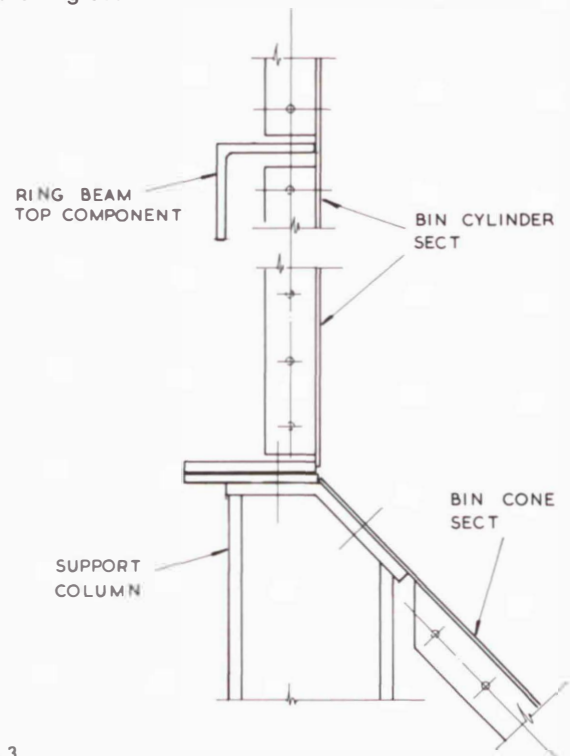
Fig. 3

The bin as constructed was provided with flange plates at the edges of each section of the bin to facilitate joining by bolts on site (Fig. 3).

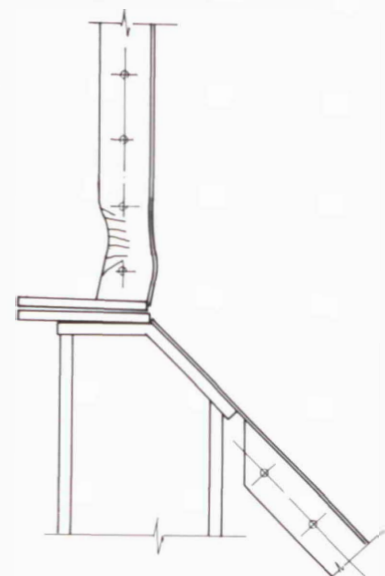
Fig. 3a

In the area over the column connections and in the ring beam section this flange plate was not stiffened at its outer edge and therefore buckled under the concentrated column loading (Fig. 3a).
