Whitepaper

## **Conveyor Dust and Spillage: The Importance of Skirtboard Sealing Systems**

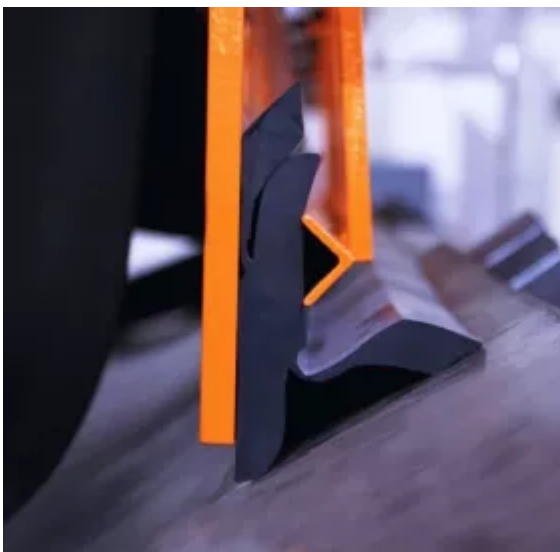
ApronSeal™ Double Skirting offers a dual seal and can be flipped for extended equipment life. (Pictures: ©Martin Engineering)

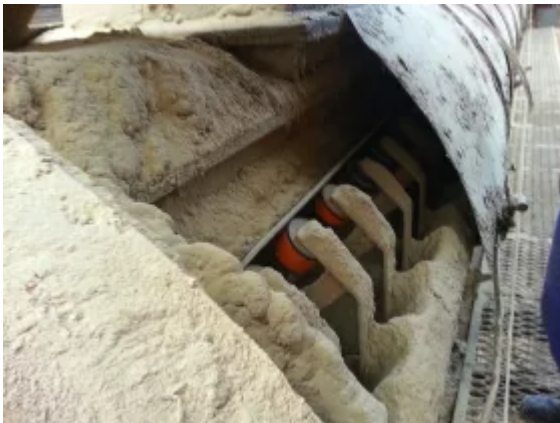
Dust and spillage clogs idlers, requiring them to be replaced and raising the cost of operation.

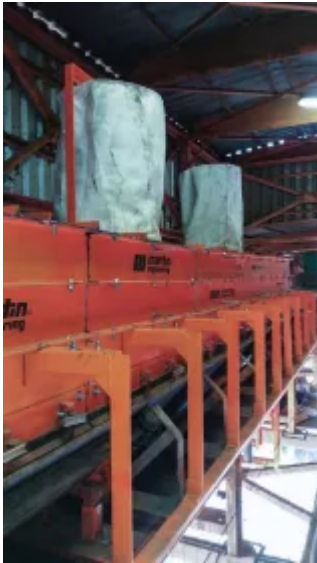
The new loading zone featured a sealing system that mitigated spillage and dust supported by dust bags.

Martin Engineering technicians constructed a longer sealed enclosure with the ability to control airflow and give dust extra space to settle. They added several other critical components including external dual seal skirtboard and wear liner system. Impact cradles and slider cradles replaced the idlers to seal gaps in the chute.

Operators immediately observed significant results. As material moved through the system, particulates remained within the enclosure and either collected in the dust bags or settled back into the cargo flow. After a lengthy observation period, operators report that there has been less downtime for cleanup and maintenance, as well as improved workplace safety.
