Whitepaper

Many sticky Returns - A Gold Mine seeks Solution to Carryback

[Published in bulk solids handling, Vol. 35 \(2015\) No. 5](#)

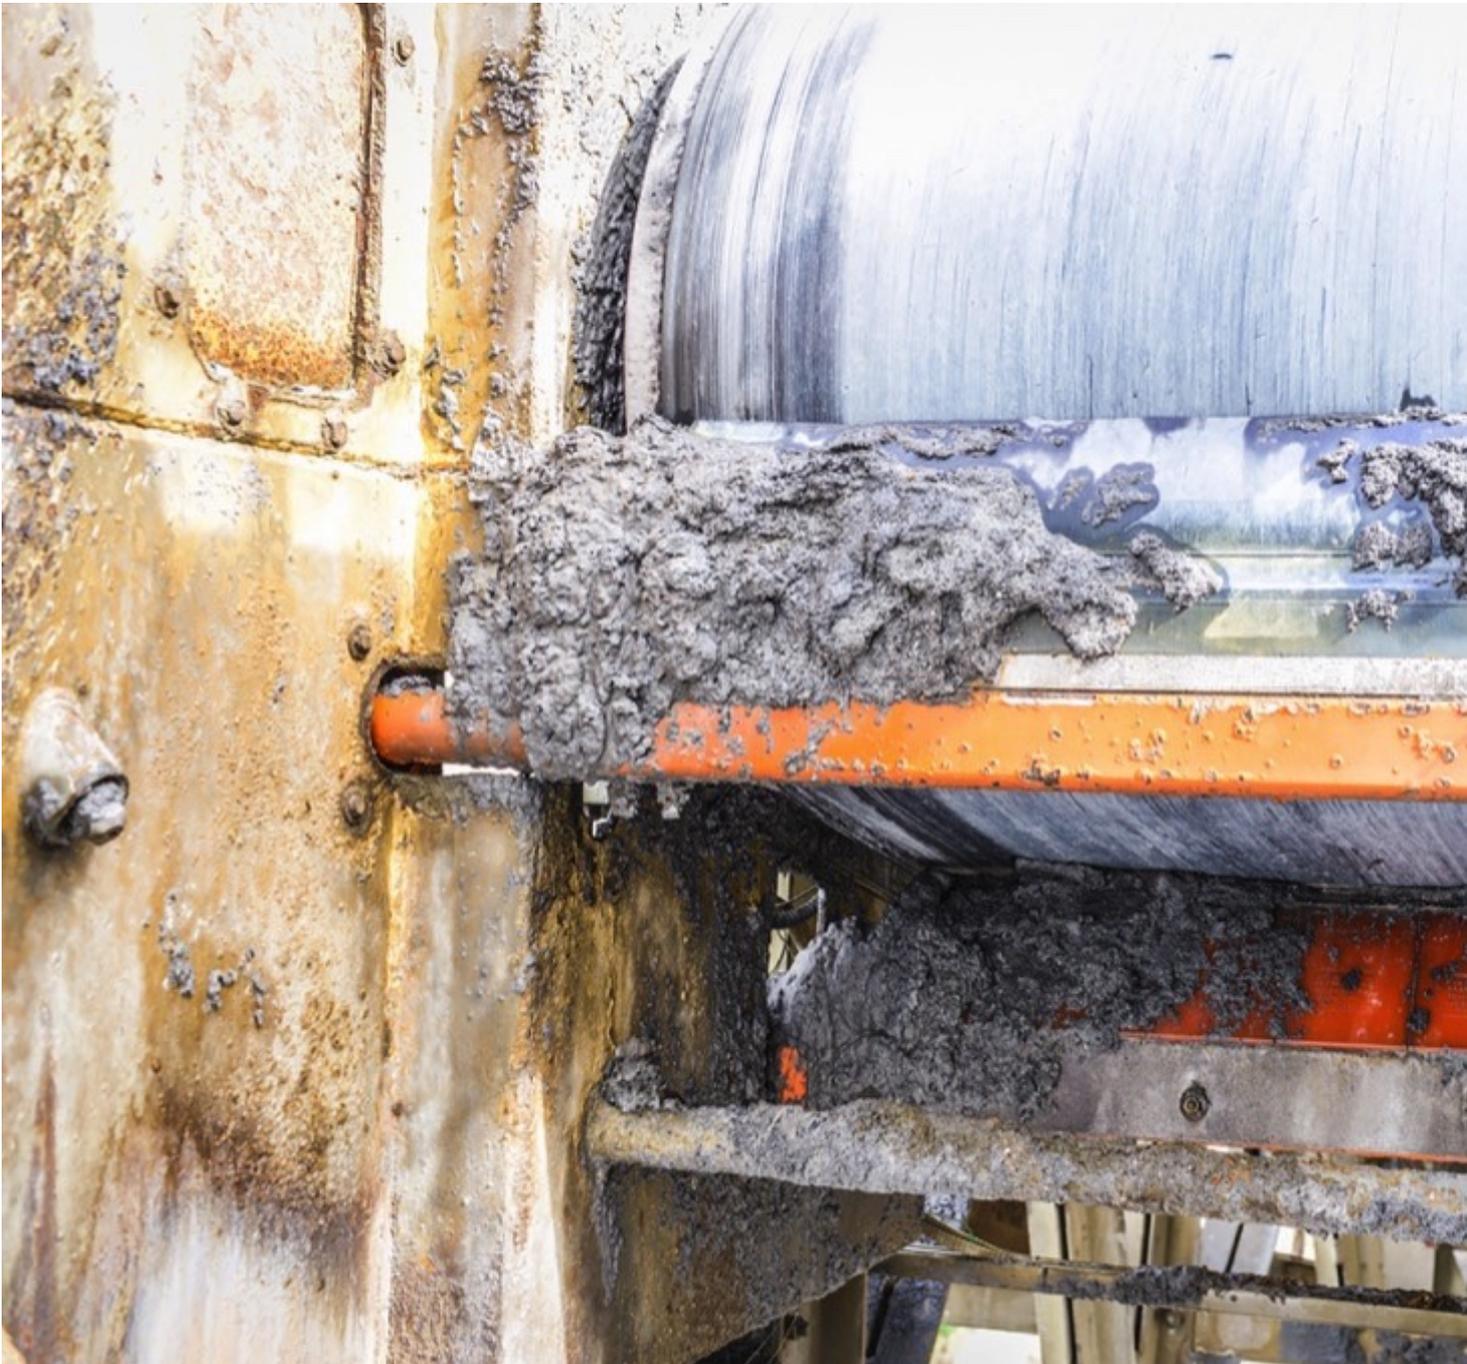
The carryback had the consistency of toothpaste, adhering chunks of aggregate to the belt and causing damage to pulleys and headers.

The carryback on discharge conveyors caused the whole system to suffer excessive downtime. According to Mike Lenart, Mechanical General Supervisor for PVDC, "The substance had the consistency of thick toothpaste, which was also able to adhere small chunks of aggregate to the belt, causing a destructive carryback that wreaked havoc on our pulleys and headers. It was a mess." The clay and sulfur in the soil at the PVDC site work in tandem: **Particulate cohesion:** Production is 365 days a year, however, between April and October

the area can receive as much as 6-feet (183 cm) of precipitation. Moisture can cause cohesion in fine clay particulates, which reacts to load pressure, causing it to stick to the contact surface [1]. **Sulfur adhesion:** Throughout human history sulfur has been used in a variety of applications as a strong adhesive and sealant [2]. This can cause gumming on the belt and adhere aggregate that would have previously been discharged to remain as part of the carryback.

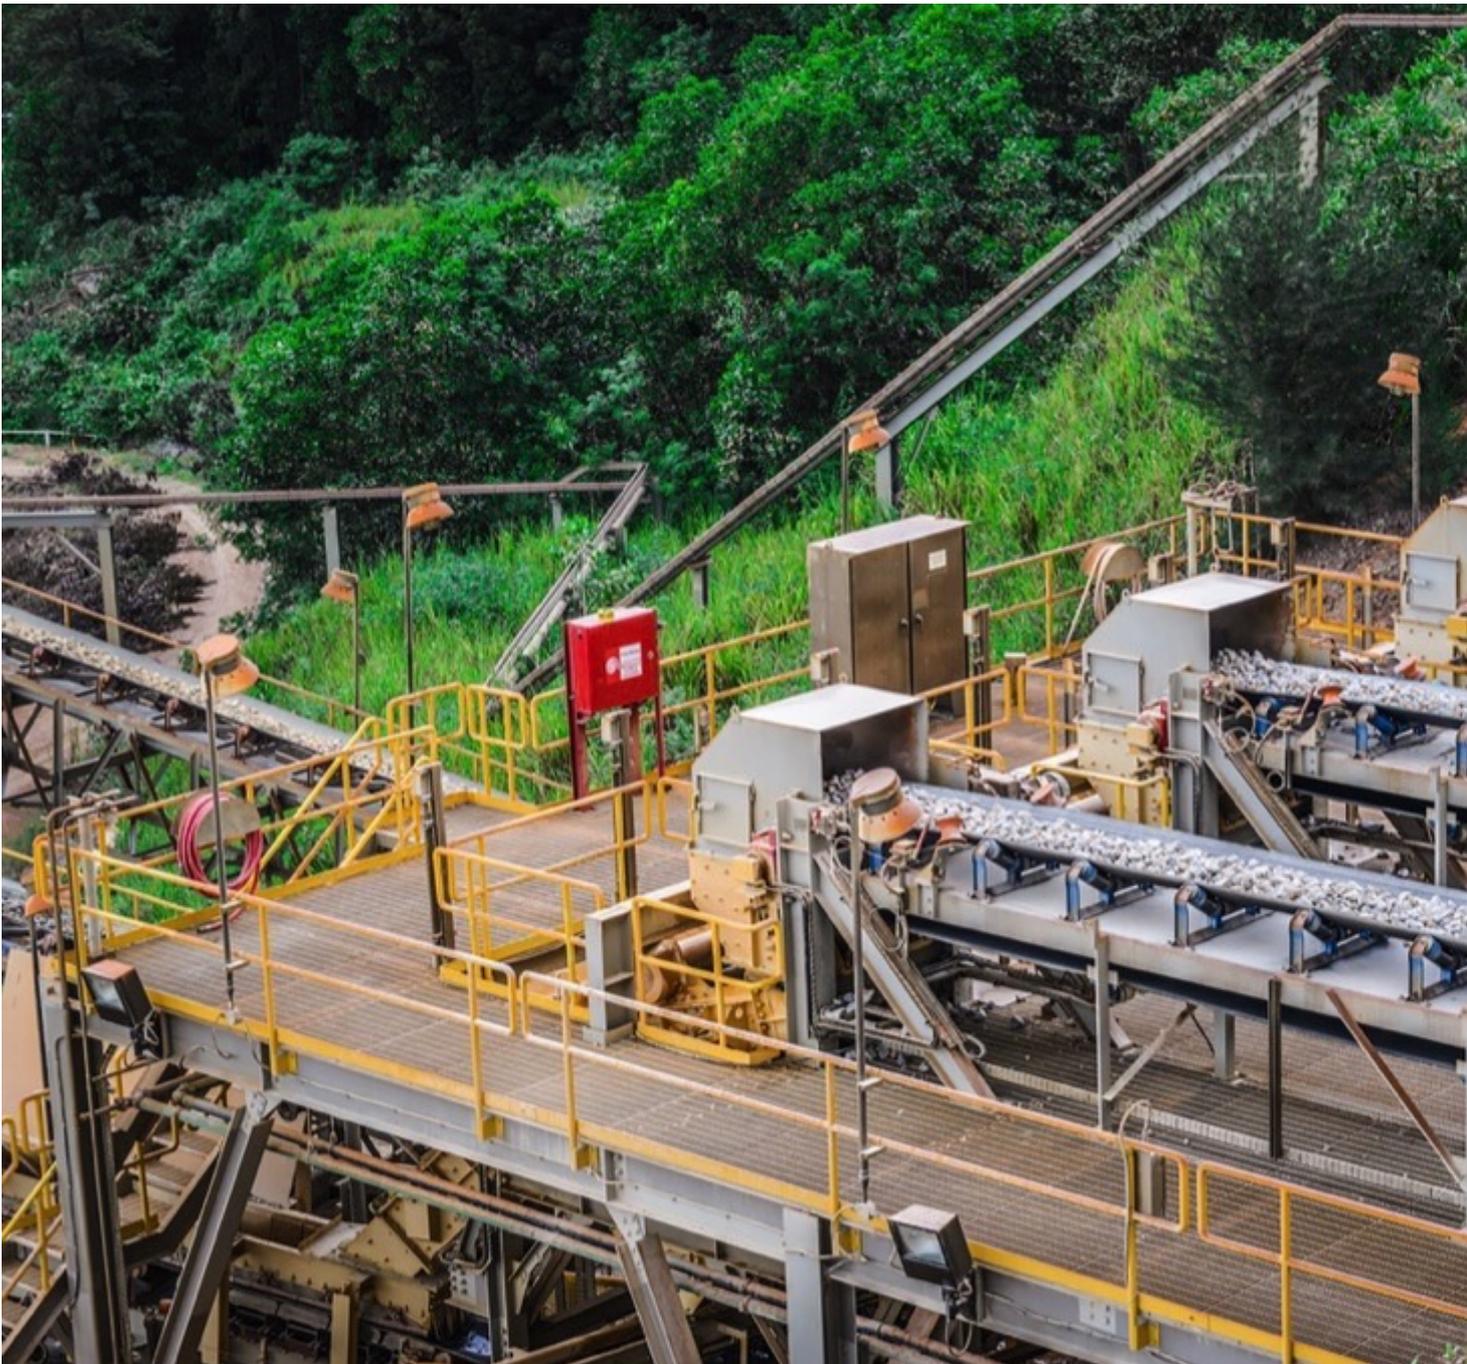
The original conveyor belt cleaners could not manage the overburden, resulting in carryback that caused

equipment failures and downtime.

The original primary and secondary belt cleaners and dust suppression systems were not adequately addressing the overburden. “Our search for a solution included Martin Engineering, due to their reputation in the industry,” said Power. “We wanted to quality test all of our options, so we also included the original equipment manufacturer and a third supplier. ”Martin Engineering representatives created a full site report, complete with assessments and equipment recommendations. Along with the report, the team added a presentation containing budget and timeline to help site managers explain the issues, needs and solutions to company executives. Once the corporate office gave the green light, technicians from each competitor attached belt cleaners to three of the site’s main discharge points. Martin Engineering equipment was installed on the large discharge belt that presented the most carryback. “The superior product was immediately apparent once the quality testing phase started,” Lenart said. “Though testing lasted for weeks, the Martin product was more effective, hands down.”

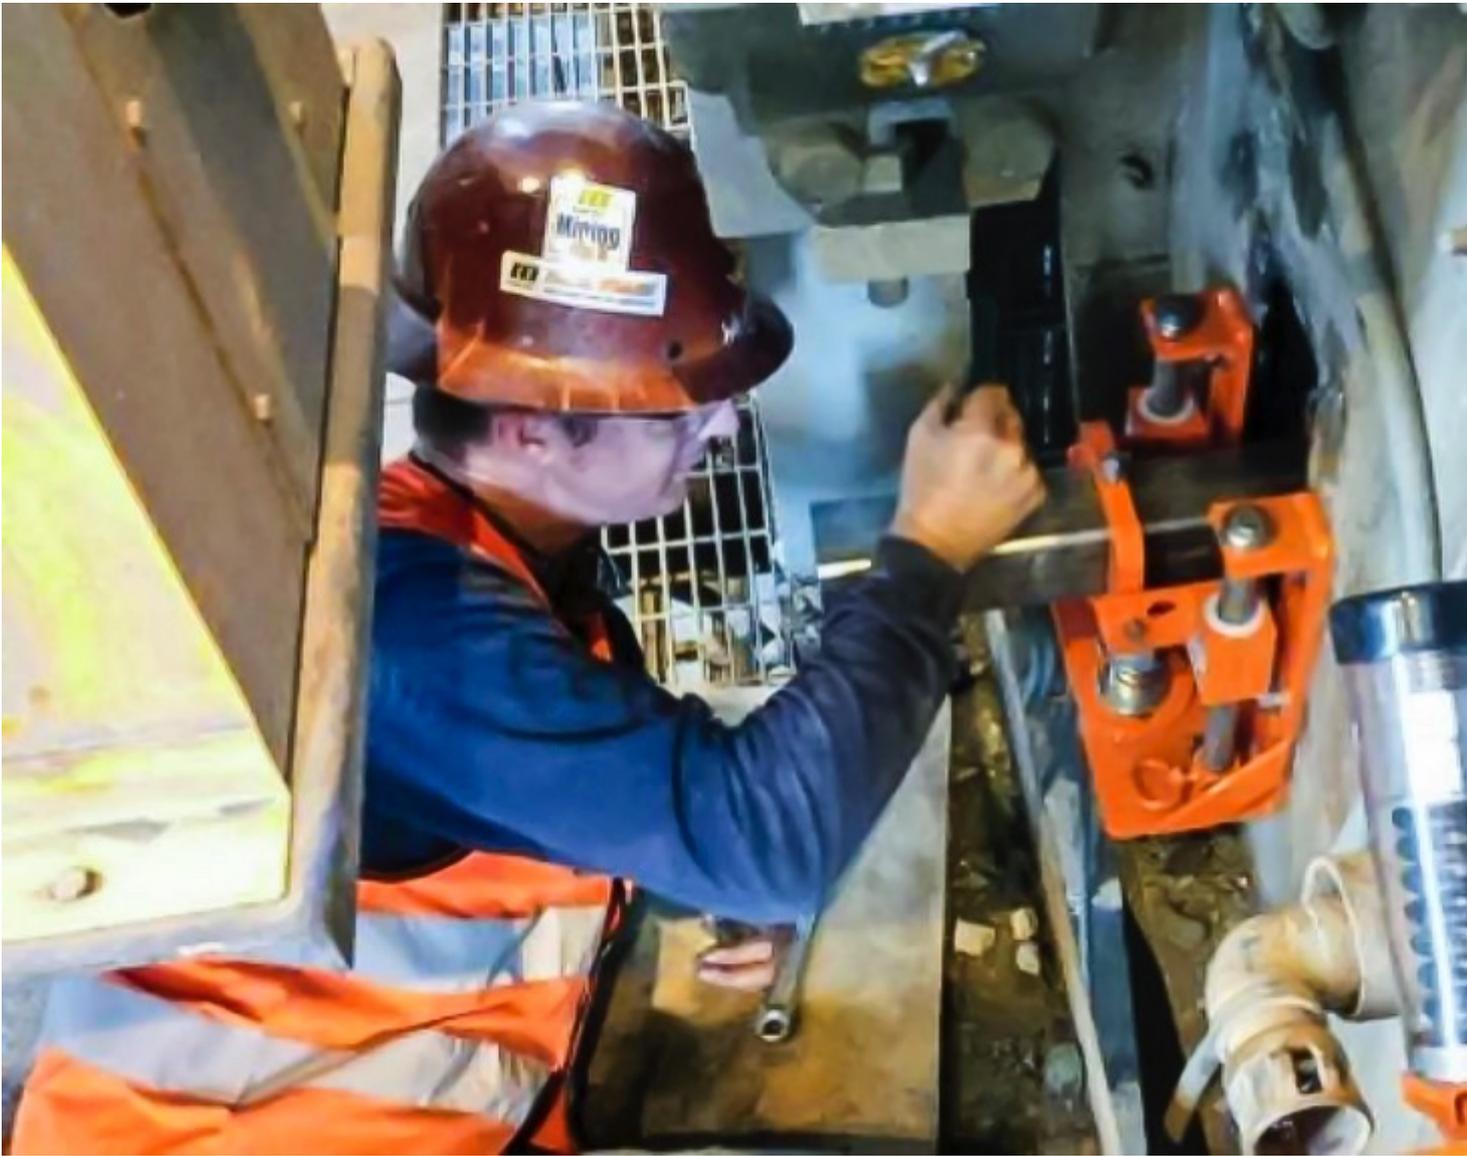
Martin Engineering replaced existing primary cleaners at sixteen discharge points, fitting them with low-adhesion urethane blades.

Barrick accepted most of the team's recommendations, and installation took just two weeks. Martin Engineering replaced the existing belt cleaners with QC1-Cleaner XHD primary belt cleaners at sixteen discharge points. These extra heavy-duty units are able to handle speeds of up to 1,200 FPM (6.1 m/s) on belts as wide as 96 inches (2.438 meters) and pulley diameters of more than 30 inches (762 mm). Installers fitted them with low-adhesion urethane blades specifically designed for sticky and tacky material. Able to withstand temperatures from -20° to 160° F (-30° to 70°C) with up to 12 inches (305 mm) of wear life, the blades endure high summer temperatures and constant production schedules with more time between replacements. "The curved scraper is designed in sections, adjusted individually to conform to the belt, assuring continuous contact across the belt profile," said Granata. "Martin manufactures different cleaning blades, which

specifically address the chemical make-up of almost all types of conveyed bulk materials.”

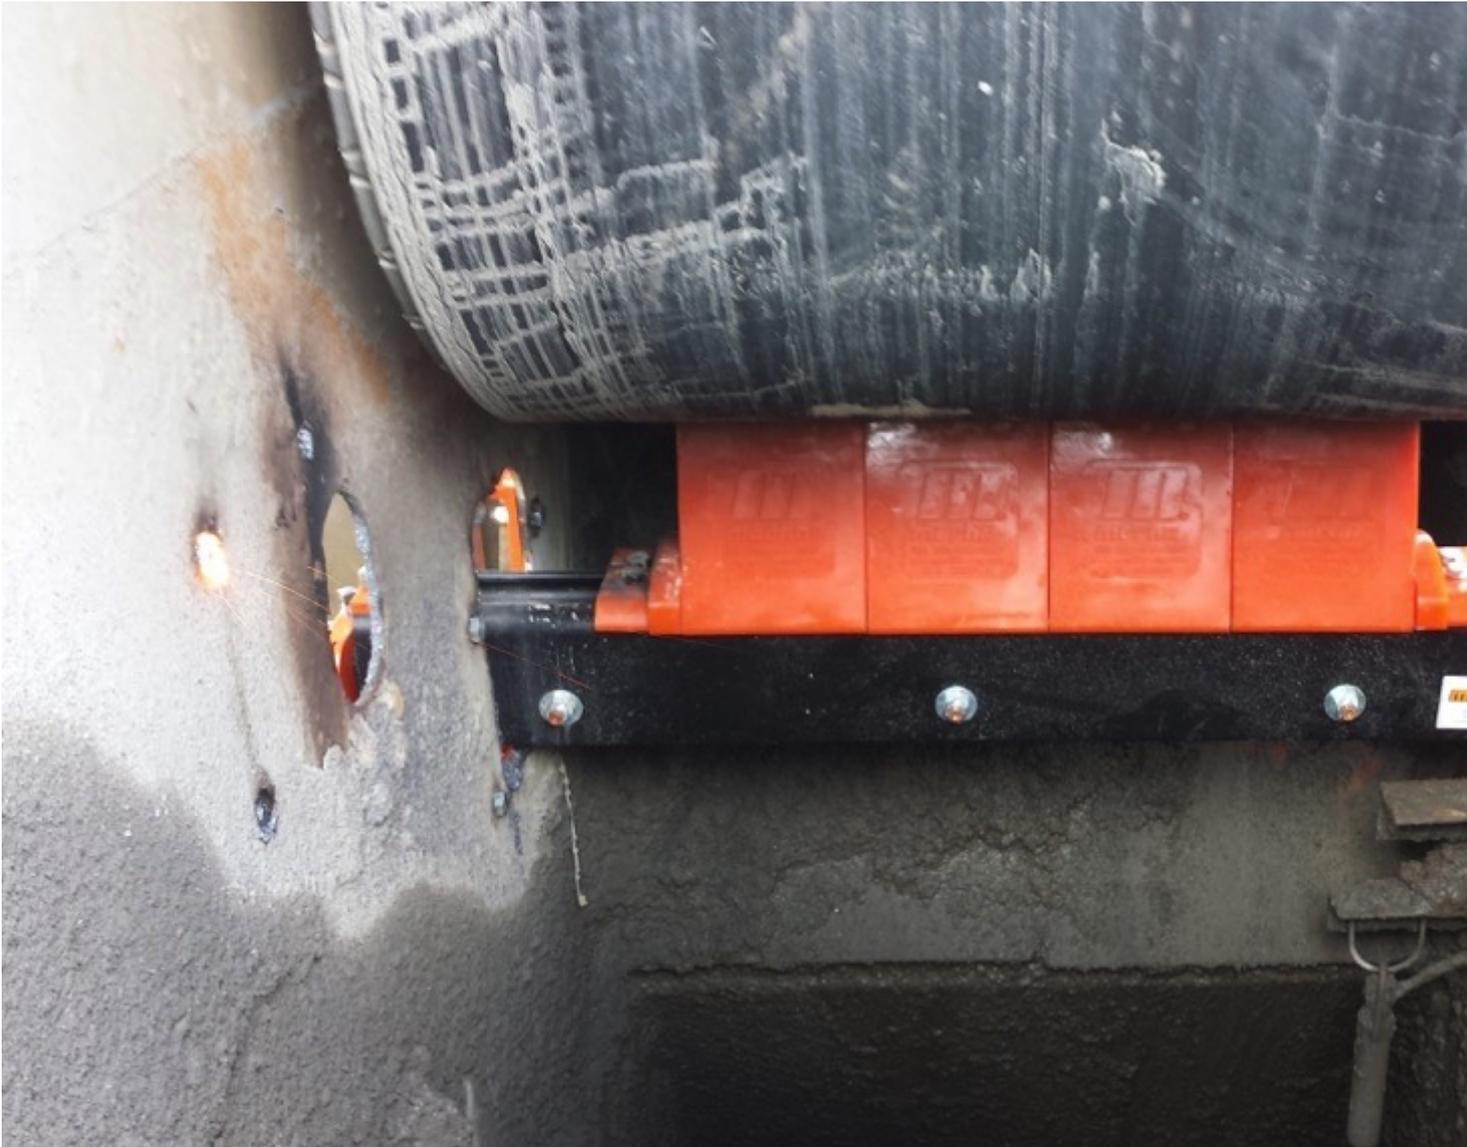
Sixteen additional secondary belt cleaners were attached behind the header, equipped with tungsten tipped blades.

Sixteen additional Martin DT2H secondary belt cleaners accompanied the primary units to mitigate belt fouling. Attached two to three feet behind the header, the units were equipped with tungsten tipped urethane blades suited for heavy-duty applications. To avoid product loss due to fugitive material, the Martin Engineering team also installed 300 feet of Apron seal skirting constructed from 70 durometer EPDM rubber composite for its low abrasion index characteristics.

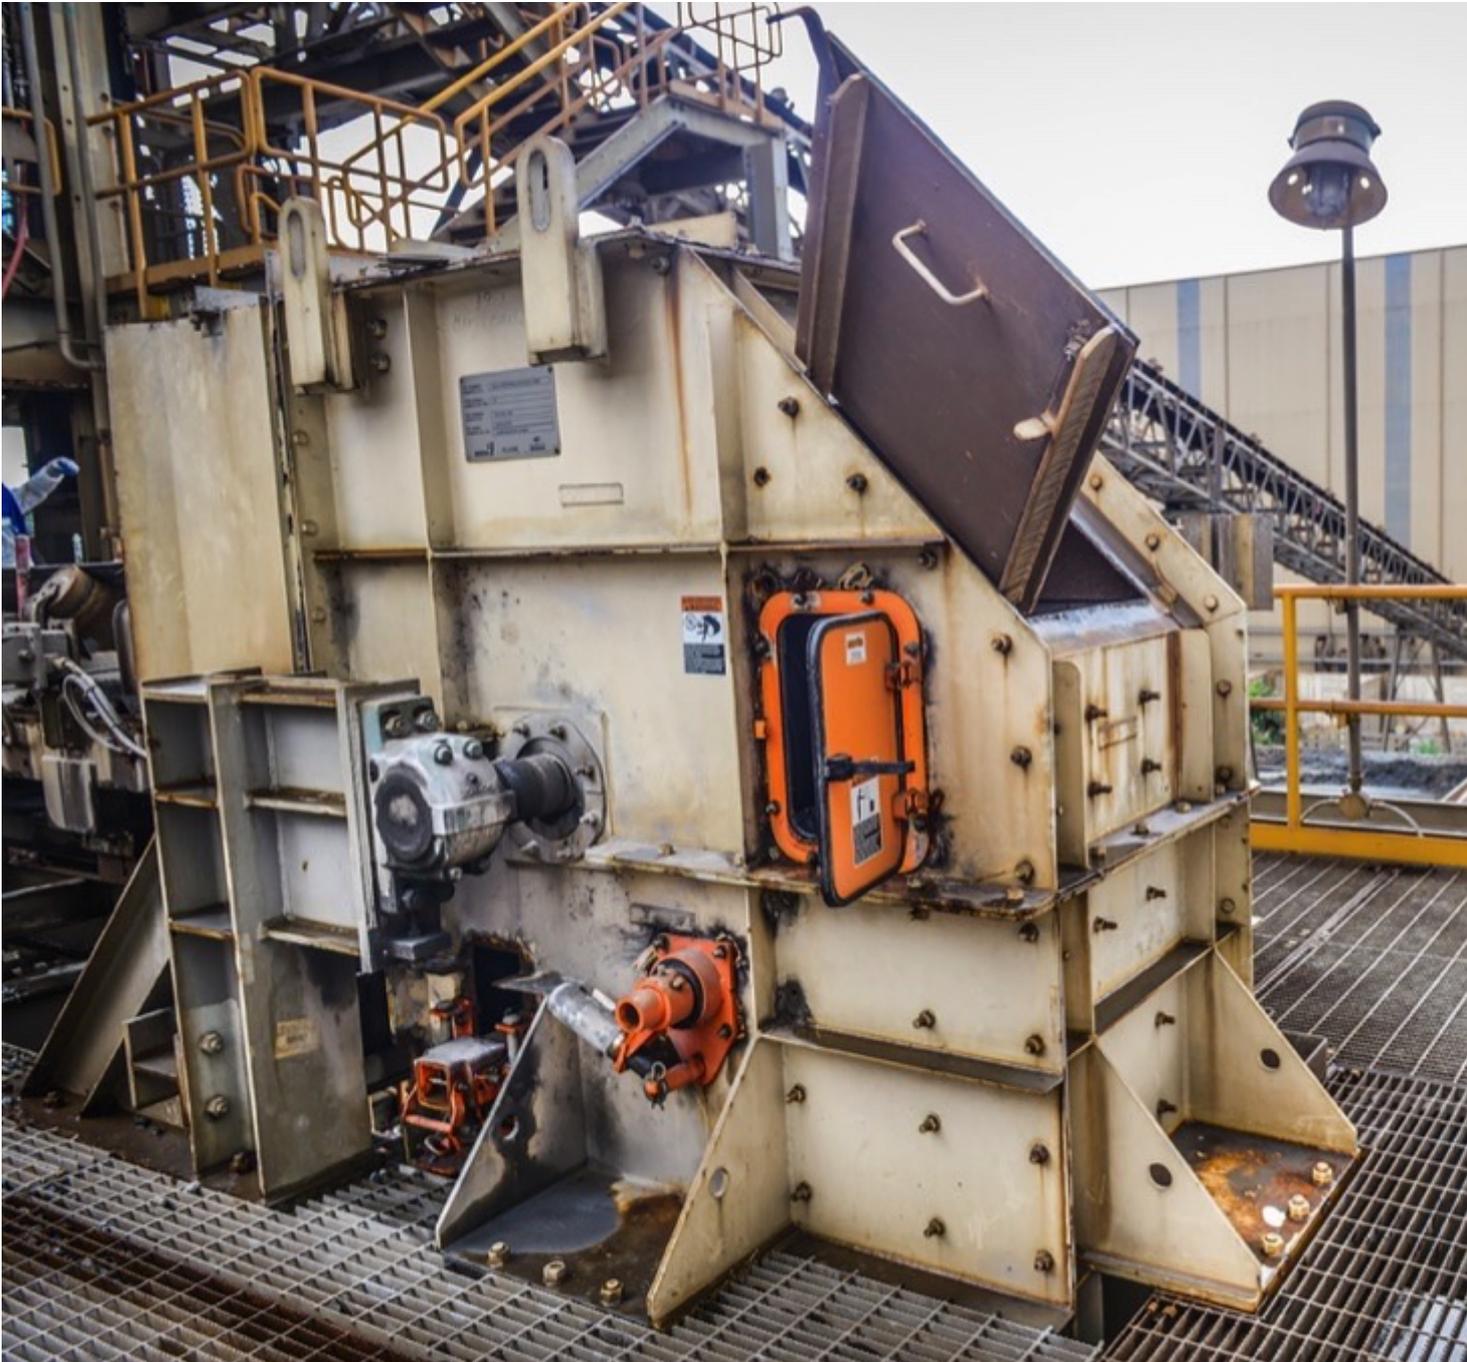
Access doors and view points facilitate routine observation of potential trouble spots and contribute to easier maintenance.
