Less Spillage - less Costs! Conveyor Upgrade tackles Dust and Spillage at Coeur Rochester Mine

[Published in bulk solids handling, Vol. 36 \(2016\) No. 4](#)

After almost 30 years of utilization, a North-American Silver- and Gold-Mine took action together with specialists of Martin Engineering to update its conveyor system with improvements regarding safety, spillage reduction, endurance and efficiency.

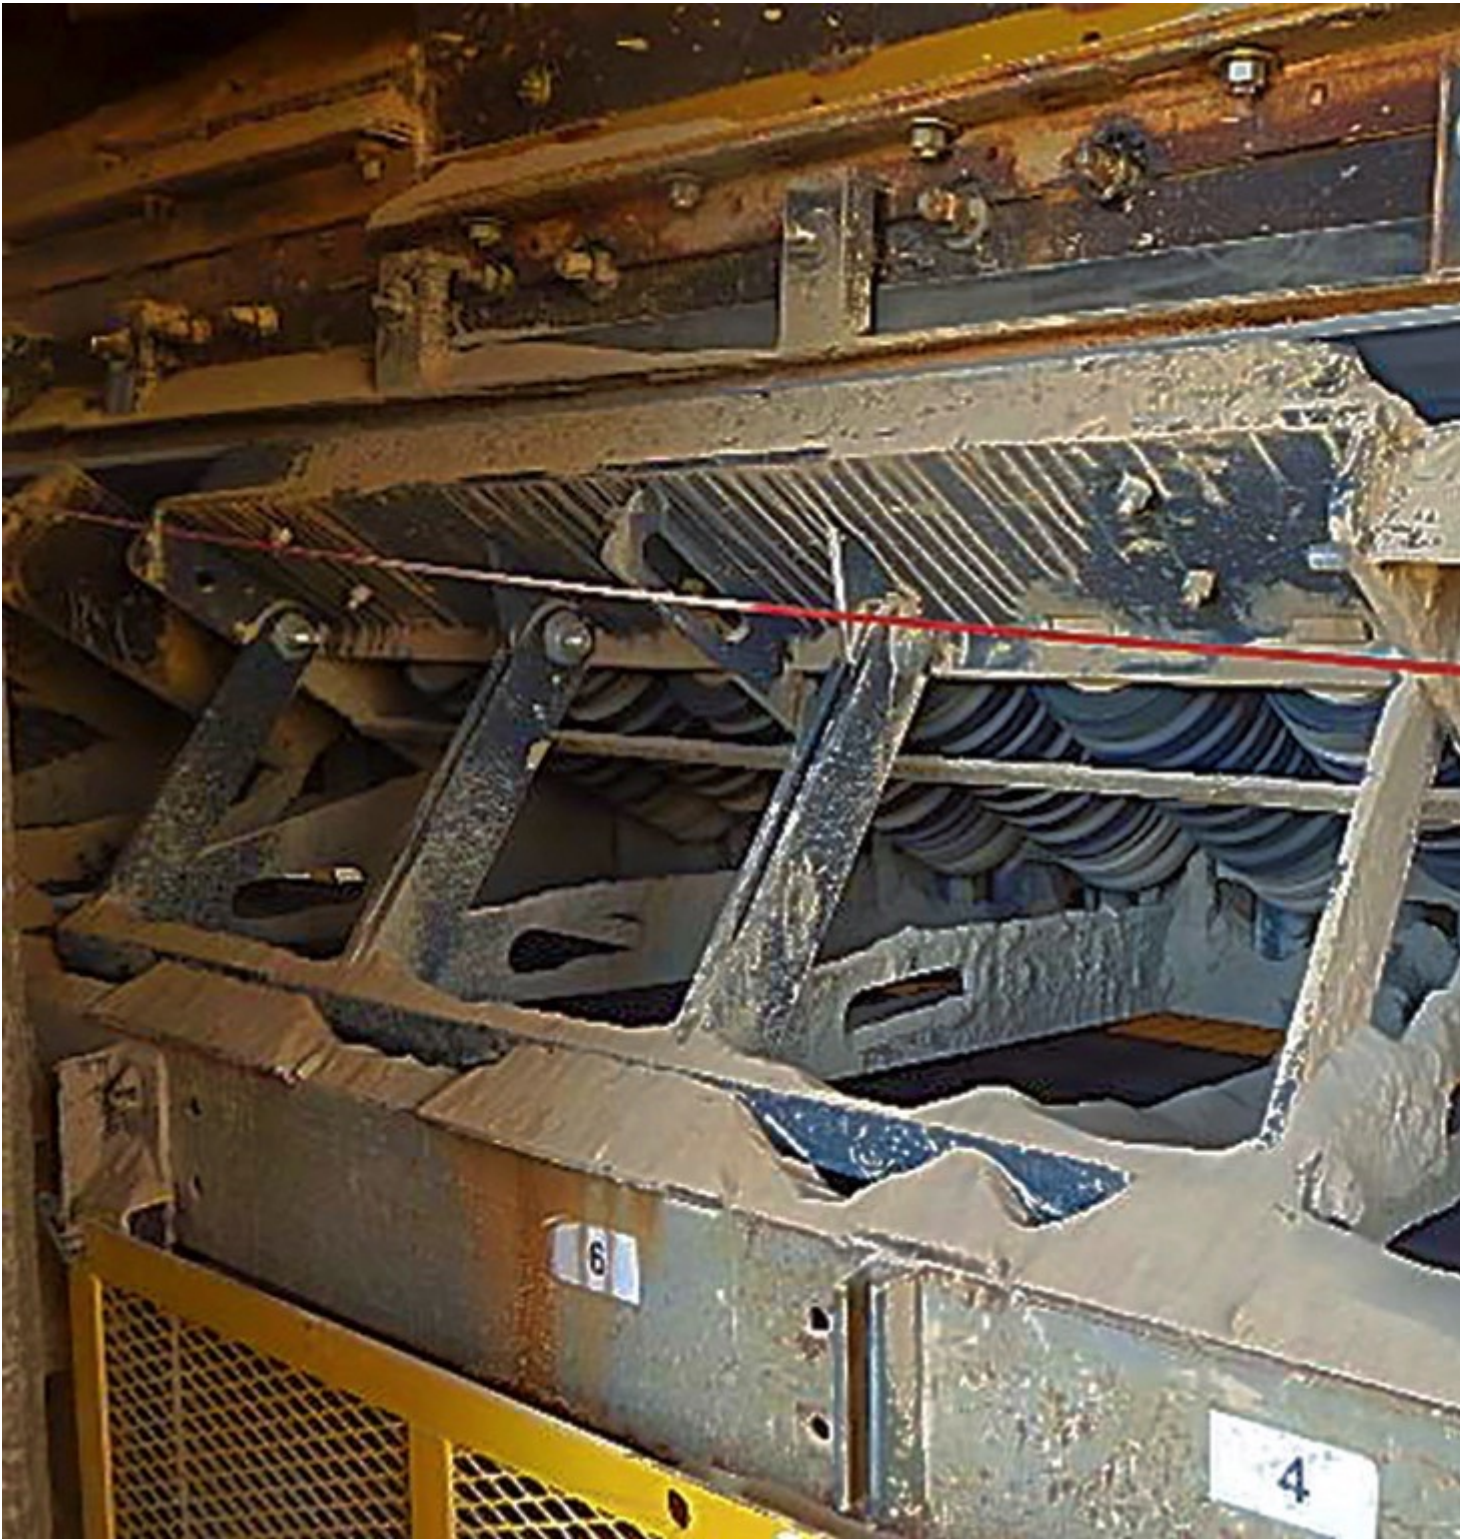
Conveyor B was chosen as the starting point with the most potential for improvement, a 48-inch (122 cm) wide belt running at 386 FPM (1.95 m/s), with a 40-foot (12.2 m) chute wall. With a troughing angle of 35°, conveyor B handles nearly 1500 tph of rock that has been sized to 4-inch (10.2 cm) minus, carrying it from the secondary cone crusher to the surge pile stacker. It's loaded directly by a vibrating grizzly feeder under the chute and the secondary crusher. "There's a long fall going to the secondary crusher, and that creates a huge disturbance in the material flow," explained crusher Operations / fixed plant maintenance superintendent Wayne Maita. "We were seeing a lot of dust and spillage in that area. It not only affected the air quality and presented a potential safety risk from accumulated material on floors and structures, but it also meant putting operational personnel in close proximity to the moving conveyor for cleanup." (Fig. 2)

Fig. 2: Dust and spillage created a maintenance burden and potential safety hazard (Picture: © Martin Engineering)

Maita estimated that dealing with the spillage required 5-10 man-hours per day, seven days a week. So in addition to the safety aspect of the fugitive material, there was a significant cost in wasted labor. Coeur also noticed belt damage occurring as a result of fugitive material. "As material escapes, it accumulates on

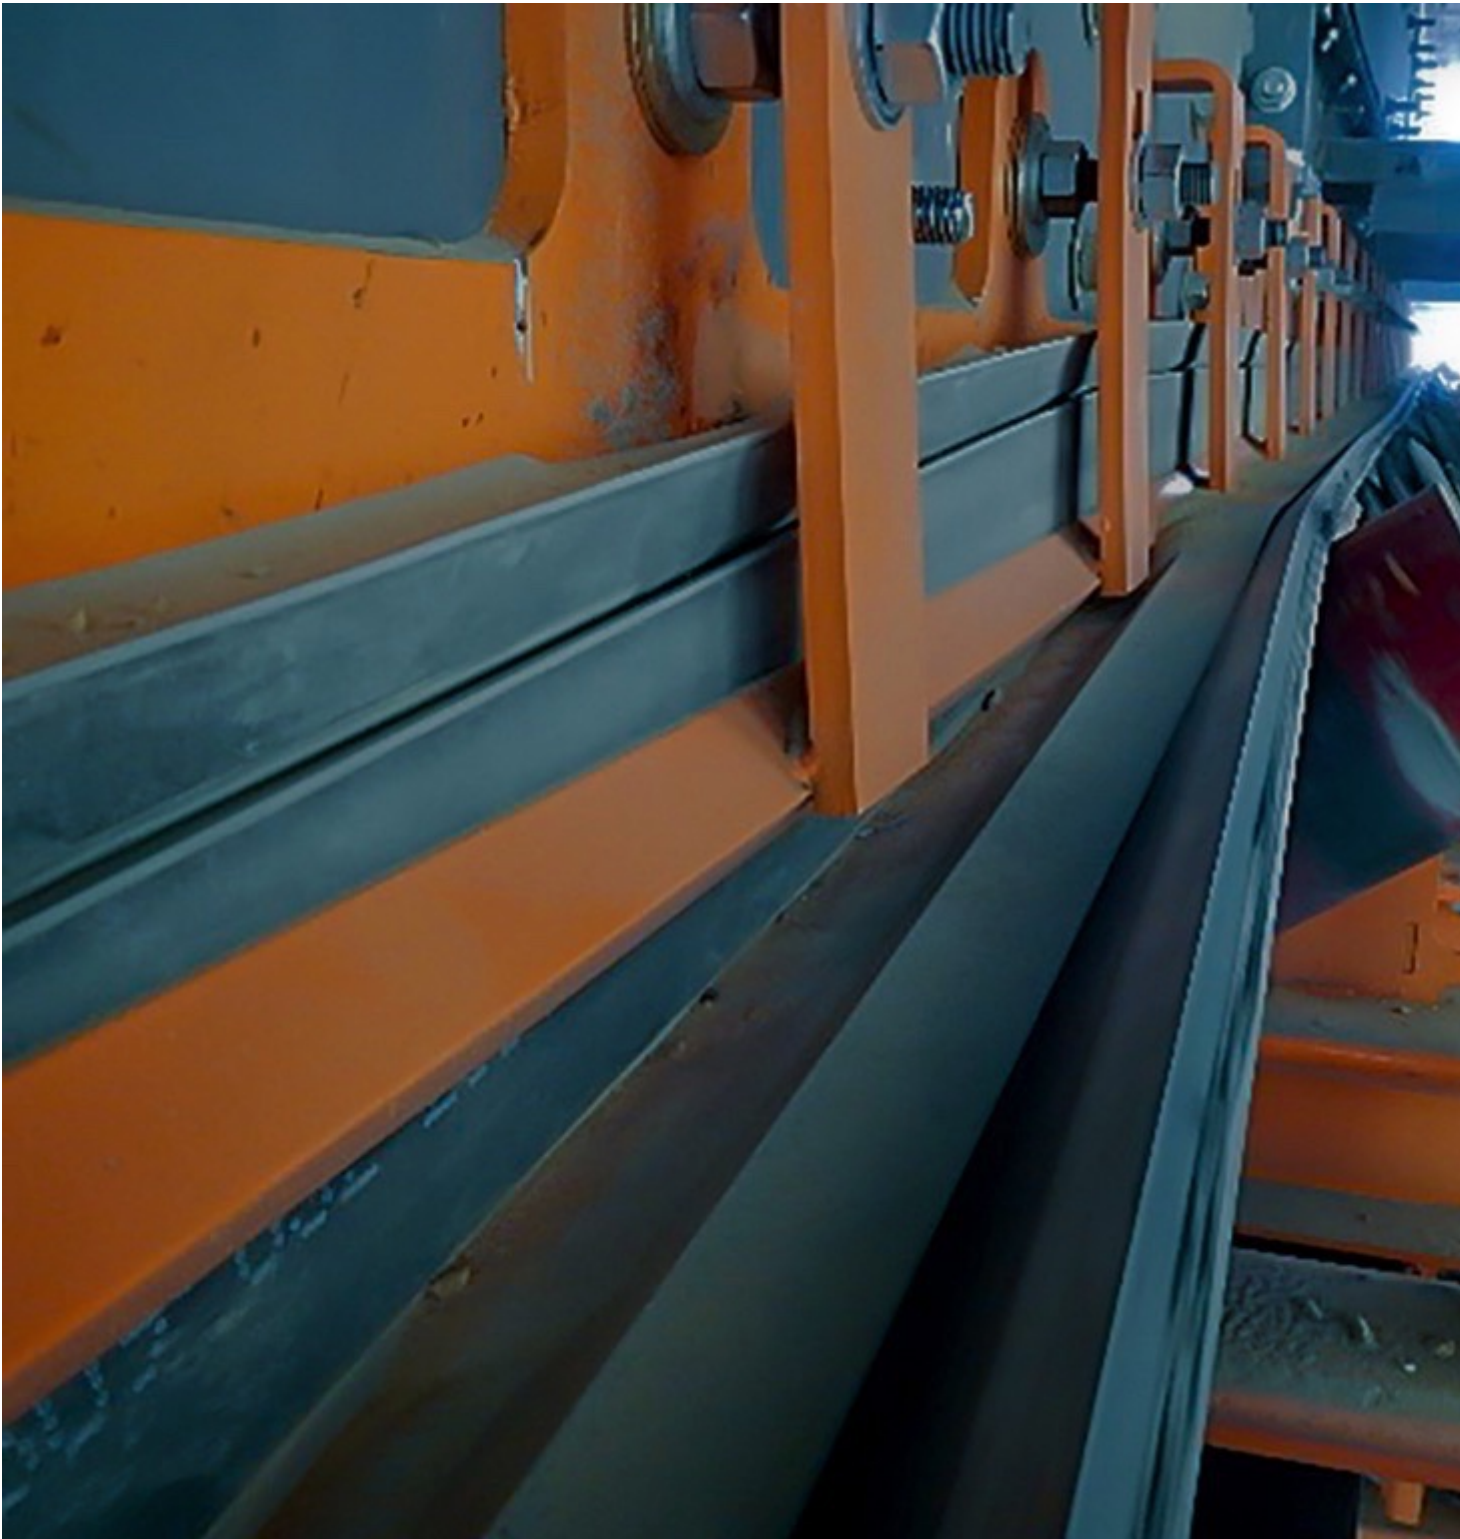
Fig. 3: Impact cradles absorb the force of the falling load, yet slide in and out for easy service. (Picture: © Martin Engineering)

The cradles employ Martin Engineering's Trac-Mount technology, allowing the units to slide in and out easily for maintenance or replacement. The modular components are light enough to be removed by one person, without using heavy lifting equipment. "Conveyor downtime is extremely expensive, especially for

high-speed operations,” Marshall added. “The longer components last and the easier they are to replace, the lower the cost of ownership.” (Fig. 3) Technicians also installed five EVO slider cradles with low-friction bars to support the belt edges and stabilize the belt line, eliminating belt sag and bounce. The slider cradles are also track mounted for ease of installation and maintenance. Located in the chute box after the impact cradles, the units feature “double-life” slider bars, which offer a superior seal with low friction. The proprietary box design allows each bar to be flipped over at the end of its useful life to provide a second wear surface. The result is a flat and stable belt surface throughout the settling zone, reducing fugitive material and extending belt health.

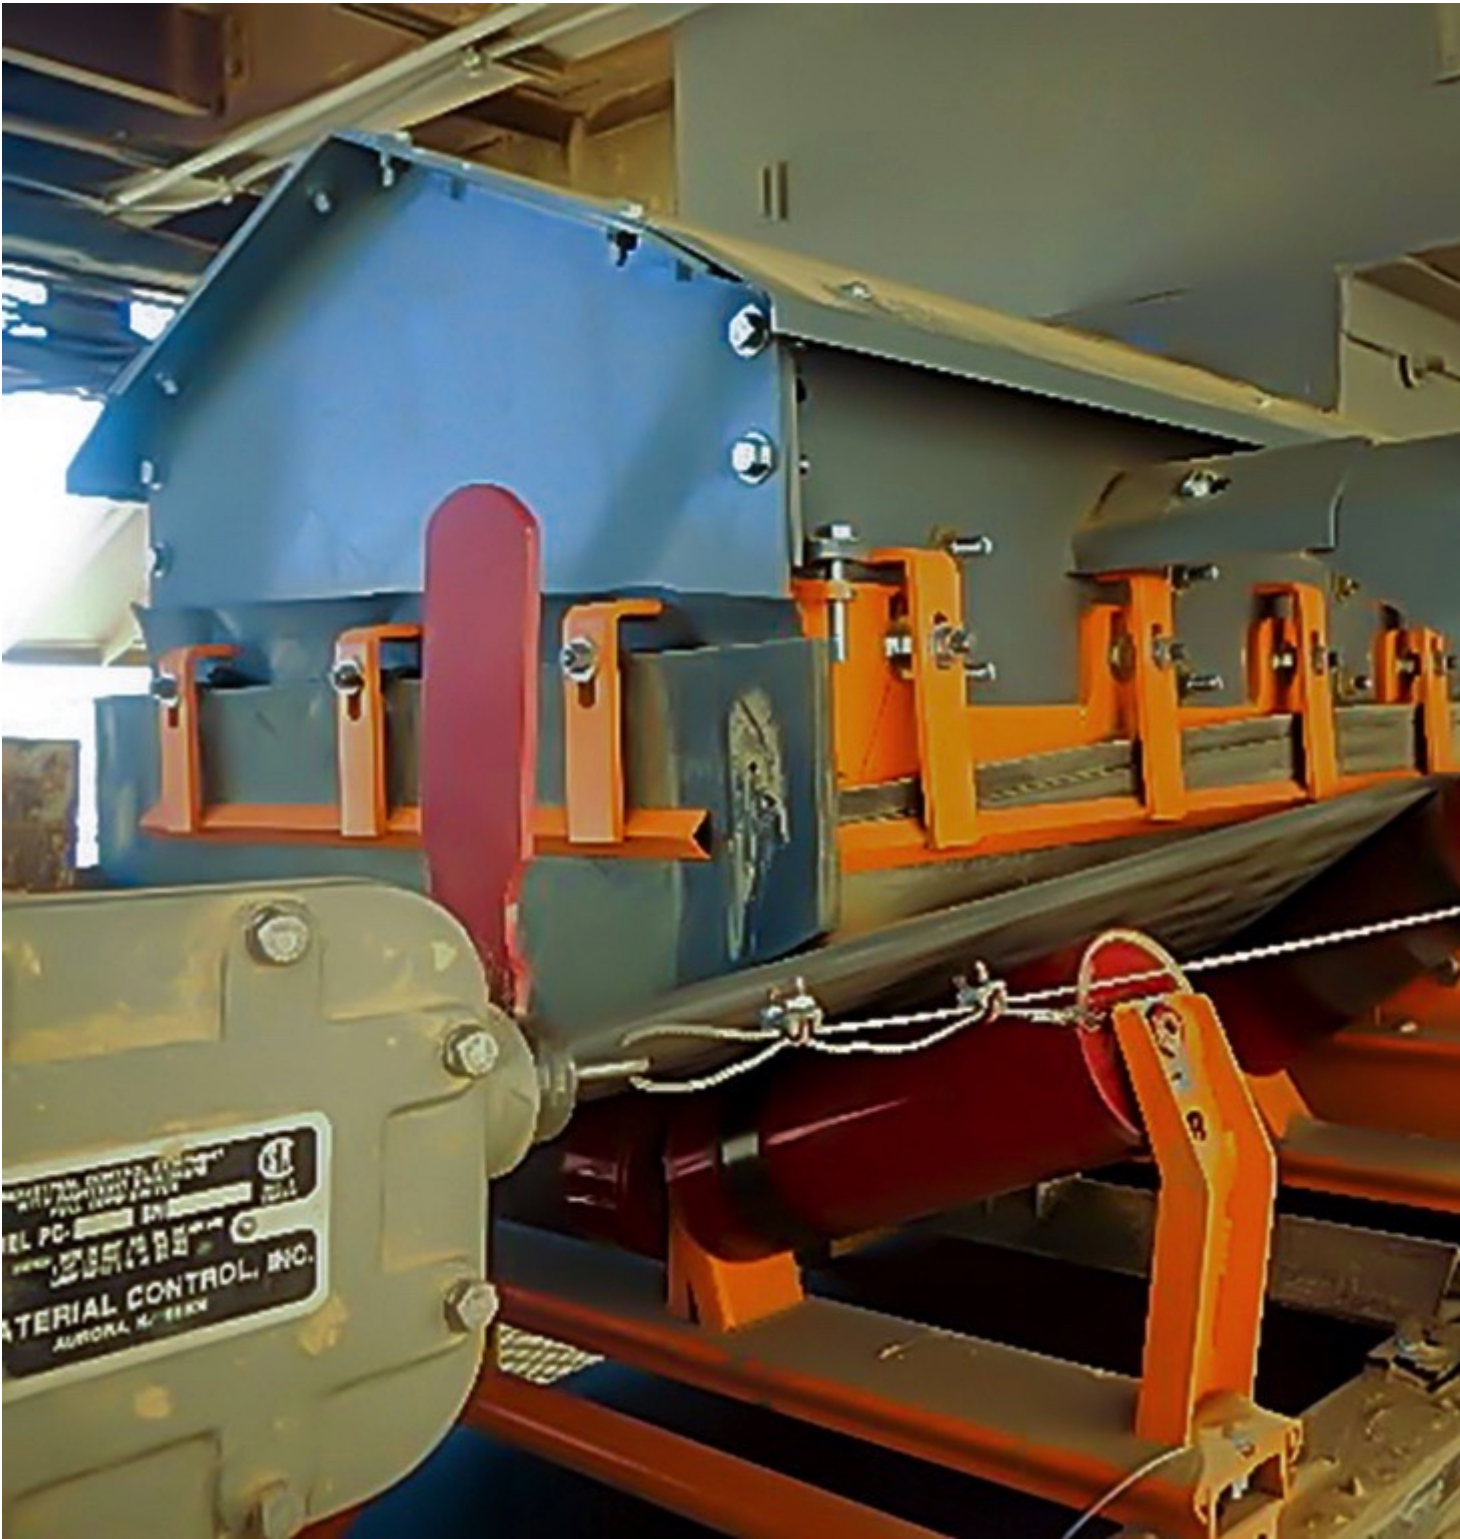
Forty feet (12.2 m) of modular chute wall was used to replace the old structure, with a tail box and integrated dust curtains. A chromium carbide overlay on the inside protects the new containment system from intermittent high-burden depths on the conveyor. (Fig. 4)

Fig. 4: The modular chute wall allows easy installation of skirt boards and stilling zone components to manage dust. (Picture: © Martin Engineering)

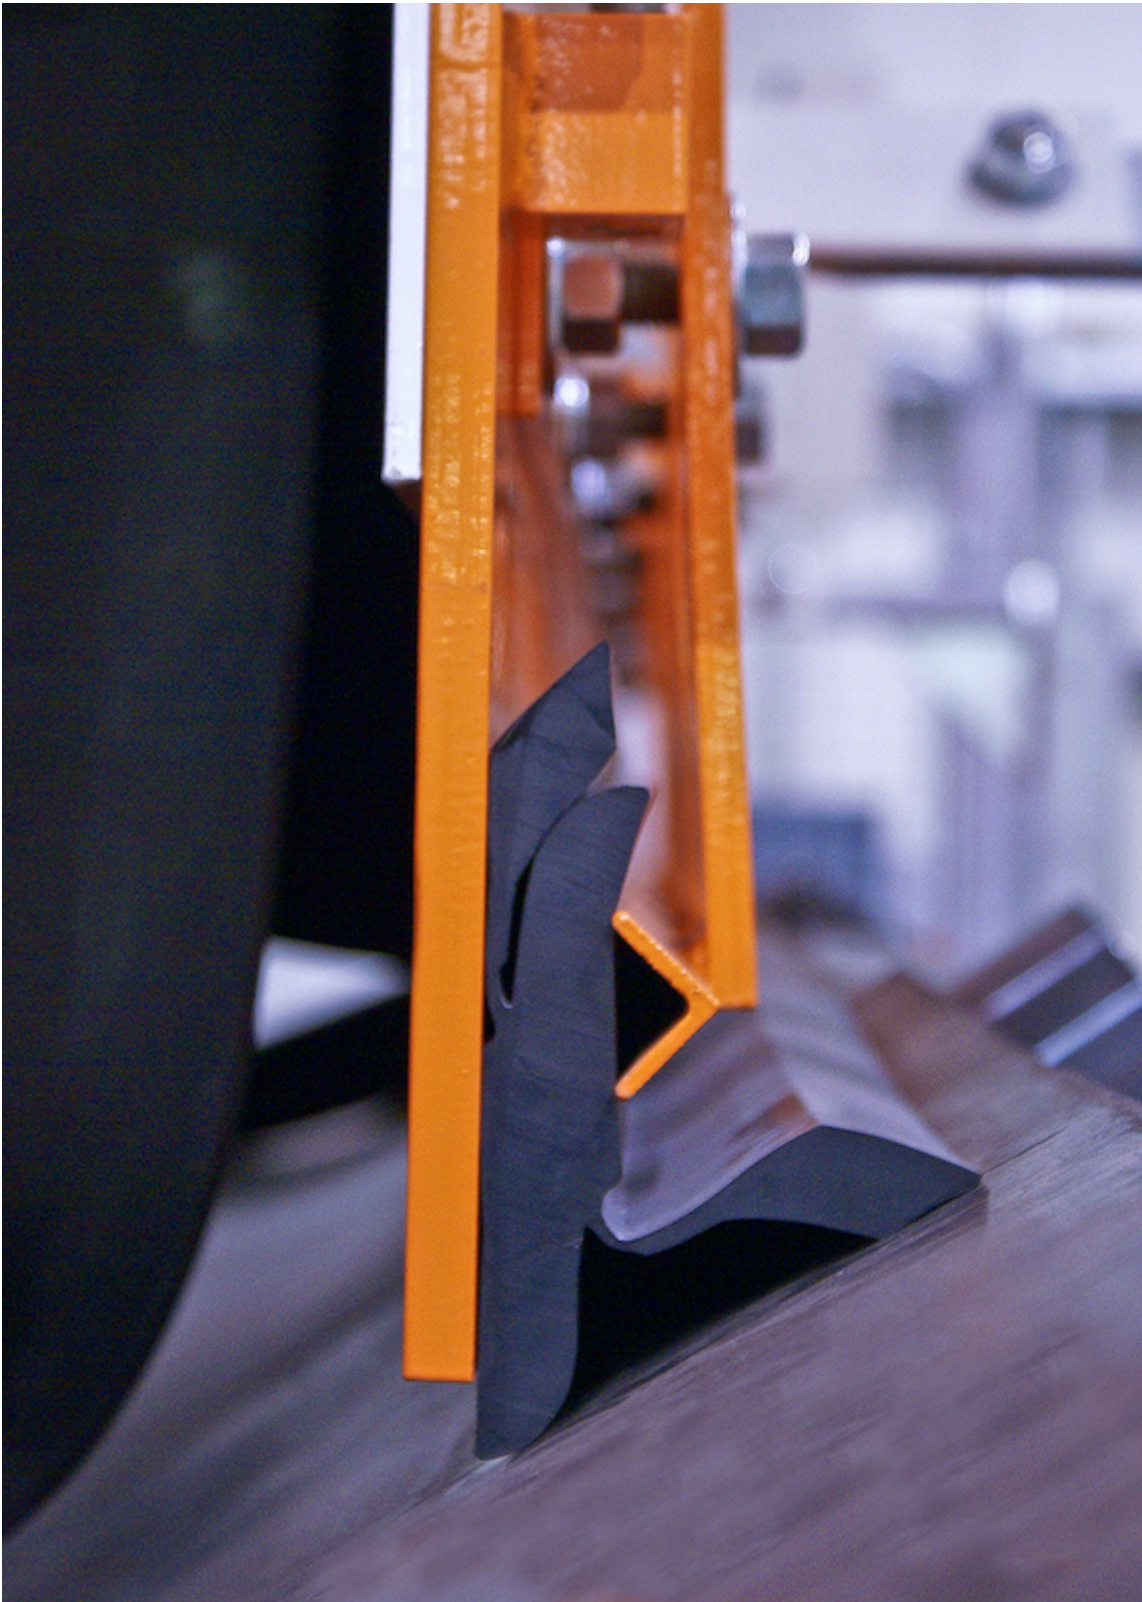
Fig. 5: The primary seal is clamped to the steel skirtboard and a secondary “outrigger” strip captures the fines.
(Picture: © Martin Engineering)

The design was the first dual-sealing system for belt conveyors, incorporating a primary seal clamped to the steel skirtboard to keep lumps on the belt and a secondary or “outrigger” strip to capture any fines or dust particles that pass

beneath the primary seal. The secondary seal lies gently on the belt and self-adjusts to maintain consistent strip-to-belt pressure (Fig. 5). To maintain a straight and consistent belt path, technicians then installed a Martin heavy duty Tracker belt tracking system, both upper and lower units- Rollers attached to the end of a sensing arm assembly ride both sides of the belt edge detect slight misalignments initiated by unbalanced loads and fouled rollers, using the force of the belt to immediately adjust the belt's position and realign the path. To address belt carryback and further reduce the chance of fugitive material, a dual belt cleaner system was mounted on the face of the head pulley. The primary unit is a QC1 cleaner XHD, engineered to deliver durable belt scraper performance in challenging applications. The unit's patented CARP (constant angle radial pressure) design maintains cleaning performance through all stages of blade life. Directly after the primary cleaner is a DT2 inline cleaner XHD, a secondary conveyor belt scraper featuring rugged blades, with its installation allowing quick blade replacement to increase the conveyor's availability. The design's individual belt cleaner blade segments slip into a sturdy track-forming cartridge, which slides over the stainless steel mainframe for simple installation.

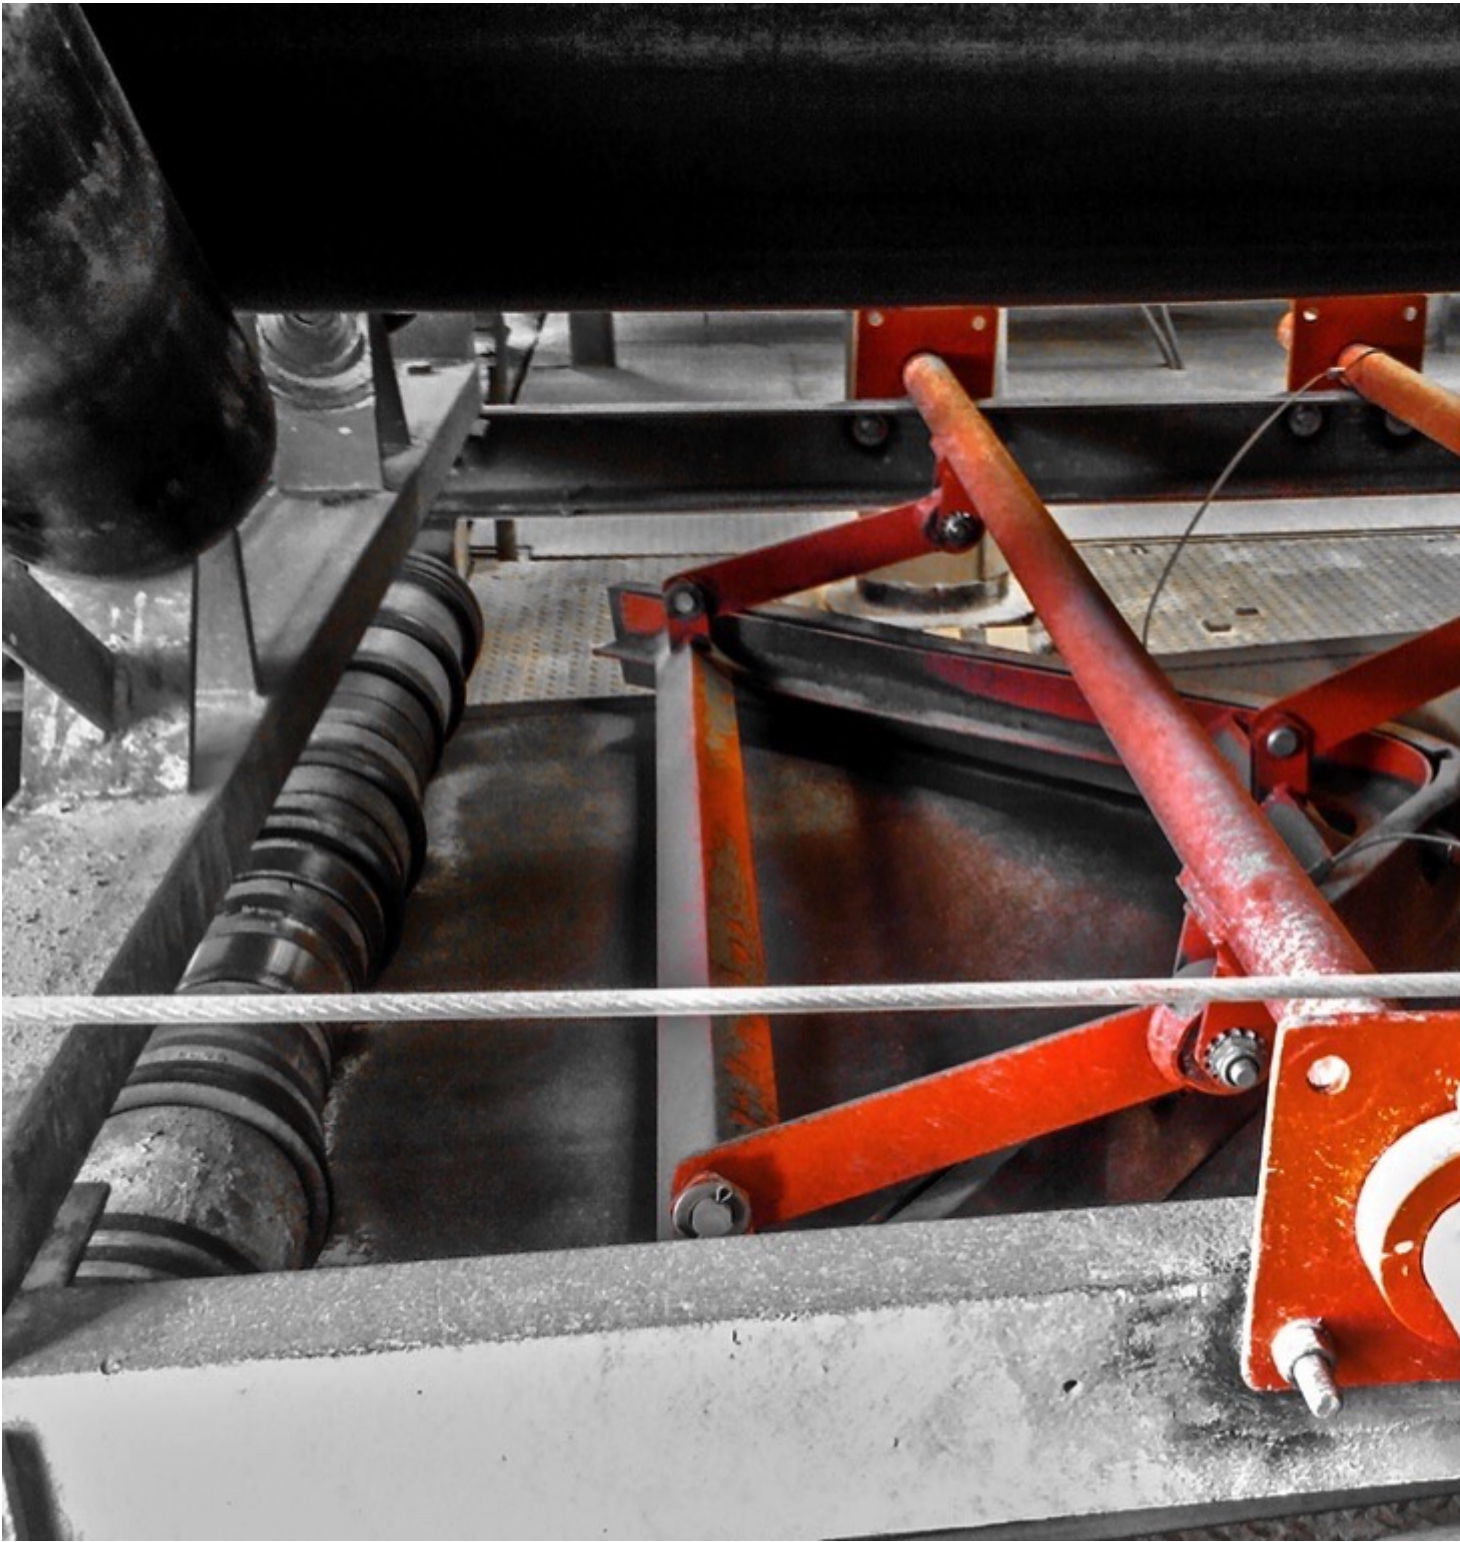
Fig. 6: The V-Plow features spring-loaded suspension to rise and fall with fluctuations in belt tension and travel. (Picture: © Martin Engineering)

A final belt protection mechanism was installed at the tail pulley. To fight the potentially damaging effects of fugitive material on the return side of the belt, the Martin Torsion V-Plow is engineered with a unique spring-loaded suspension system that allows the plow to rise and fall with fluctuations in belt tension and

travel. Attached with dual steel crossbars bolted to the conveyor frame a few feet from the tail pulley, the unit is secured by two heavy-duty safety cords. (Fig. 6)“Bulk material bounces when it comes in contact with a fast moving conveyor and often shifts as it travels over carrying idlers.” explained Marshall. “Occasionally, some material ejected from the belt will be collected on its non-carrying side. If trapped between the tail pulley and the belt they can do significant damage to both.”

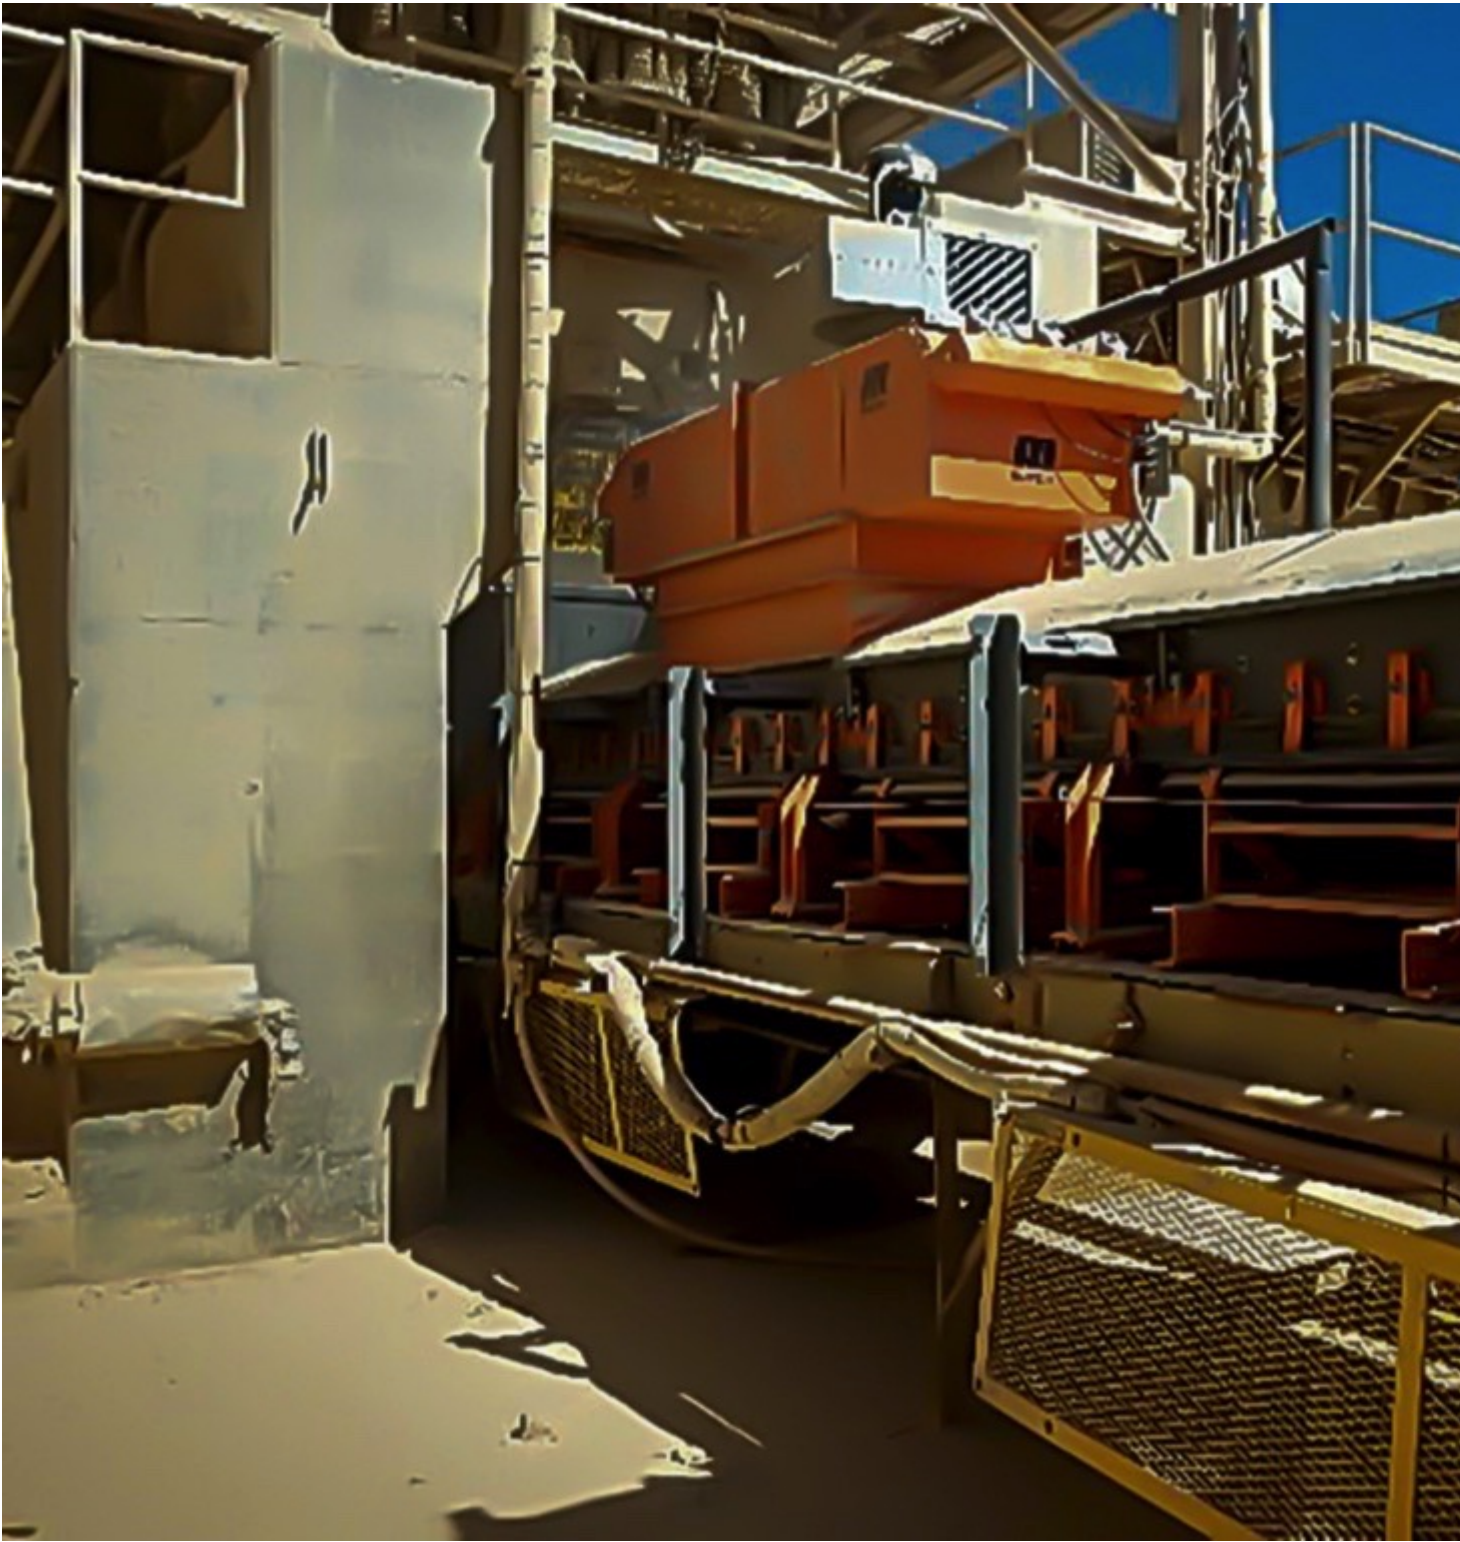
To complete the containment system, technicians also installed an integrated air cleaner, which contains a suction blower, filtering elements and a filter cleaning system. Instead of a centrally located unit connected to dust generation points via ductwork, the Martin air cleaner is incorporated into the dust generation point itself. The particles are not extracted, but are instead collected within the enclosure and periodically discharged back into the material stream using a pulse of compressed air. As material is captured by the filters, it agglomerates against the filter media. When the filter media is pulsed, the material will fall. If it is agglomerated and large enough, it will fall back into the material stream. The pulse system is designed to alternate pulses to each filter element. When one filter is being pulsed, the adjacent filter is still drawing air. If a pulsed particle is too small to drop out of the air stream, it is immediately pulled into an active filter. (Fig. 7)

Fig. 7: The integrated air cleaner is an independent unit positioned directly at a dust generation point. (Picture: © Martin Engineering)

Like the central system, integrated units use negative pressure, with airflow created by a blower sized to provide the airflow needed for the pickup point. As there is no ducting, there are no pressure losses other than the filters that must be accounted for. Because of this, the power requirements of an integrated air

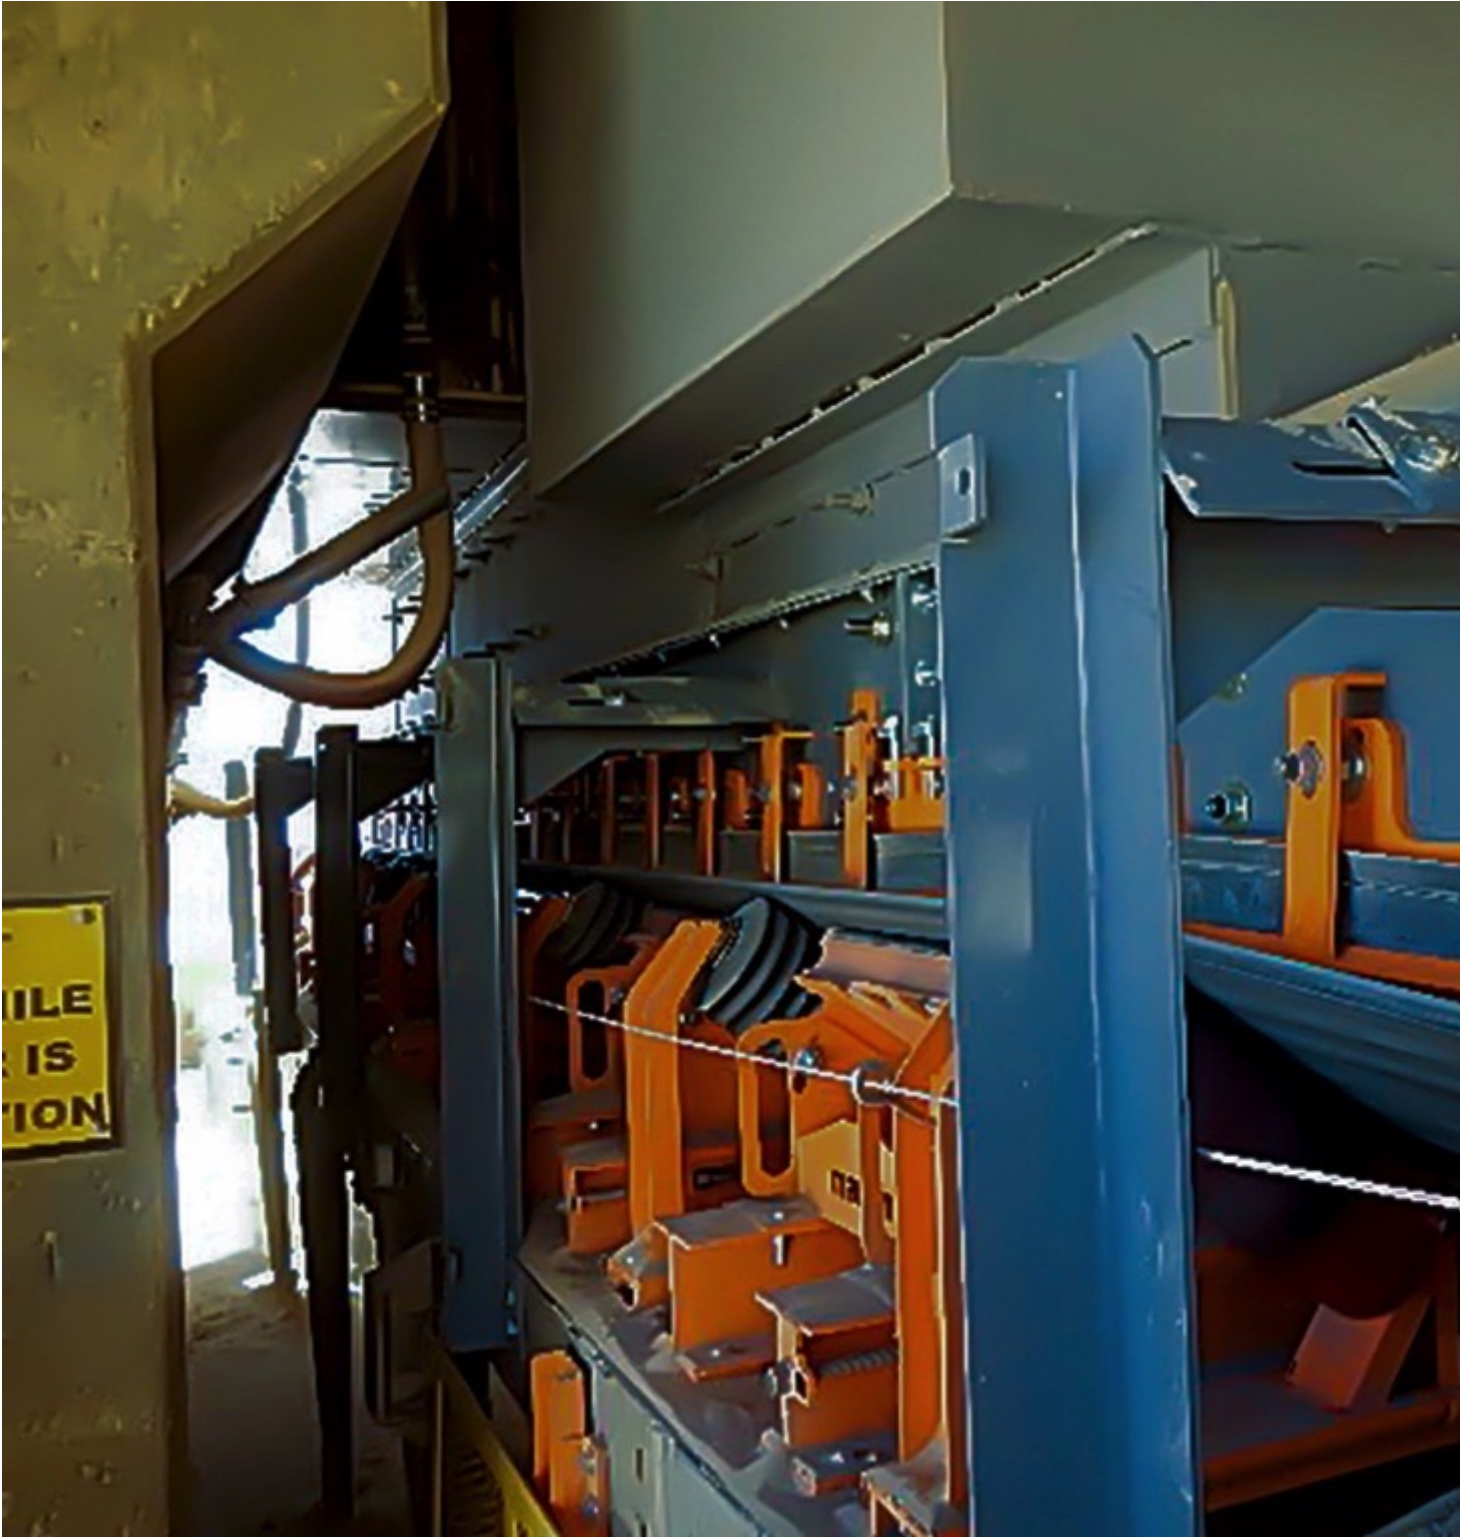
cleaning system are far lower than for central collection systems. The entire upgrade was completed within the seven-day shutdown, and the results were immediately apparent. Instead of spending 7 to 10 man-hours per day in the past, now there is one man going down there with a broom every few days.

Fig. 8: The upgraded conveyor now requires only minimal clean-up, instead of as many as 70 man-hours per week.

Coeur Rochester is currently evaluating five additional conveyor areas for its next upgrade, with a plan currently under development to address those locations in 2016. “We’re extremely happy with the system,” Maita concluded. “The installation was well done, and changed a nightmare into an extremely functional system that operates at a high level.” (Fig. 8)
