Whitepaper

Martin Engineering: Reduce Conveyor Maintenance Time through better Access

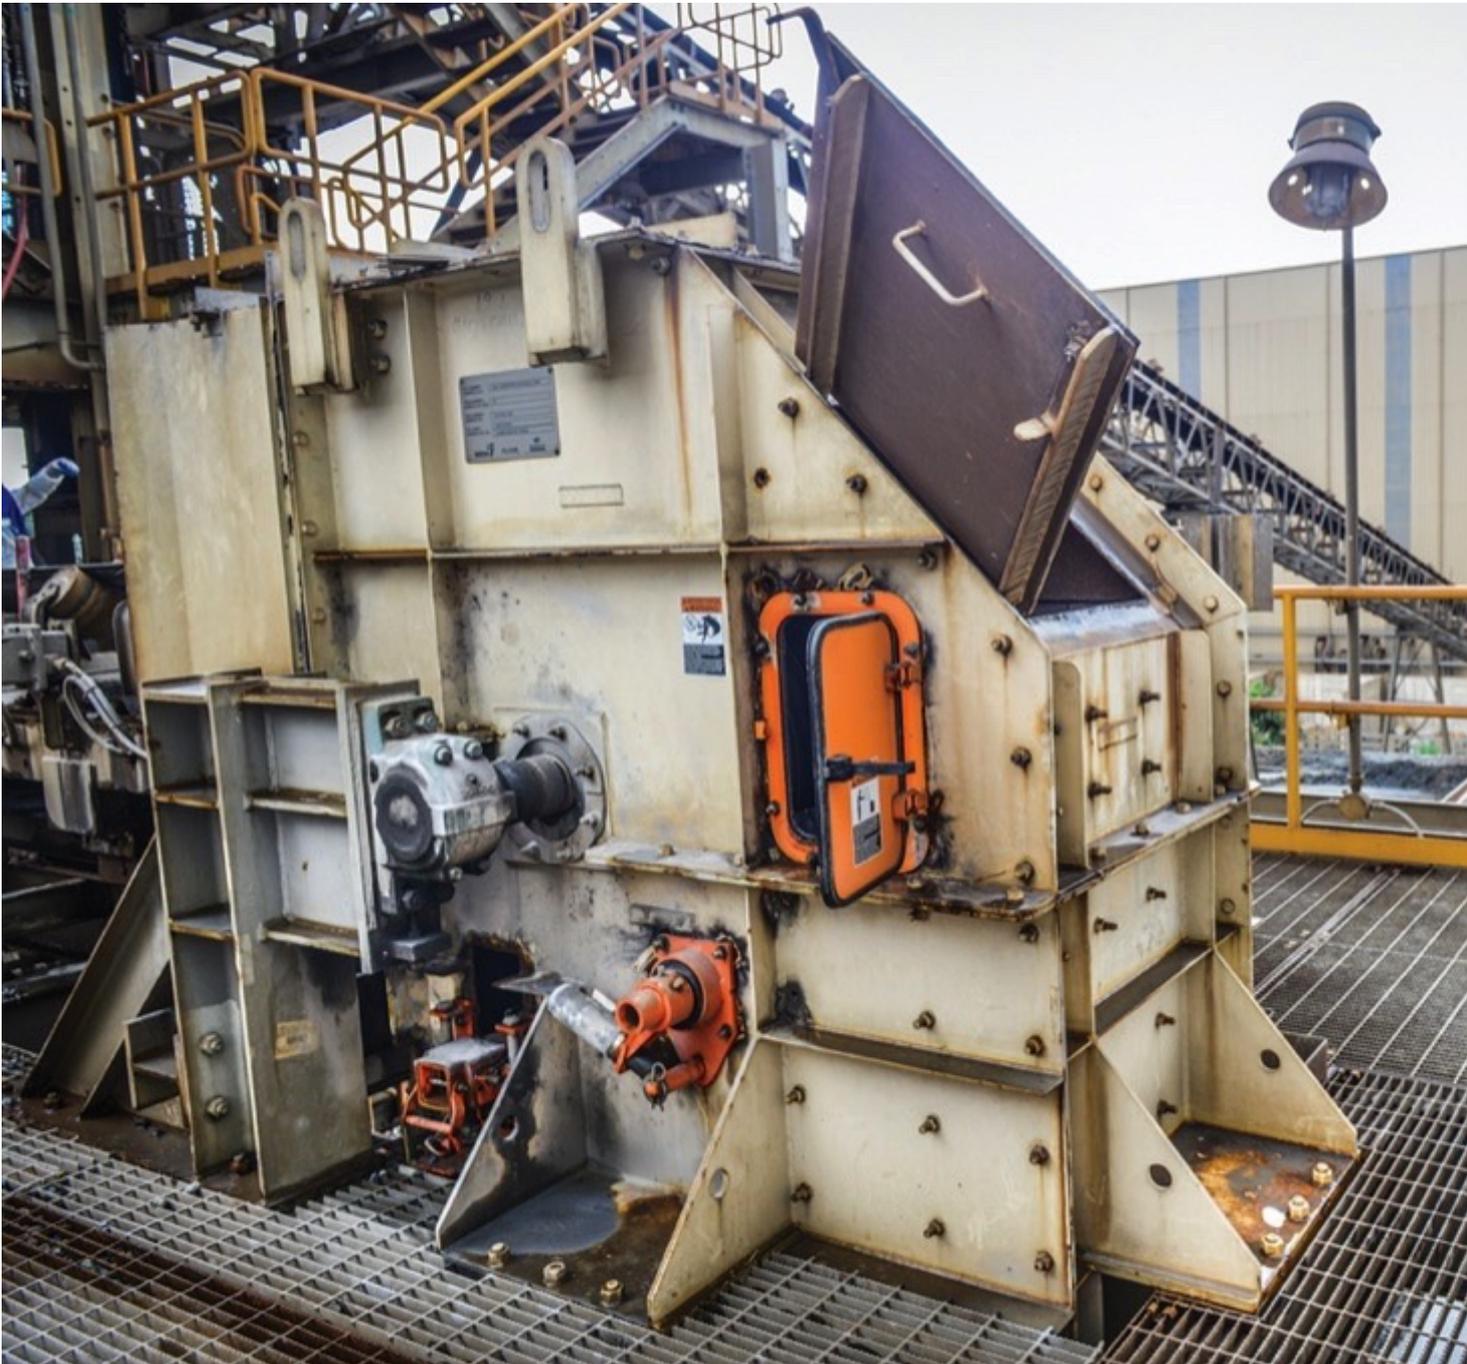
“Access” can mean observation points, entry doors and workspace for service.

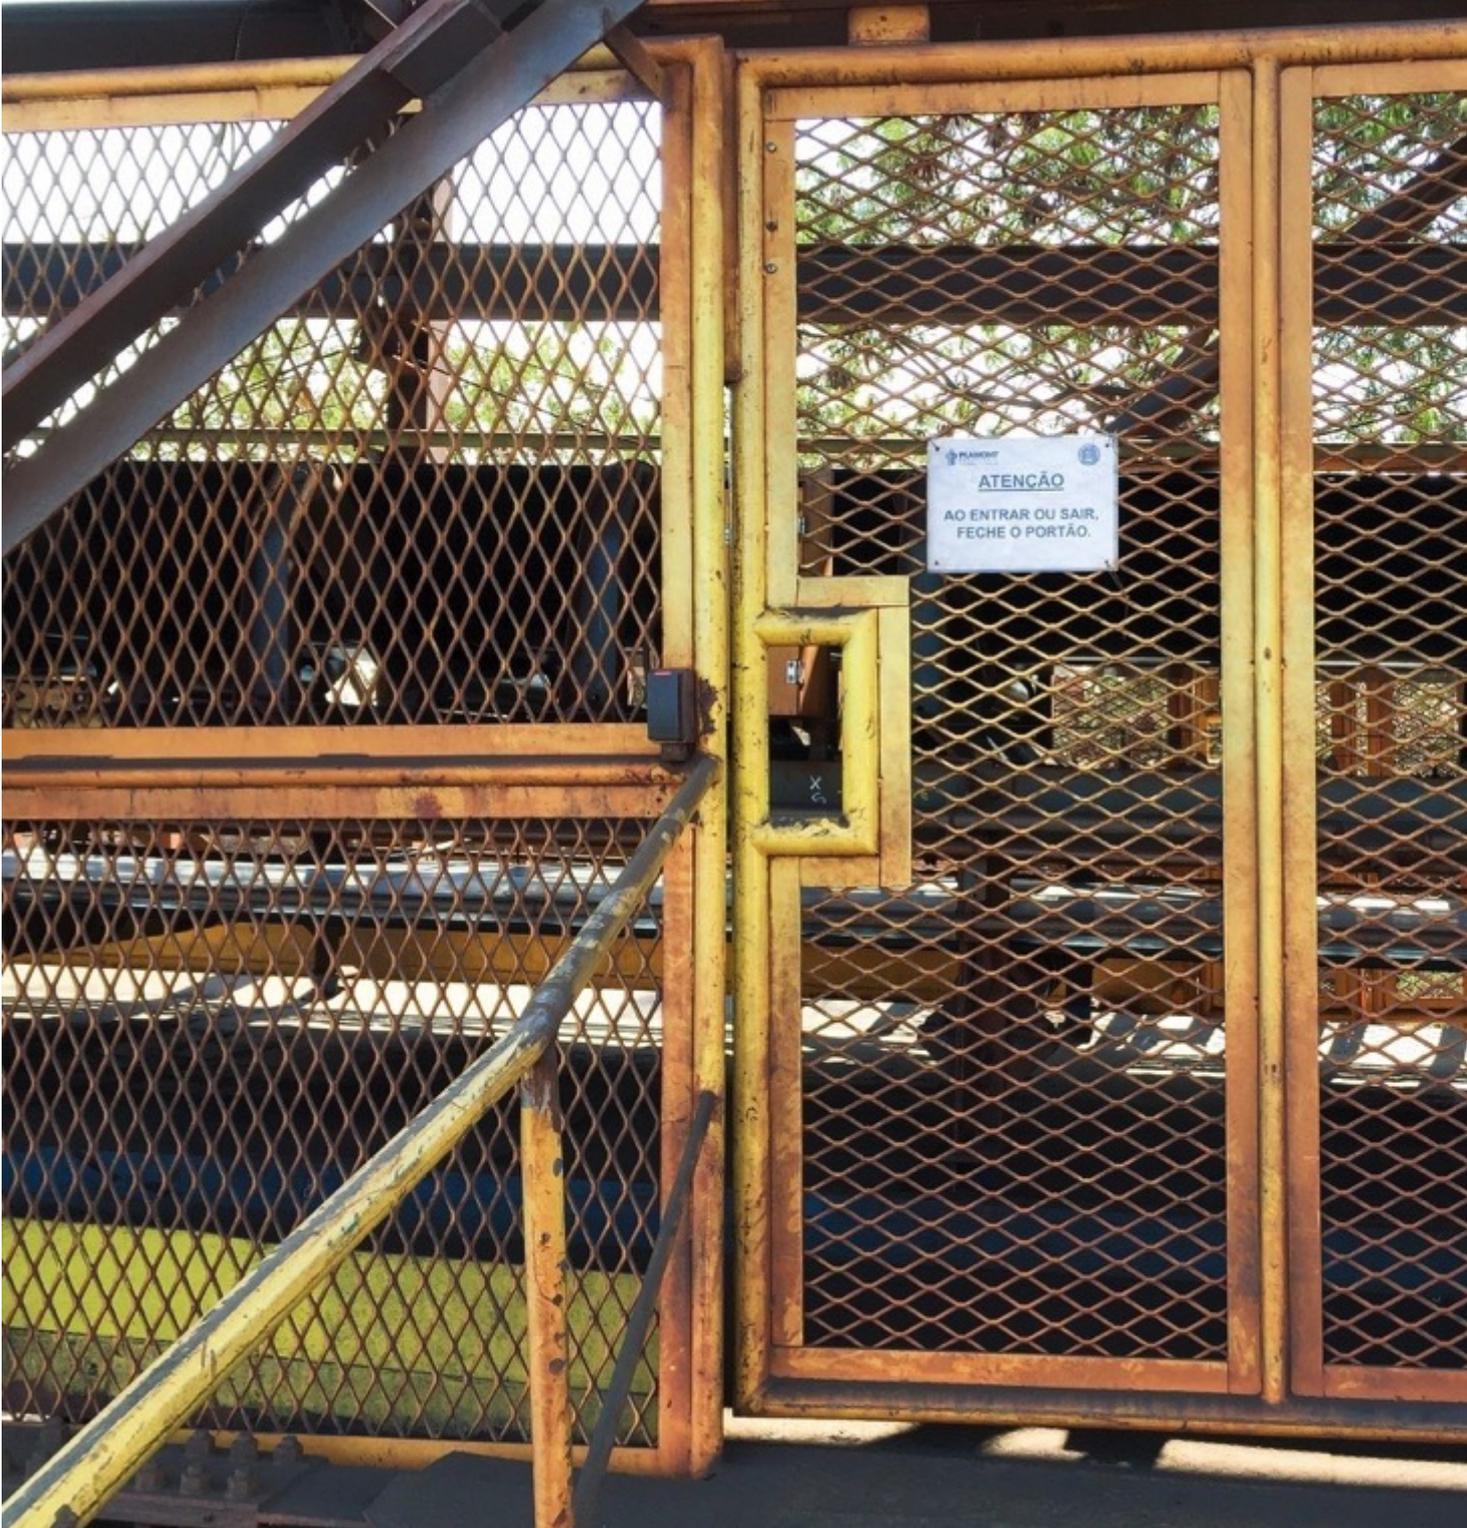
A gate to a conveyor walkway,
controlled with an RFID sensor.

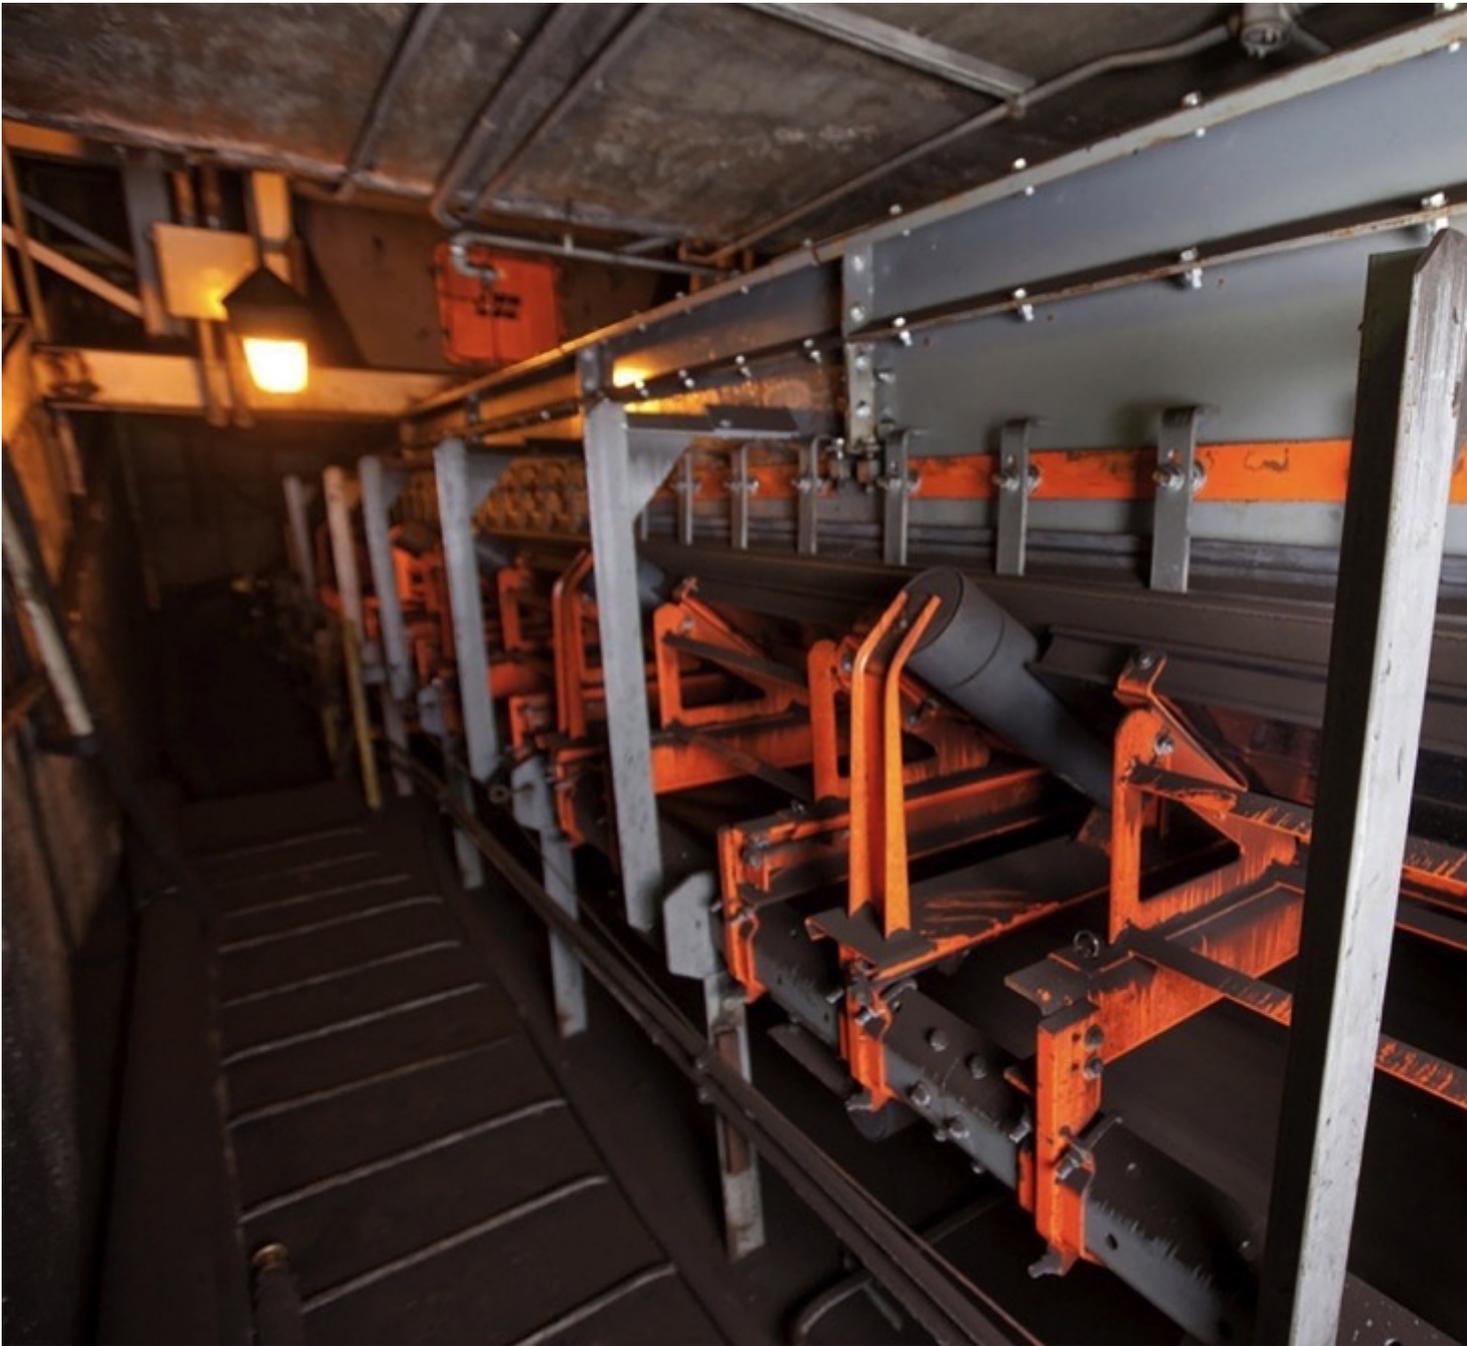
Inspection doors and track-mounted components facilitate maintenance for extended equipment life.

A tight seal is the key to preventing fugitive dust from leaving any chute. Many current setups require workers to crouch or crawl under the system or even enter a confined space to inspect it or perform maintenance, which can result in serious injuries. Inspection of the system needs to be fast, easy and safe. Small inspection doors –either solid or grated – can allow several observation points. Larger doors can offer access points with ample space for service of specific wear parts.

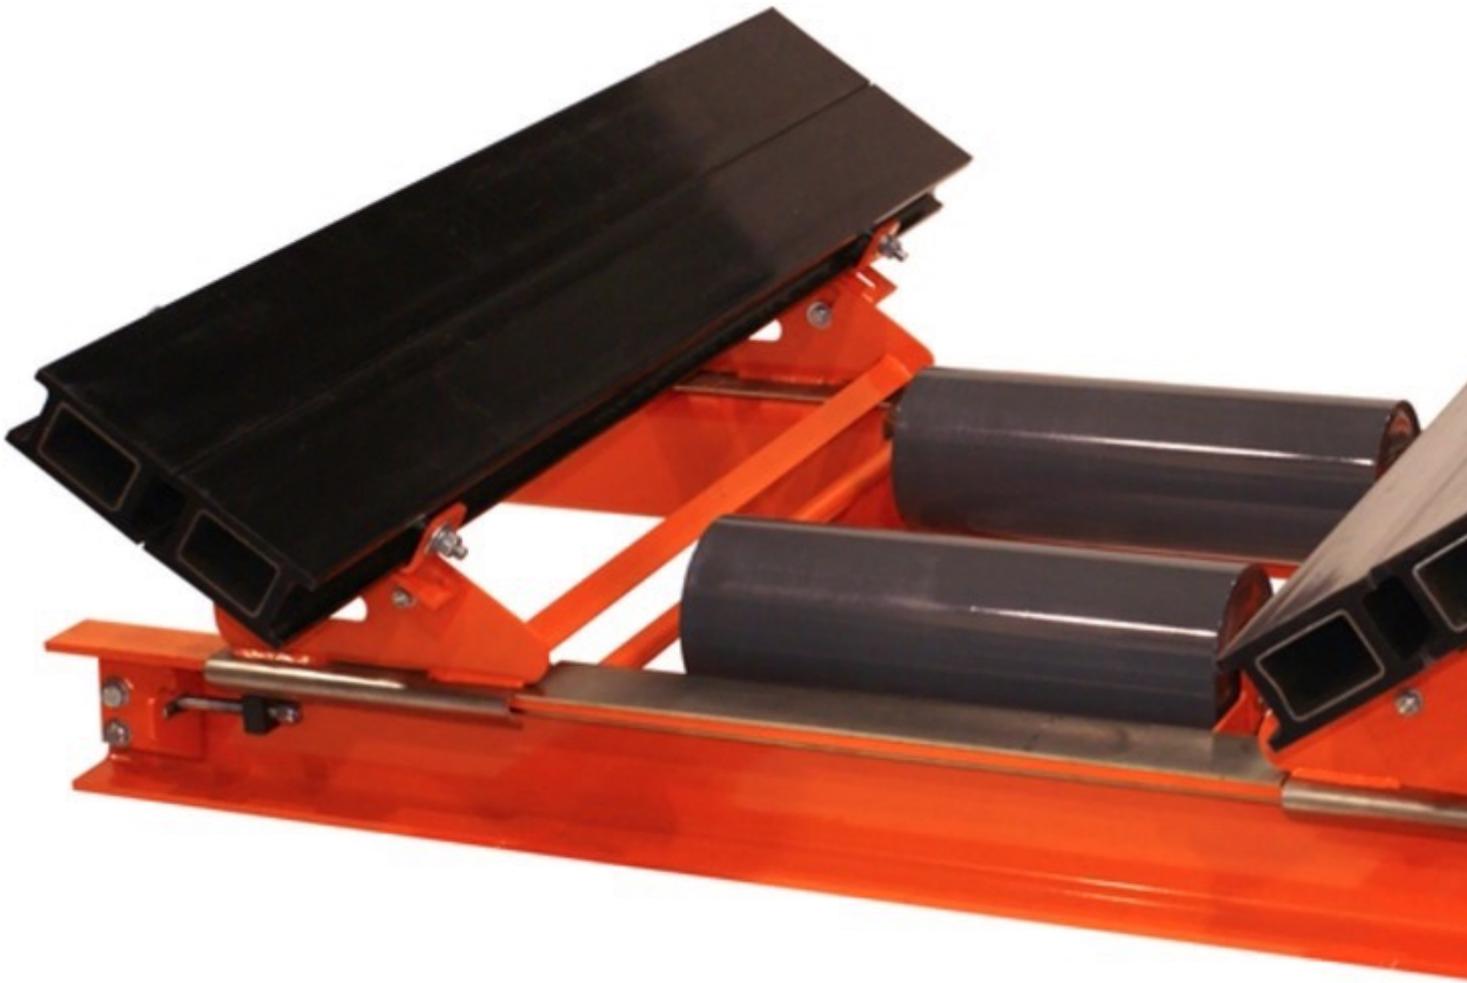
Track-mounted designs allow components to slide in and out easily for maintenance.

Located under the skirtboard and mounted with rugged steel assemblies, the cradles feature large impact-absorbing UHMW polymer “box bars” engineered with smooth surfaces that the belt can slide across with little friction or belt wear. These assemblies can be pulled out by a single worker and – working safely from outside the conveyor and using only a single tool – the box bars can be simply removed and flipped in a matter of minutes to double the service life.

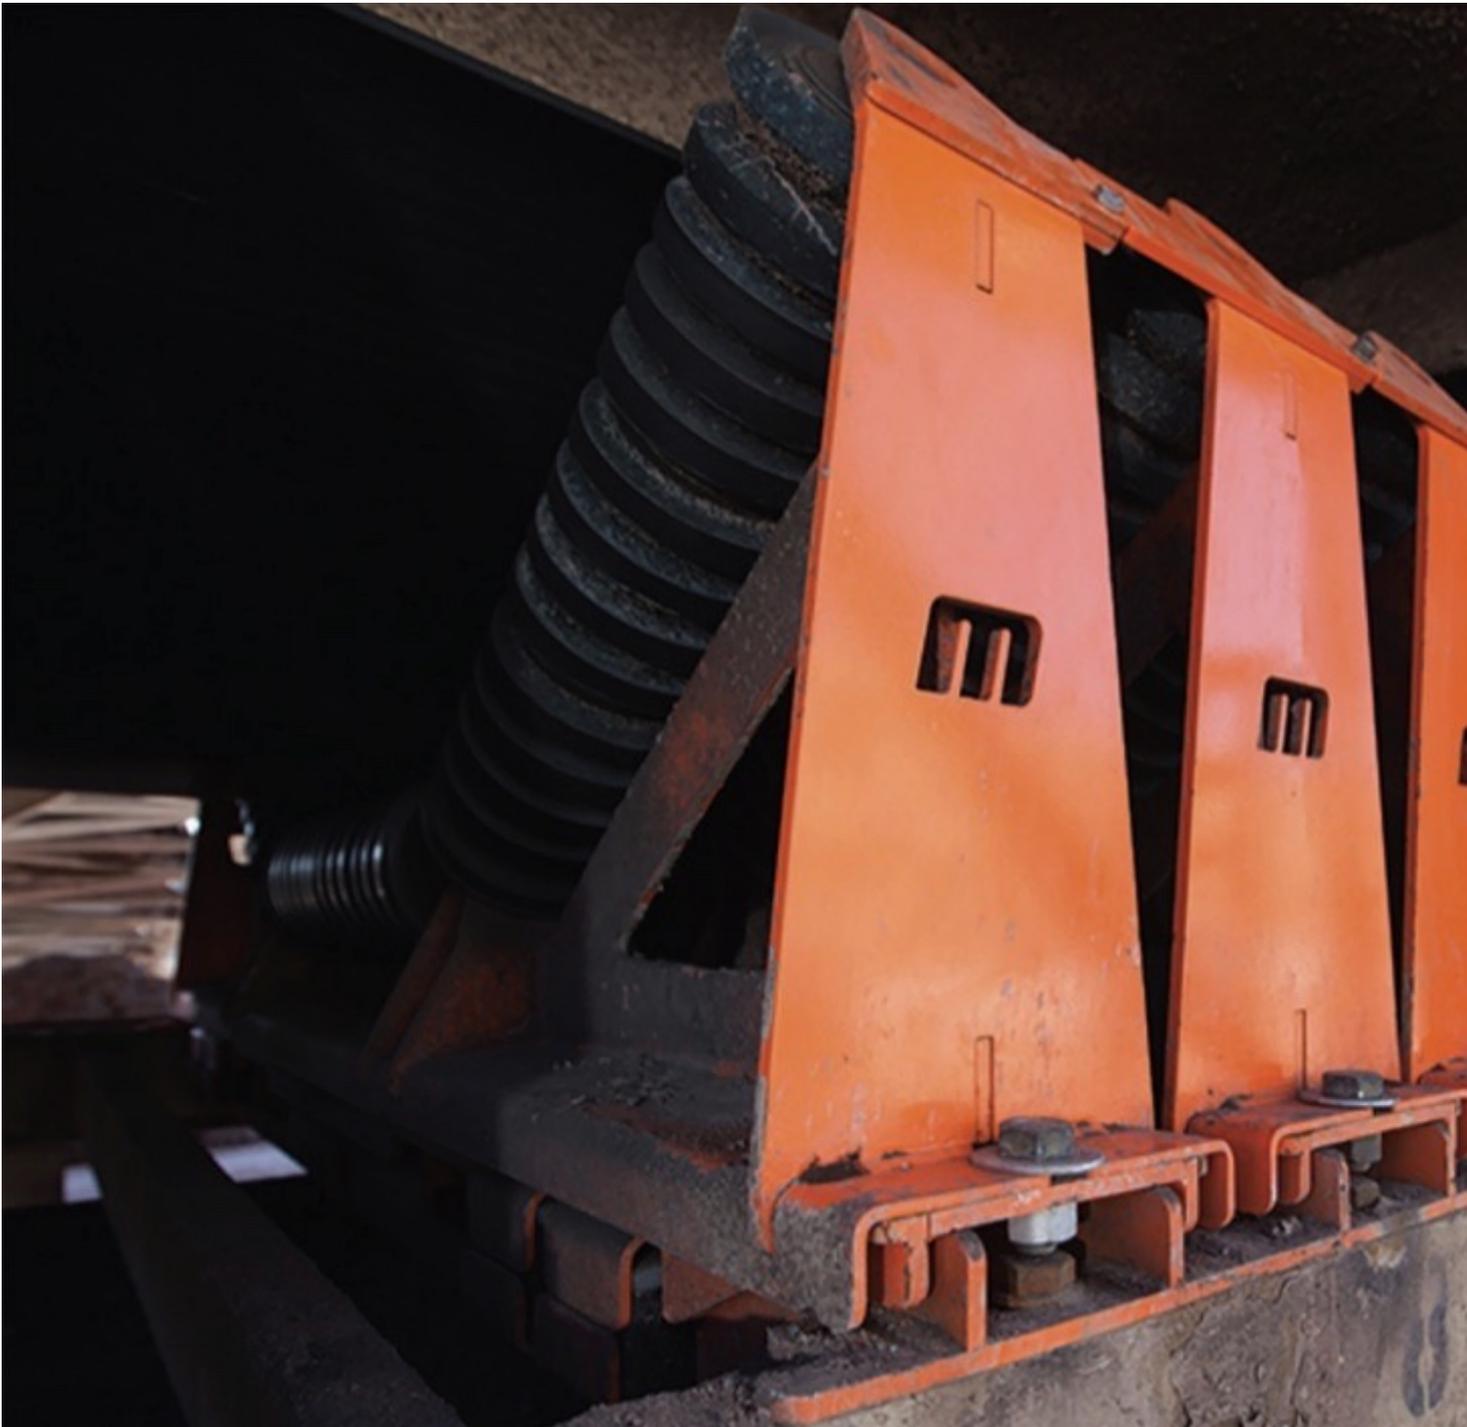
Track-mounted idlers allow easy access for quickly swapping out seized rollers.

Along the cargo path in the settling zone and beyond, retractable idlers support the belt and maintain the trough angle. Exposed to the punishing environment, gritty dust and extreme weather, rollers can seize over time. Often set closely together in the loading zone to avoid belt sag, slide-out/slide-in roller frames permit workers to perform idler service outside of the belt plane without the need to raise the belt or remove adjacent idlers.

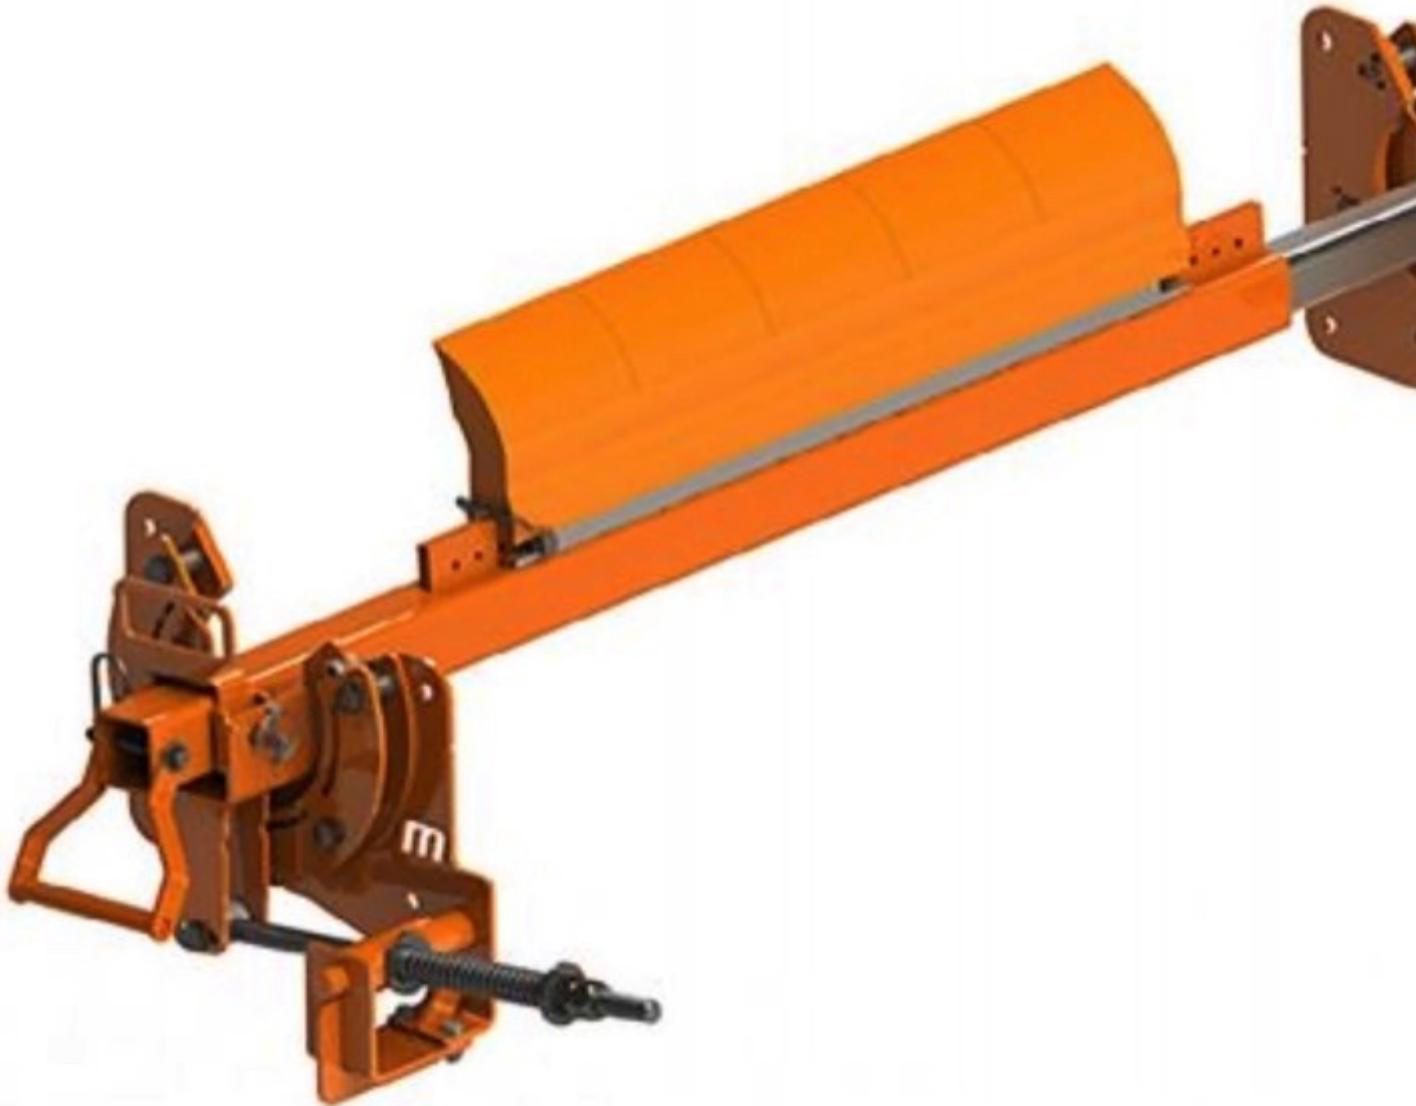
Belt cleaners can also be designed to slide out easily for fast replacement by a single worker.

Primary cleaners – located on the underside of the head pulley – are mounted on rotating assemblies designed to retain the proper tension between the blade and the belt. Secondary cleaners are located behind the head pulley and raised slightly above the belt line for tension. Specially-designed units can slide in and out by simply pulling a lever and releasing a pin. This allows blade maintenance to be performed outside of the system by a single worker in under an hour.

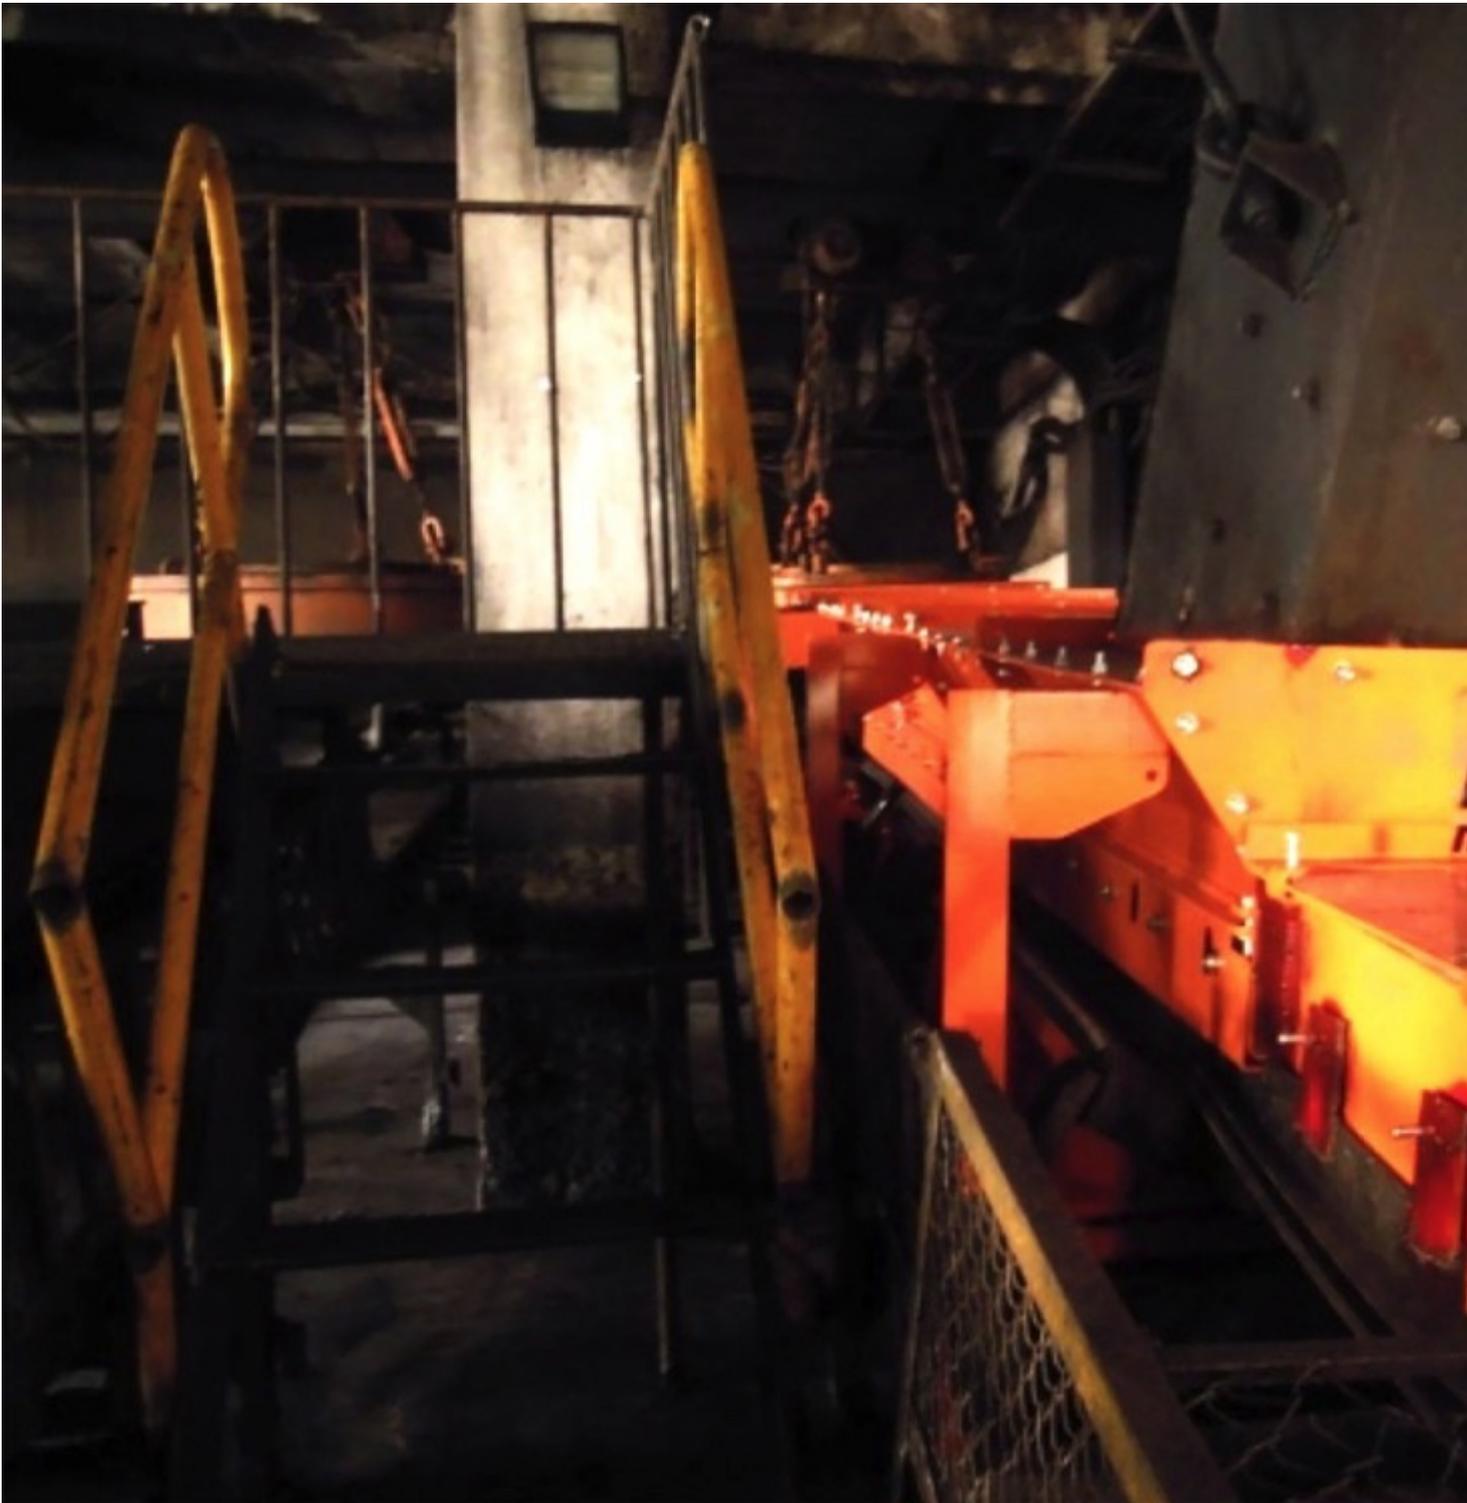
A hatch over the tail pulley allows staff to easily detect entrapped material.
