Case Study

BFM® fitting solves Dust and Downtime Issues for Minerals Processor

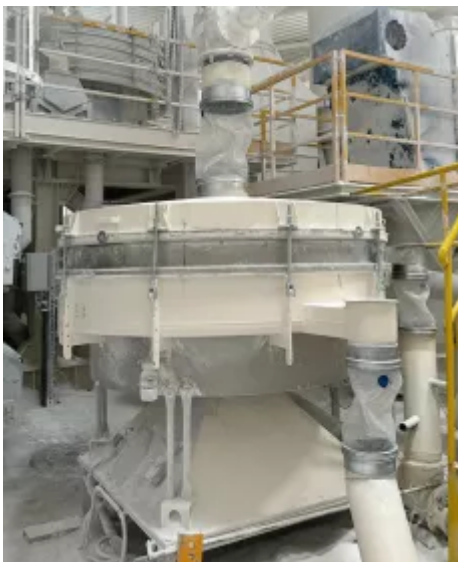
The switch to BFM® fitting stopped the leakage of the fine powder.

The elimination of excessive downtime for replacements is just one of the advantages experienced by the plant. Although abrasive, the leakage of the fine powder has been stopped thanks to the internal seal of the BFM® fitting snap-fit system and the durability of the Seeflex 040E material.

Local BFM® fitting distributor Rocom recommended installing BFM® fitting's durable Seeflex 040E blue-band connectors on each sifter inlet and outlet. They also suggested standardizing all diameters and connector lengths to be the same for ease of maintenance and inventory control.

To help support a long-term, sustainable approach, the IG (Installation Gap) was accurately adjusted for all the sieves, so now, only one standard-sized connector needs to be held in stock.
