Research Paper

Dynamic Damage of Rubber-Textile Belts in Pipe Conveyor Application

[Published in bulk solids handling, Vol. 35 \(2015\) No. 4](#)

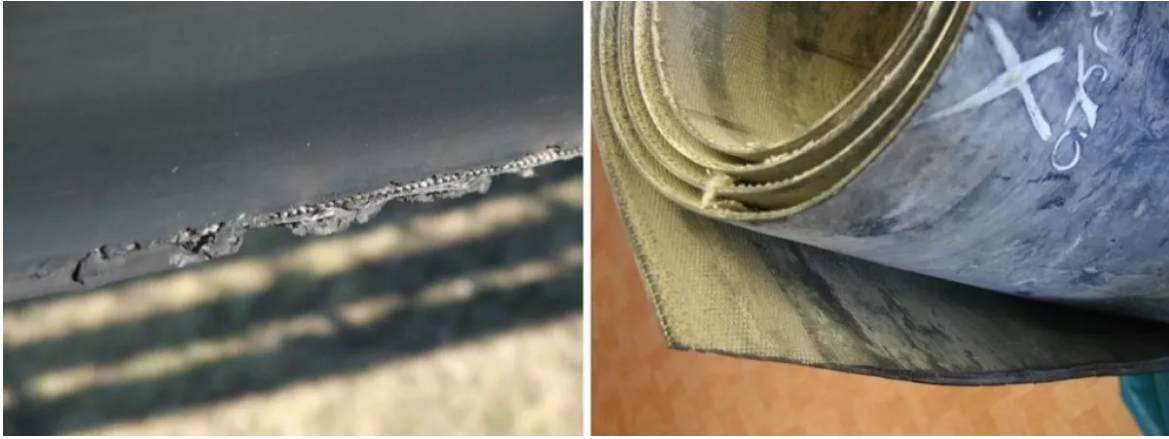
Fig. 1. Example of damage on edge of the pipe conveyor belt. (Pictures: © Technical University of Košice)

The rubber-textile conveyor belts are used for installation in the pipe conveyors much more than steel-cord conveyor belts. The rubber-textile conveyor belts are suitable for most of the pipe conveyor installations with regard to the strength conditions during the pipe conveyor operation as well as with regard to other circumstances. The conveyor belts installed in pipe conveyors are subjected not only to an influence of the transported material, but they are also exposed to a specific loading, which is caused by a cyclic process of the conveyor belt closing into the piped shape and following opening of it into the flat shape. Important factors are also influences of the operational conditions, quality of maintenance, etc. All these facts are able to cause various damage of the conveyor belt

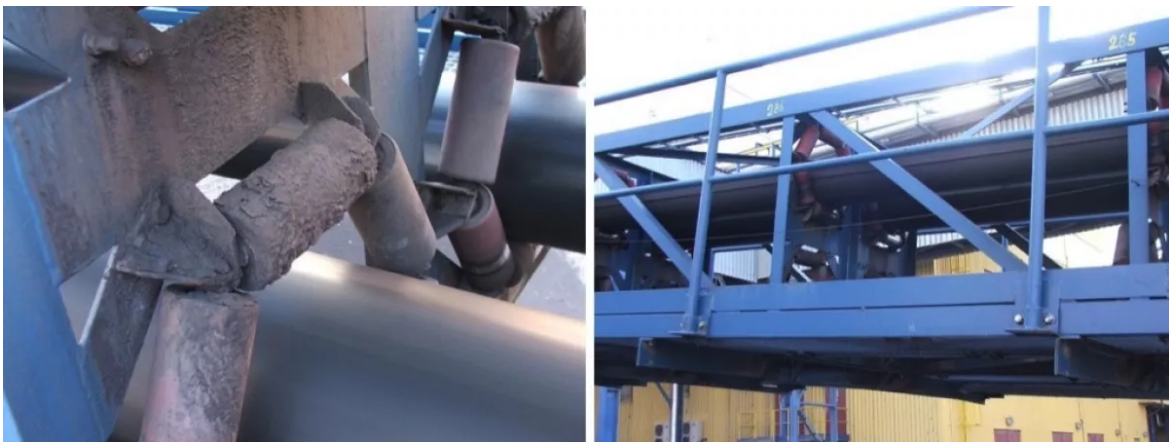
Fig. 2. Example of situation when the conveyor belt does not have a contact with all idler rolls in the hexagonal idler housing.

Another possible negative phenomenon, which is occurring within the pipe conveyor operation, is such situation when the rubber-textile conveyor belt does not have a full or stable contact with all six idler rolls situated in the hexagonal idler housing (Fig. 2). This unfavourable situation is occurring in the straight sections of the pipe conveyor trajectory as well as in the sections curved horizontally and vertically. The negative result of this situation is a deformed shape of the conveyor belt cross-section, i.e. the flattened or even flat shape of the belt cross-section what means that the conveyor belt does not have the required dynamic properties and is damaged dynamically. The final result of this undesirable situation is a local increasing of intensity of the conveyor belt wear-out process, which causes a damage of the belt cover layers, higher motional resistances and a possibility of material spillage along the conveying trajectory, as well. All these facts are resulting in undesirable technical and economical consequences for pipe conveyor operator or user.

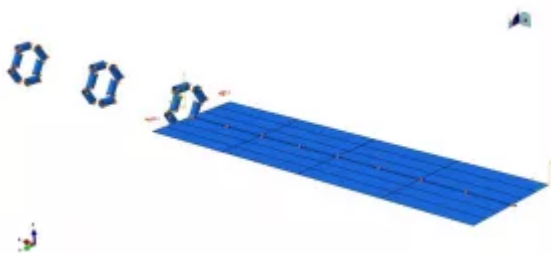
Fig. 4. Geometrical model created using the software CAE Abaqus.

The experimentally obtained results established a database for the development and application of a computational model in order to realise the FEM-analysis. Geometry of this model is visible in Fig. 4. Realisation of this computational model required application of a pre-processor, which is a basic part of the software Abaqus. Three idler housings with an offset arrangement of the guiding idlers were simulated within the framework of the computational model geometry.

Model of the conveyor belt was divided into the six axial parts taking into consideration the results obtained experimentally from the analysed sample. The six-parts division was selected in order the conveyor belt model could contain six zones with various modulus of elasticity values in accordance with the results obtained from the individual experimental measurements specified for modulus of elasticity determination. The given zones are characterised by the same modulus of elasticity values in transversal direction as well as by the equal material density values, while in longitudinal direction the individual modulus of elasticity values are different in each of zones.

The boundary conditions are defined in such a way that each of the guiding rolls has removed all degrees of freedom. The conveyor belt has removed three degrees of freedom in the middle in all directions except of longitudinal direction. This arrangement enables to do the required shift of the conveyor belt into the correct position in the idler housing within the framework of the calculation process.

Margins of the conveyor belt are bound by means of two referential points and there are situated the auxiliary torques in these referential points in order to form the piped shape of the conveyor belt. Another loading of the conveyor belt represented the gravity force and tensional force. The finite element mesh was assembled using the finite elements of the type Shell with the global contact function defined between the individual contact pairs.

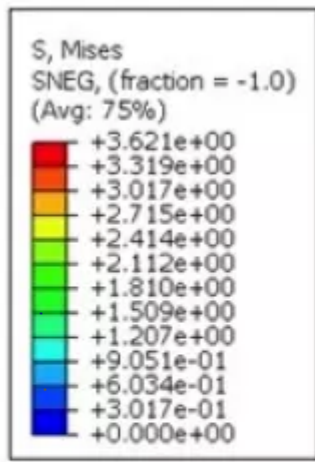
Fig. 5. Distribution of the resulting stress fields in the pipe-shaped conveyor belt.

The above-described model was applied for two computational procedures. The first computational process was realised with the different modulus of elasticity values in longitudinal direction in the divided six axial zones. The second computational process used the constant modulus of elasticity values in longitudinal direction in all six zones. All other material constants and boundary conditions remained the same for both computations. The main purpose of this methodology was a comparison of the obtained results in order to discover changes in distribution of the stress-deformation relations in both computational models.

The next figures (Figs. 5, 6) illustrate the calculated distribution of the stress fields in the conveyor belt with a dynamic damage on internal and external side of the pipe conveyor belt in any place of a straight section in conveying trajectory.

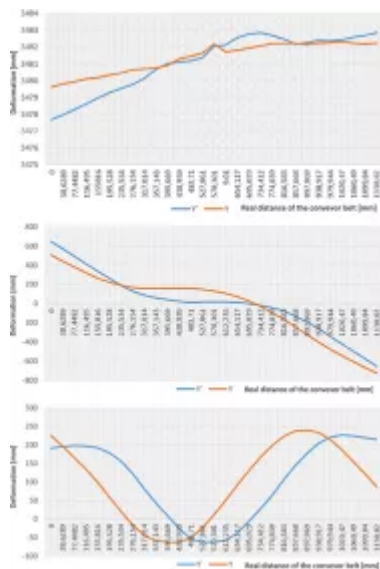
Fig. 7. Graphs of conveyor belt deformations for the belt with the dynamic damage Y and without dynamic damage Y' in direction of the axes X, Y, Z .

The graphs in Fig. 7 describe the partial values of deformations in the case of pipe-shaped belt in direction of the axes x, y, z . The graphs are recording the values obtained from both computational examples. The graphs show significant differences in the calculated results between the model of conveyor belt, which is damaged dynamically and the model of undamaged conveyor belt. It is possible to say according to the obtained results that if the belt is damaged dynamically, it is formed in the idler housing otherwise than it should be, in comparison with the undamaged belt. The contact points between the belt and forming idlers in the hexagonal idler housing are also different for both types of the conveyor belts.
