White Paper

Many sticky Returns - A Gold Mine seeks Solution to Carryback

[Published in bulk solids handling, Vol. 35 \(2015\) No. 5](#)

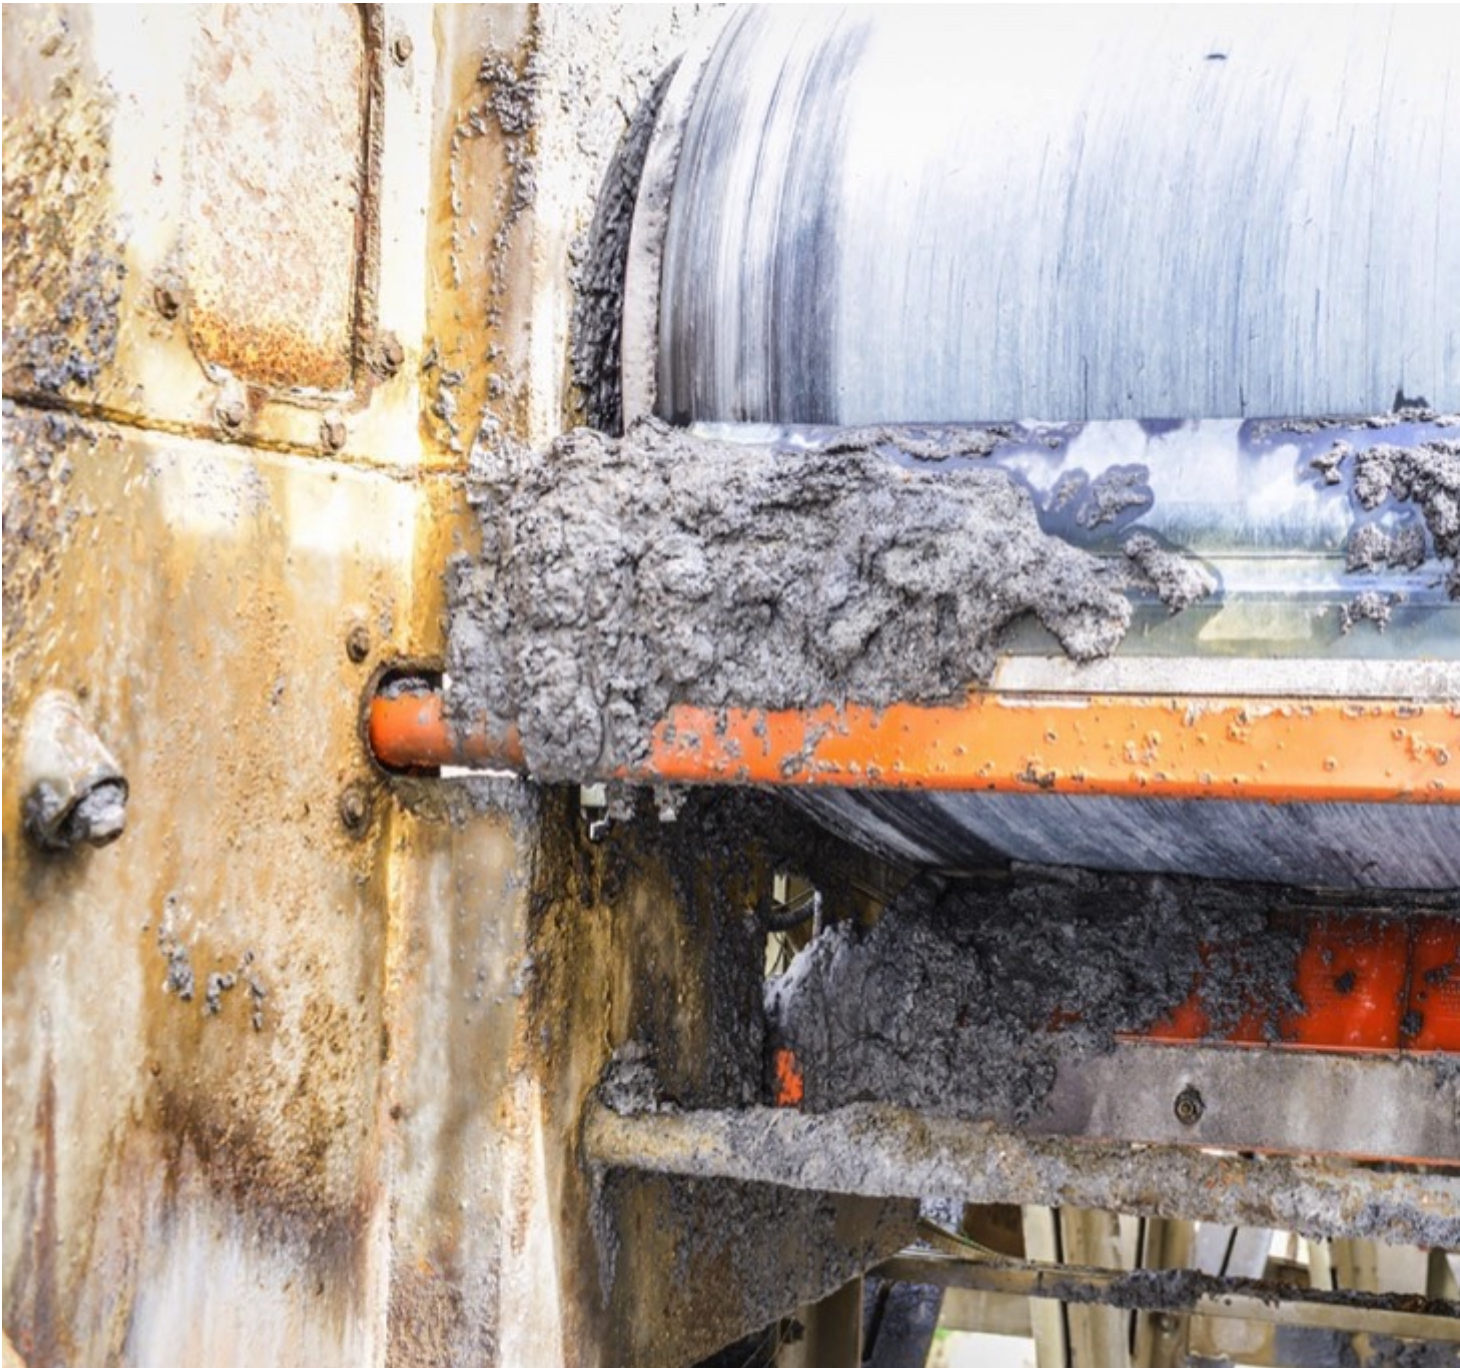
The carryback had the consistency of toothpaste, adhering chunks of aggregate to the belt and causing damage to pulleys and headers.

The carryback on discharge conveyors caused the whole system to suffer excessive downtime. According to Mike Lenart, Mechanical General Supervisor for PVDC, "The substance had the consistency of thick toothpaste, which was also able to adhere small chunks of aggregate to the belt, causing a destructive carryback that wreaked havoc on our pulleys and headers. It was a mess." The clay and sulfur in the soil at the PVDC site work in tandem: **Particulate cohesion**: Production is 365 days a year, however, between April and October

the area can receive as much as 6-feet (183 cm) of precipitation. Moisture can cause cohesion in fine clay particulates, which reacts to load pressure, causing it to stick to the contact surface [1]. **Sulfur adhesion:** Throughout human history sulfur has been used in a variety of applications as a strong adhesive and sealant [2]. This can cause gumming on the belt and adhere aggregate that would have previously been discharged to remain as part of the carryback.

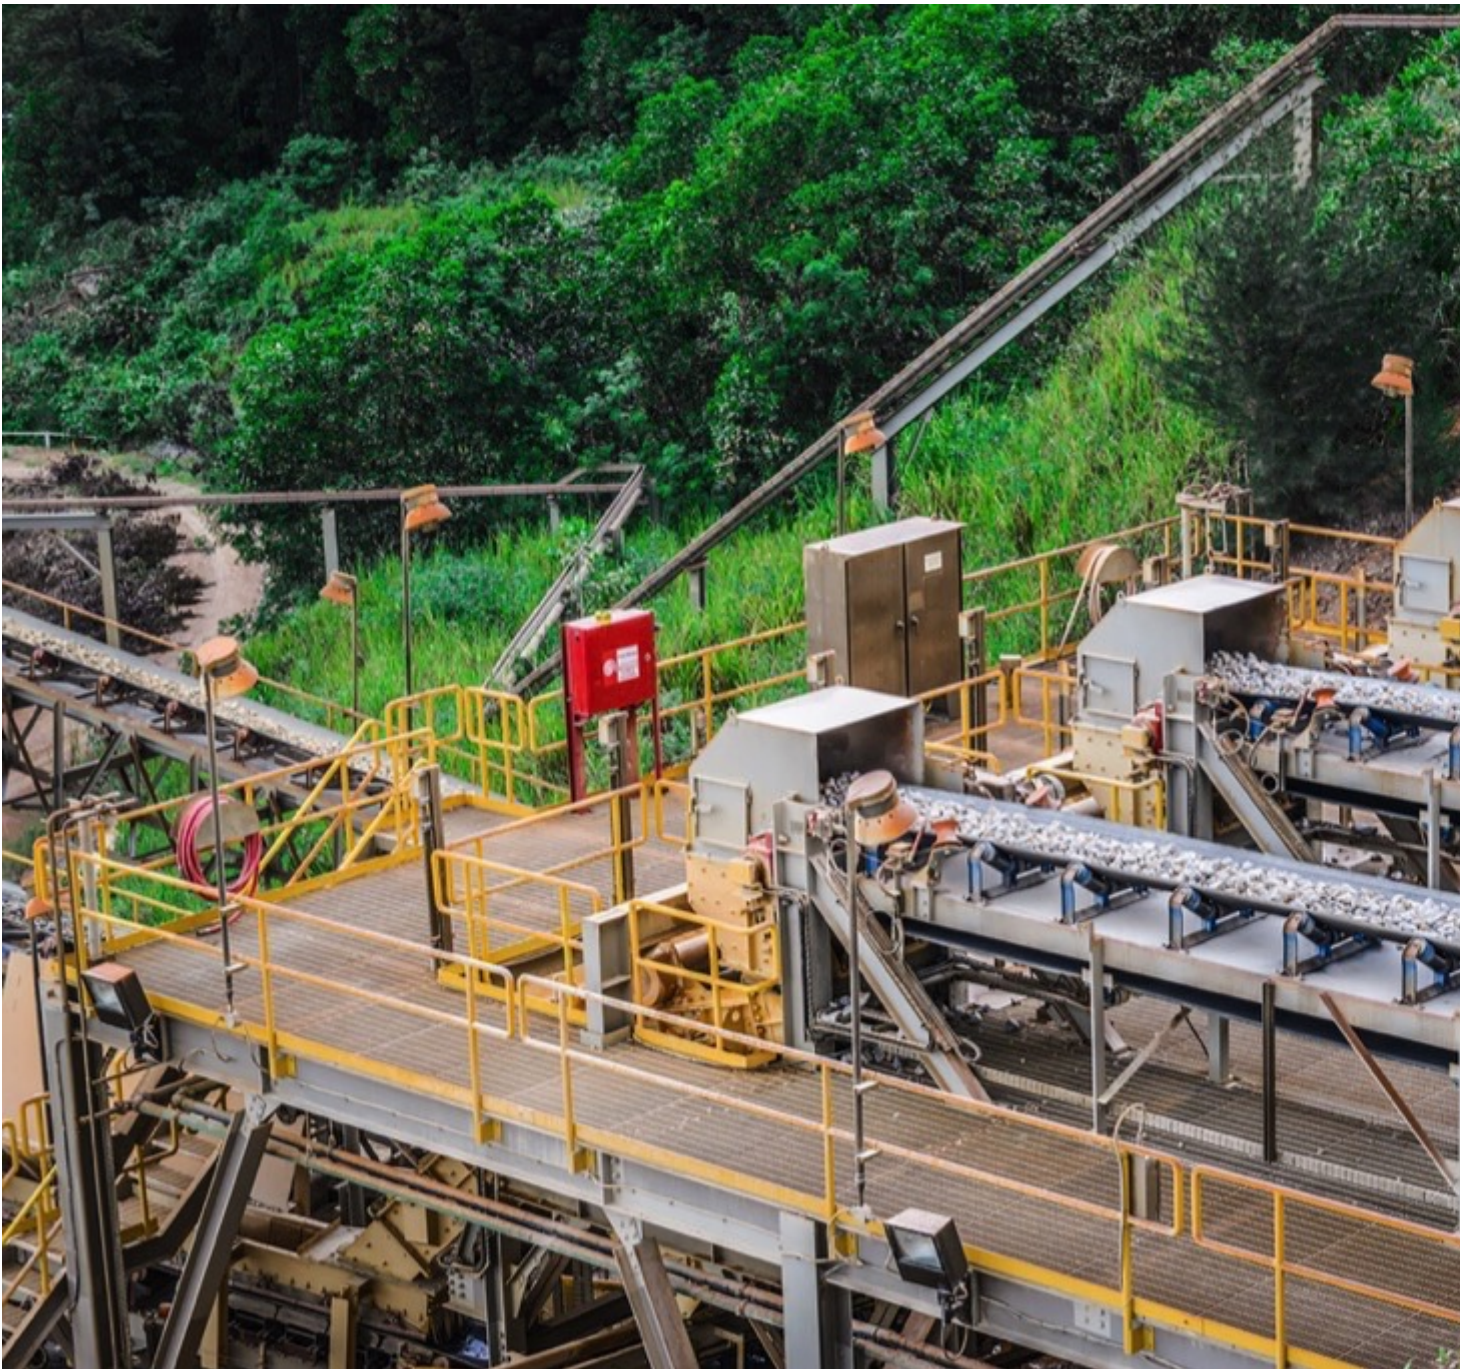
The original conveyor belt cleaners could not manage the overburden, resulting in carryback that caused

equipment failures and downtime.

The original primary and secondary belt cleaners and dust suppression systems were not adequately addressing the overburden. “Our search for a solution included Martin Engineering, due to their reputation in the industry,” said Power. “We wanted to quality test all of our options, so we also included the original equipment manufacturer and a third supplier. ”Martin Engineering representatives created a full site report, complete with assessments and equipment recommendations. Along with the report, the team added a presentation containing budget and timeline to help site managers explain the issues, needs and solutions to company executives. Once the corporate office gave the green light, technicians from each competitor attached belt cleaners to three of the site’s main discharge points. Martin Engineering equipment was installed on the large discharge belt that presented the most carryback. “The superior product was immediately apparent once the quality testing phase started,” Lenart said. “Though testing lasted for weeks, the Martin product was more effective, hands down.”

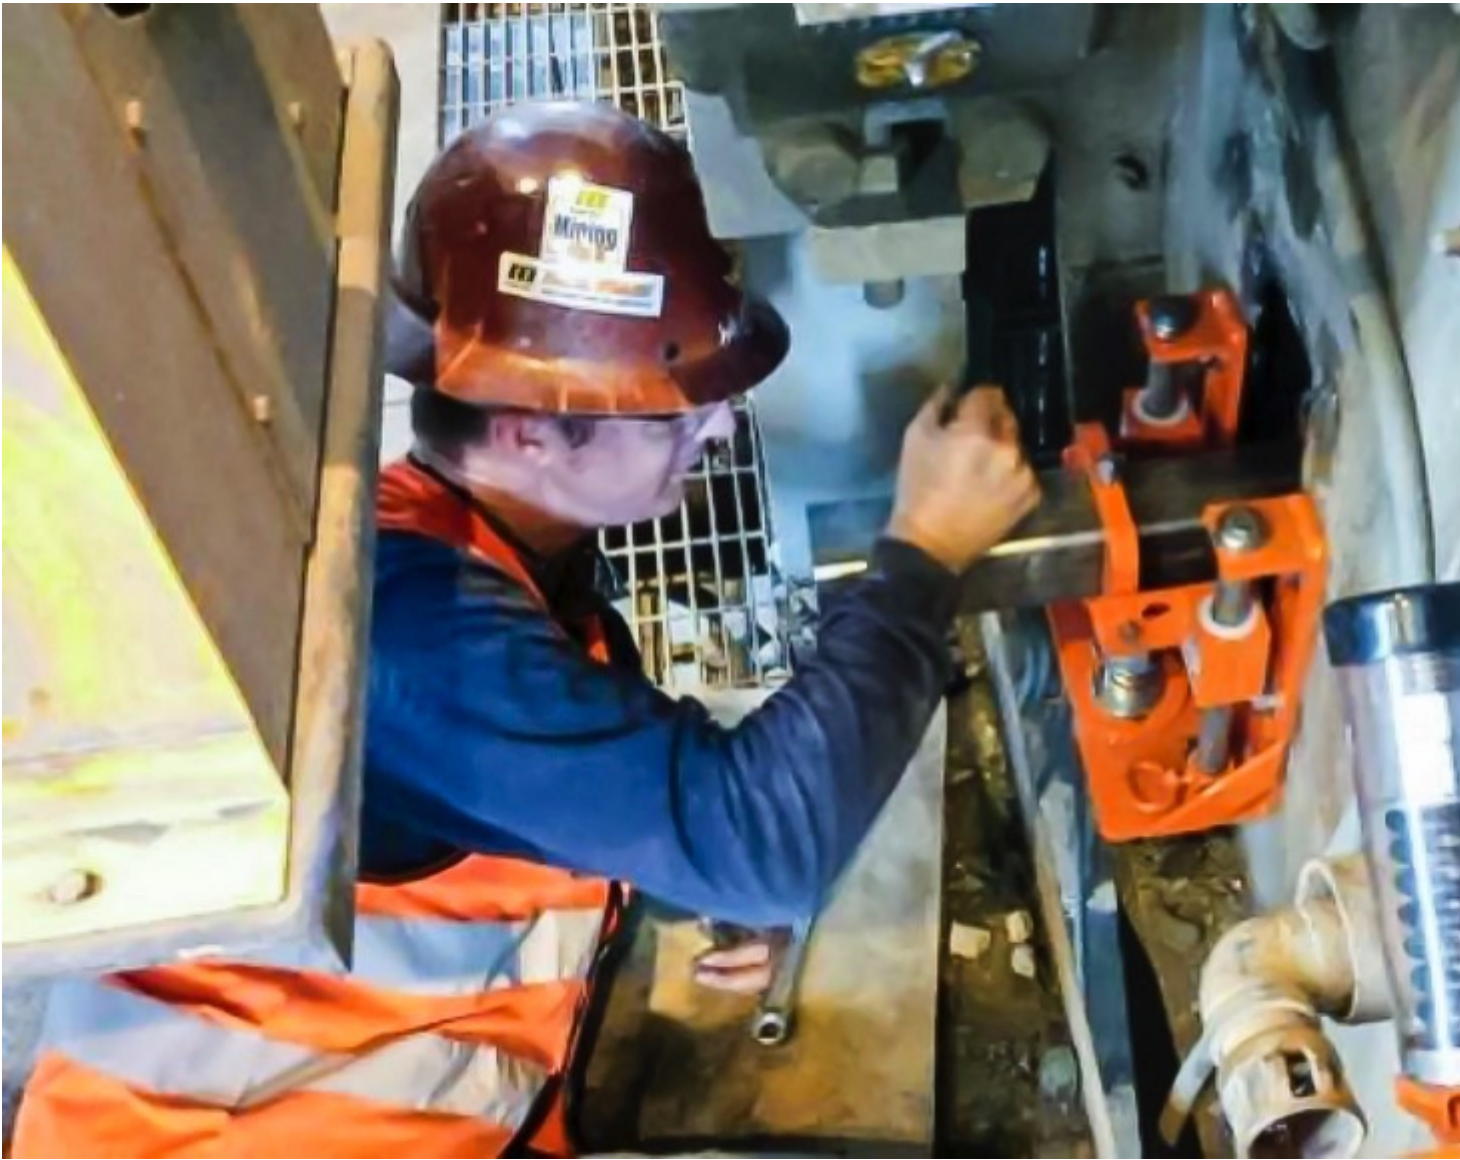
Martin Engineering replaced existing primary cleaners at sixteen discharge points, fitting them with low-adhesion urethane blades.

Barrick accepted most of the team's recommendations, and installation took just two weeks. Martin Engineering replaced the existing belt cleaners with QC1-Cleaner XHD primary belt cleaners at sixteen discharge points. These extra heavy-duty units are able to handle speeds of up to 1,200 FPM (6.1 m/s) on belts as wide as 96 inches (2.438 meters) and pulley diameters of more than 30 inches (762 mm). Installers fitted them with low-adhesion urethane blades specifically designed for sticky and tacky material. Able to withstand temperatures from -20° to 160° F (-30° to 70°C) with up to 12 inches (305 mm) of wear life, the blades endure high summer temperatures and constant production schedules with more time between replacements. "The curved scraper is designed in sections, adjusted individually to conform to the belt, assuring continuous contact across the belt profile," said Granata. "Martin manufactures different cleaning blades, which

specifically address the chemical make-up of almost all types of conveyed bulk materials.”

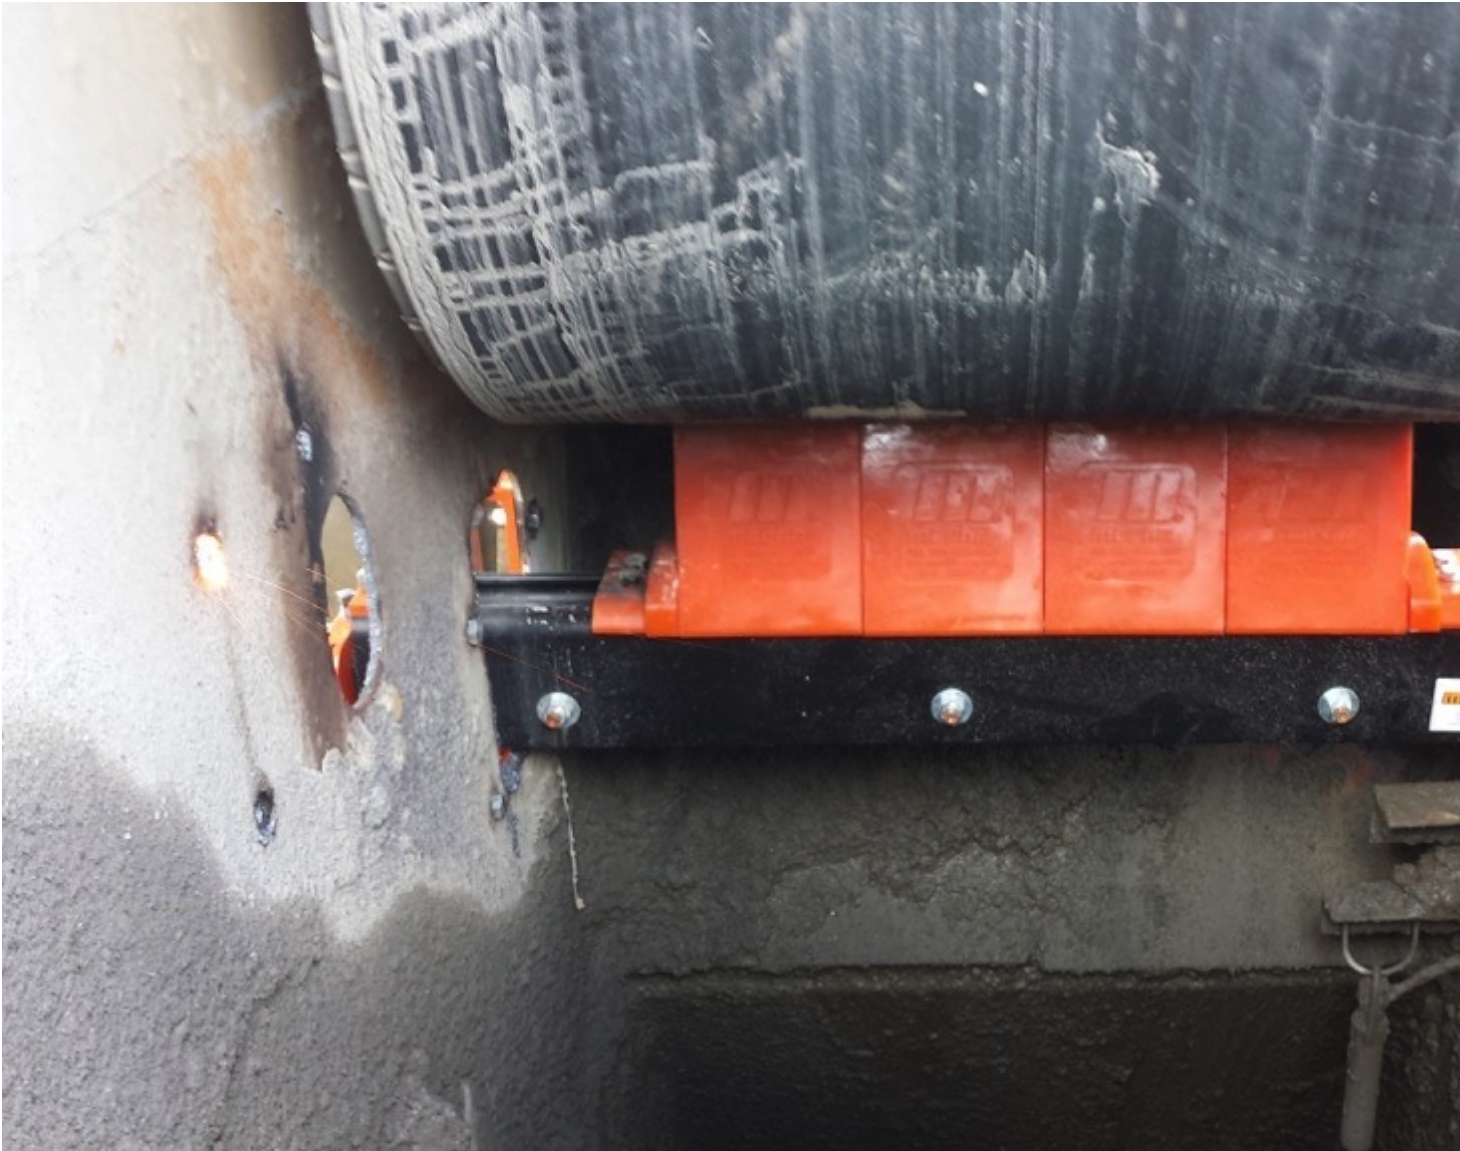
Sixteen additional secondary belt cleaners were attached behind the header, equipped with tungsten tipped blades.

Sixteen additional Martin DT2H secondary belt cleaners accompanied the primary units to mitigate belt fouling. Attached two to three feet behind the header, the units were equipped with tungsten tipped urethane blades suited for heavy-duty applications. To avoid product loss due to fugitive material, the Martin Engineering team also installed 300 feet of Apron seal skirting constructed from 70 durometer EPDM rubber composite for its low abrasion index characteristics.

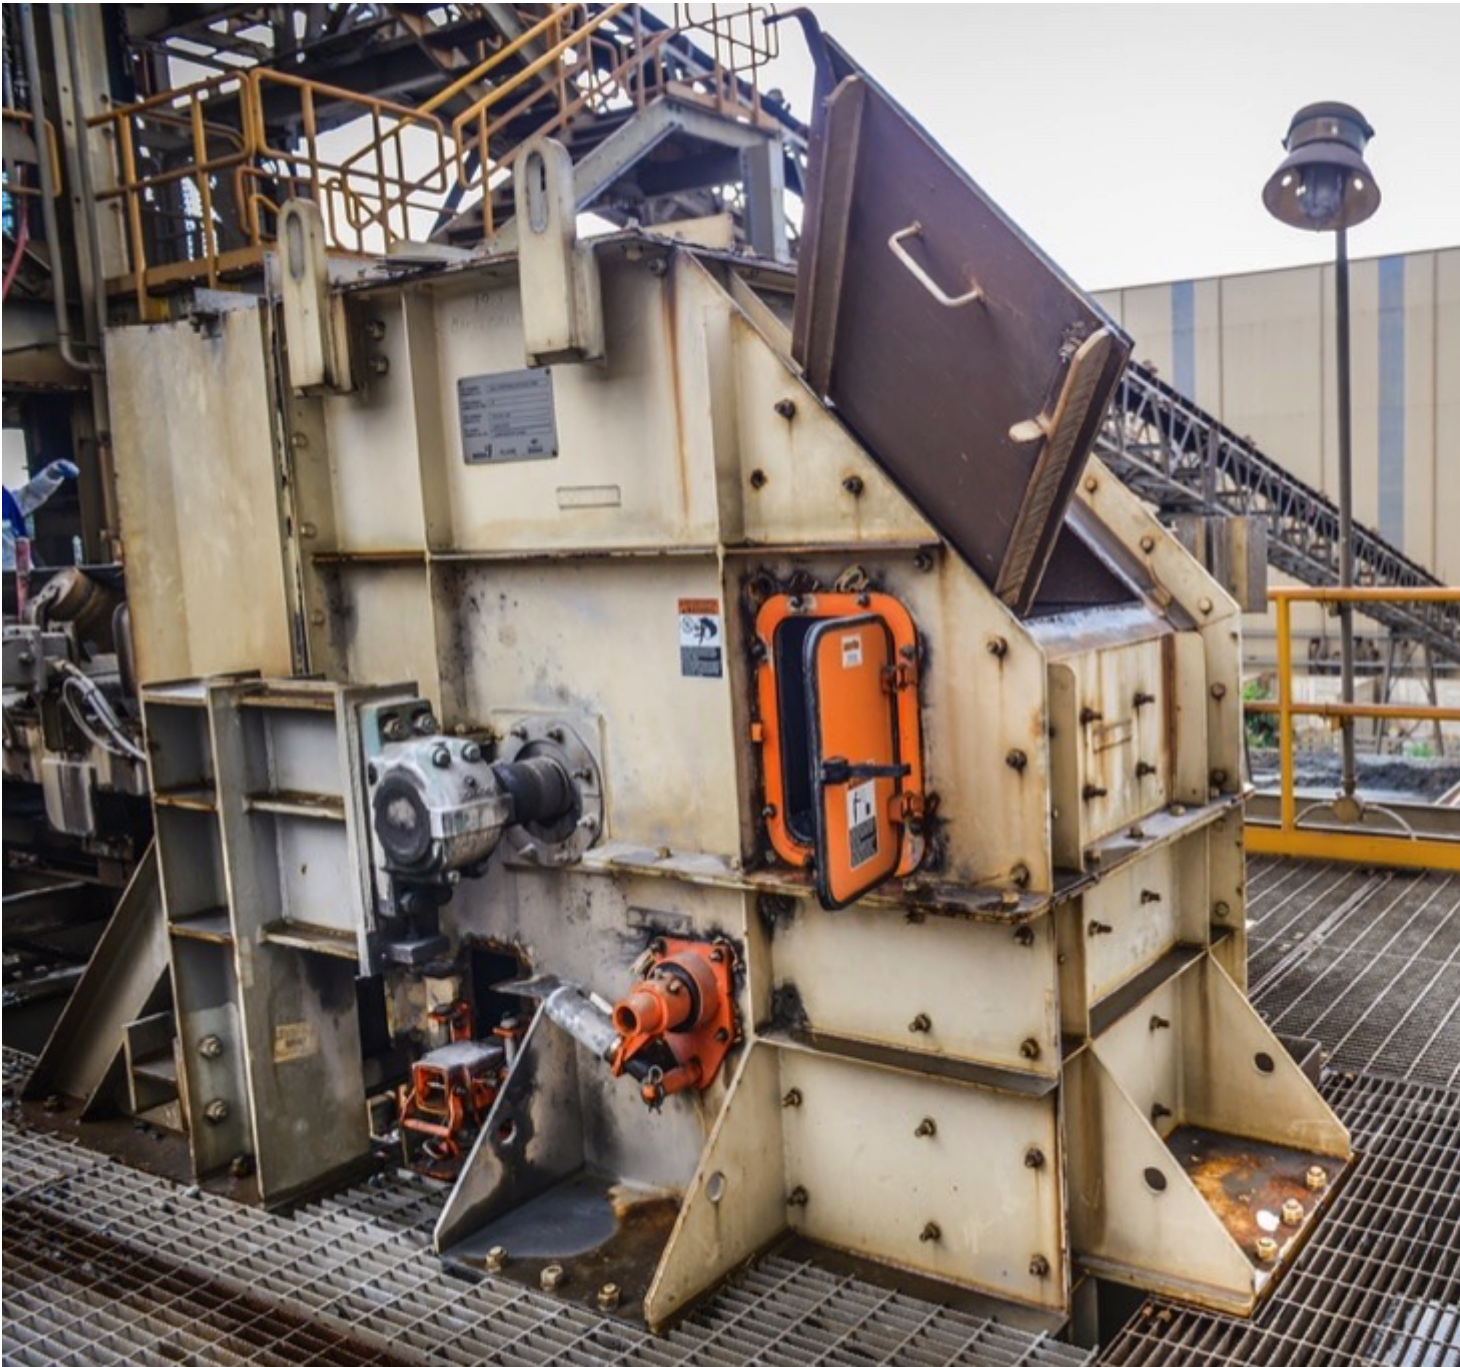
Access doors and view points facilitate routine observation of potential trouble spots and contribute to easier maintenance.
