White Paper

Conveyor Drop Points - Preventing Damage and Spillage

[Published in bulk solids handling, Vol. 36 \(2016\) No. 7](#)

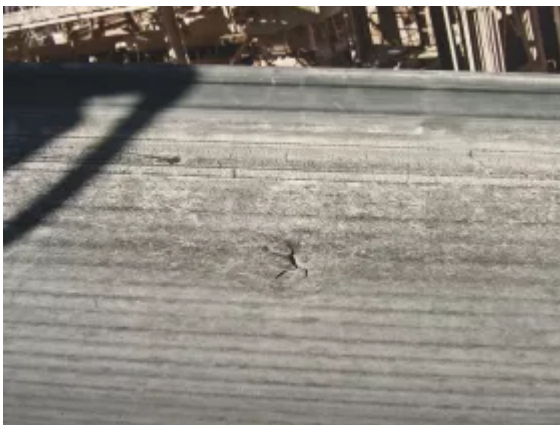
A receiving belt can experience severe damage from material transfers if it's not supported properly. (Pictures: ©Martin Engineering)

According to Cole, the problems began with the crusher, but extended along the conveyor and through the tunnel. “The crusher was producing -8 in, but the conveyor was only built to handle -4 in,” Cole observed. “The impact from the 20 ft drop blew out idlers and gouged the belt, causing misalignment and extensive spillage.”

The loads of limestone would land on the fast-moving belt with such force that it often bent or cracked idlers and caused material to bounce, denting and scraping the skirt before it settled. Without being centered, the load would throw the belt off track and continue to shift throughout the transport process. This caused dust and fines to escape from the belt and pile along the conveyor’s frame, clogging the maintenance walkway and obstructing access to the load zone.

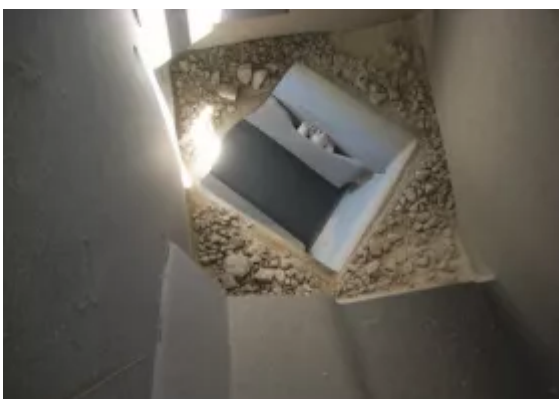
A rock box acts like a shelf, catching and distributing falling material onto the impact cradle.

After their analysis, the Martin Engineering team presented a detailed proposal offering a solution that involved several components working in concert to address the entire belt issue. “Our first recommendation was installing a rock box,” Cole explained. “Set three feet above the belt, it would work like a shelf, catching and distributing the limestone softly onto an impact cradle.”

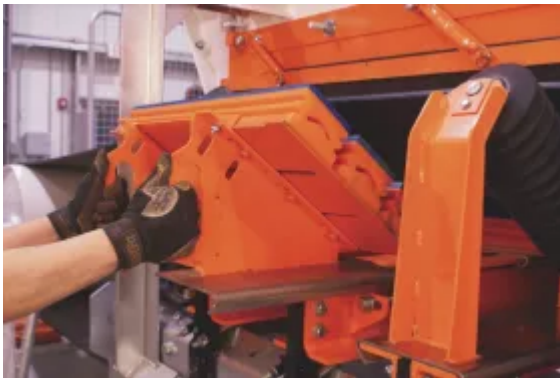
The modular impact cradle absorbs the impact of the falling load, yet slides in and out for easy service.

Located directly under the chute, the impact cradle is mounted on four rugged steel I-beam supports, able to sustain an impact force of 5443 Kg (12 000 lbs) by crushed material dropped from heights of up to 7.9 m (26 ft). The specially engineered impact bars are based on an aluminum T-slot design, which is surrounded by a layer of energy-absorbing 83A durometer urethane and coated with low-friction UHMW plastic to reduce friction and belt fraying. Wing supports adjust to a 5 percent fine-tuning angle, allowing the cradle to be precisely matched to the idler profile, assuring a tight belt seal and avoiding material shift on impact.

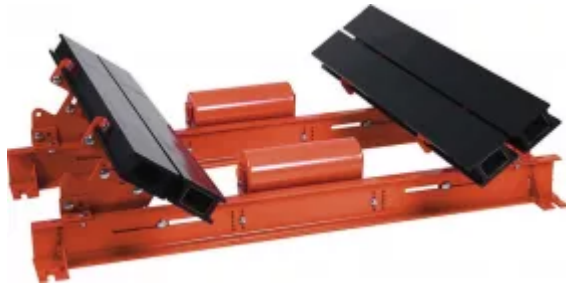
Slider cradles support the belt to prevent spillage from belt sag and eliminate material entrapment points.

Following the impact cradle within the 10.3 m long (34 ft) settling zone, the team recommended a series of adjustable slider cradles that support the belt to prevent spillage from belt edge sag and to eliminate entrapment points where material commonly got caught. To avoid belt fraying and reduce drive-power consumption, the loaded belt glides over low-friction, 62 durometer (shore D) UHMW polyethylene sidebars featuring the company’s unique “box” design.

The sidebars are “double-life,” which means they can be flipped over when one side is worn, providing a second wear surface. Using only hand tools, a single

worker simply removes the release pin and pulls the unit away from the frame on its track-mounted sub-assembly to adjust and replace components quickly.

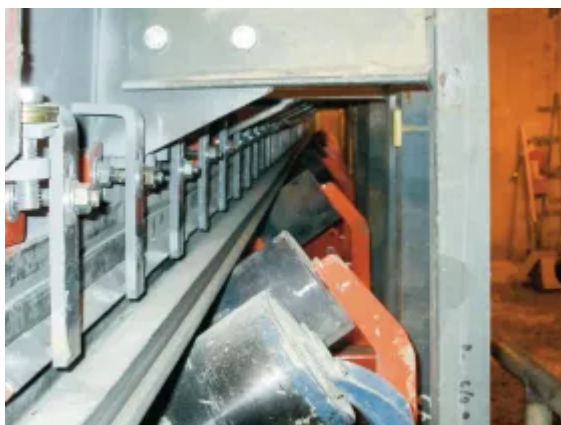
The external skirting system seals the chute to the belt.

Another key element of the assessment was an external skirting system along the chute box, sealing the chute to the belt. Specially designed to provide dual-seal efficiency with a one-piece 70 Shore D EPDM durometer rubber composite skirt and an attached strip, the skirting floats on the belt and self-adjusts to maintain an effective seal.

Offering chemical resistance and low-abrasion index characteristics, once the skirt is worn on one side, it can be flipped for dual usage by disengaging the 182.9 cm (6 ft) long angle clamps. This can be done quickly using hand tools.

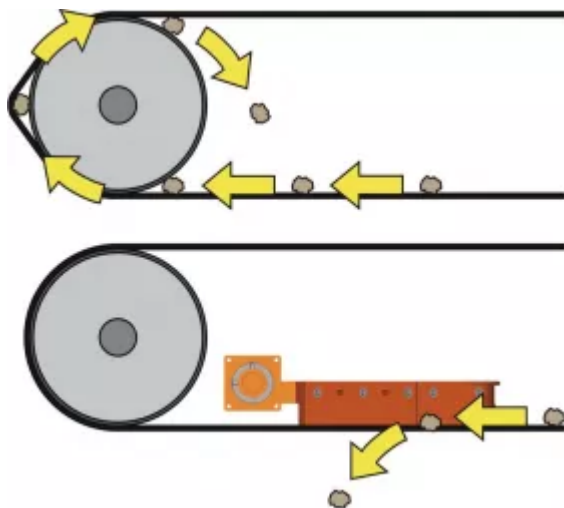
The V-Plow prevents material entrapment between the belt and tail pulley from becoming a repeating phenomenon.

belt and tail pulley, so we proposed a torsion V-plow as well.”

Mounted on a dual steel bar attached to the mainframe a few feet from the tail pulley, the V-plow has a unique suspension system that allows the polyurethane blade to rise and fall with fluctuations in belt tension. Any material carried back on the top of the belt return is deflected to either side of the frame before it reaches the tail pulley.
