White Paper

Martin Engineering: Reduce Conveyor Maintenance Time through better Access

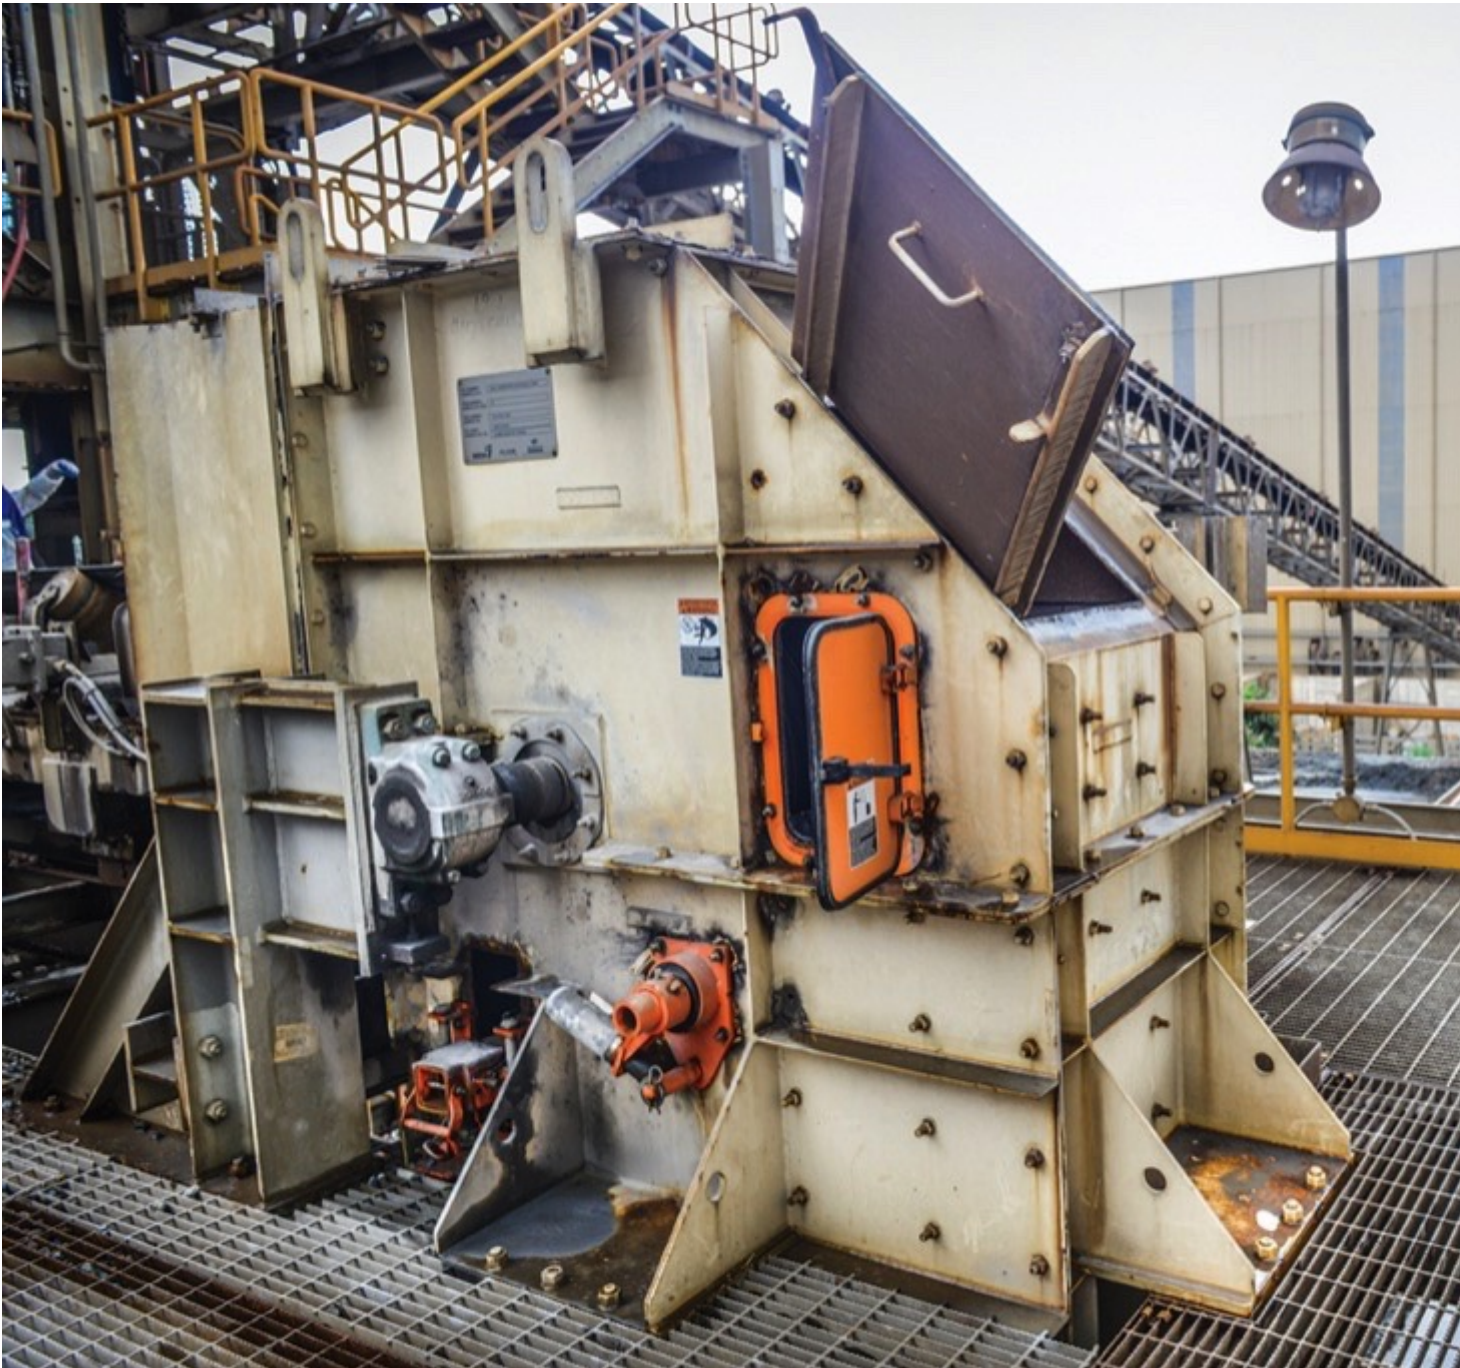
“Access” can mean observation points, entry doors and workspace for service.

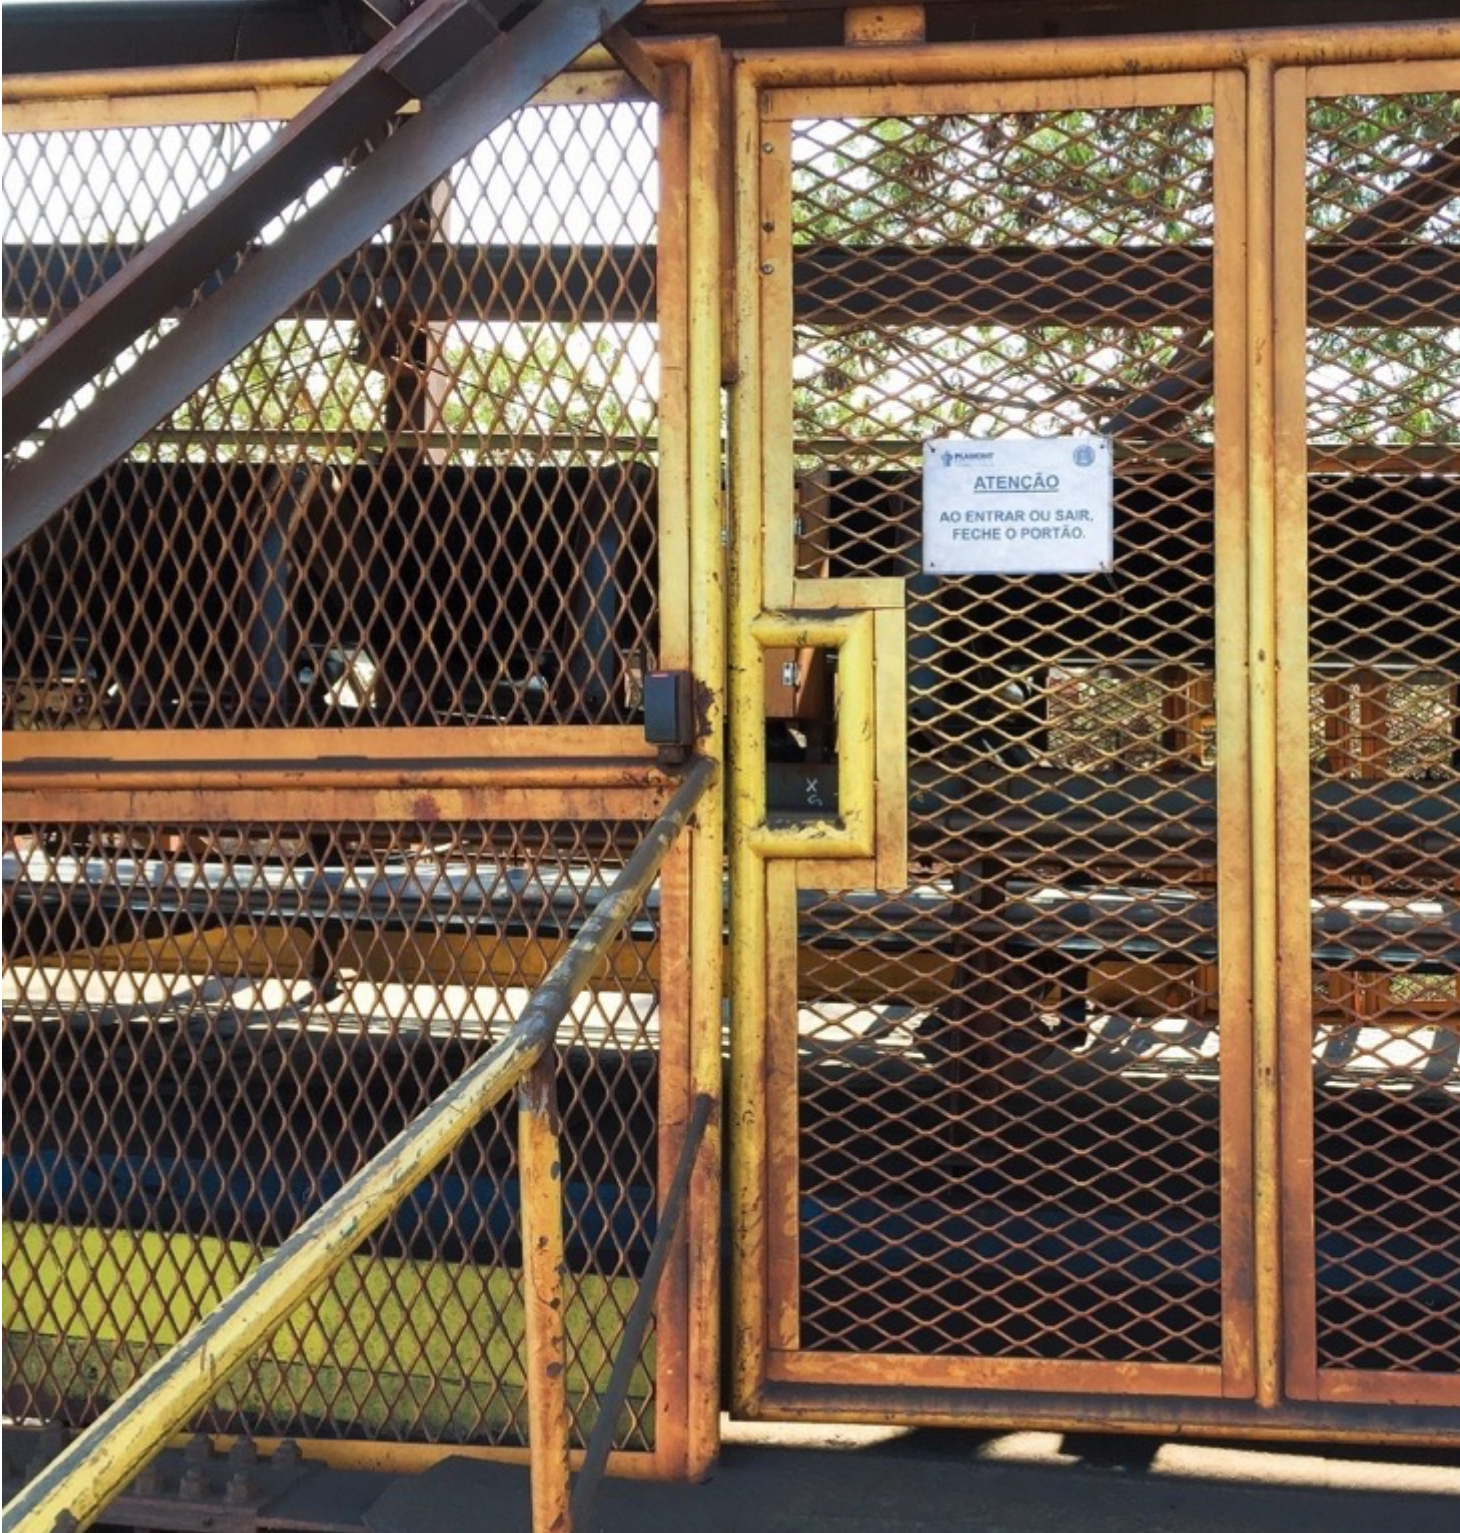
A gate to a conveyor walkway,
controlled with an RFID sensor.

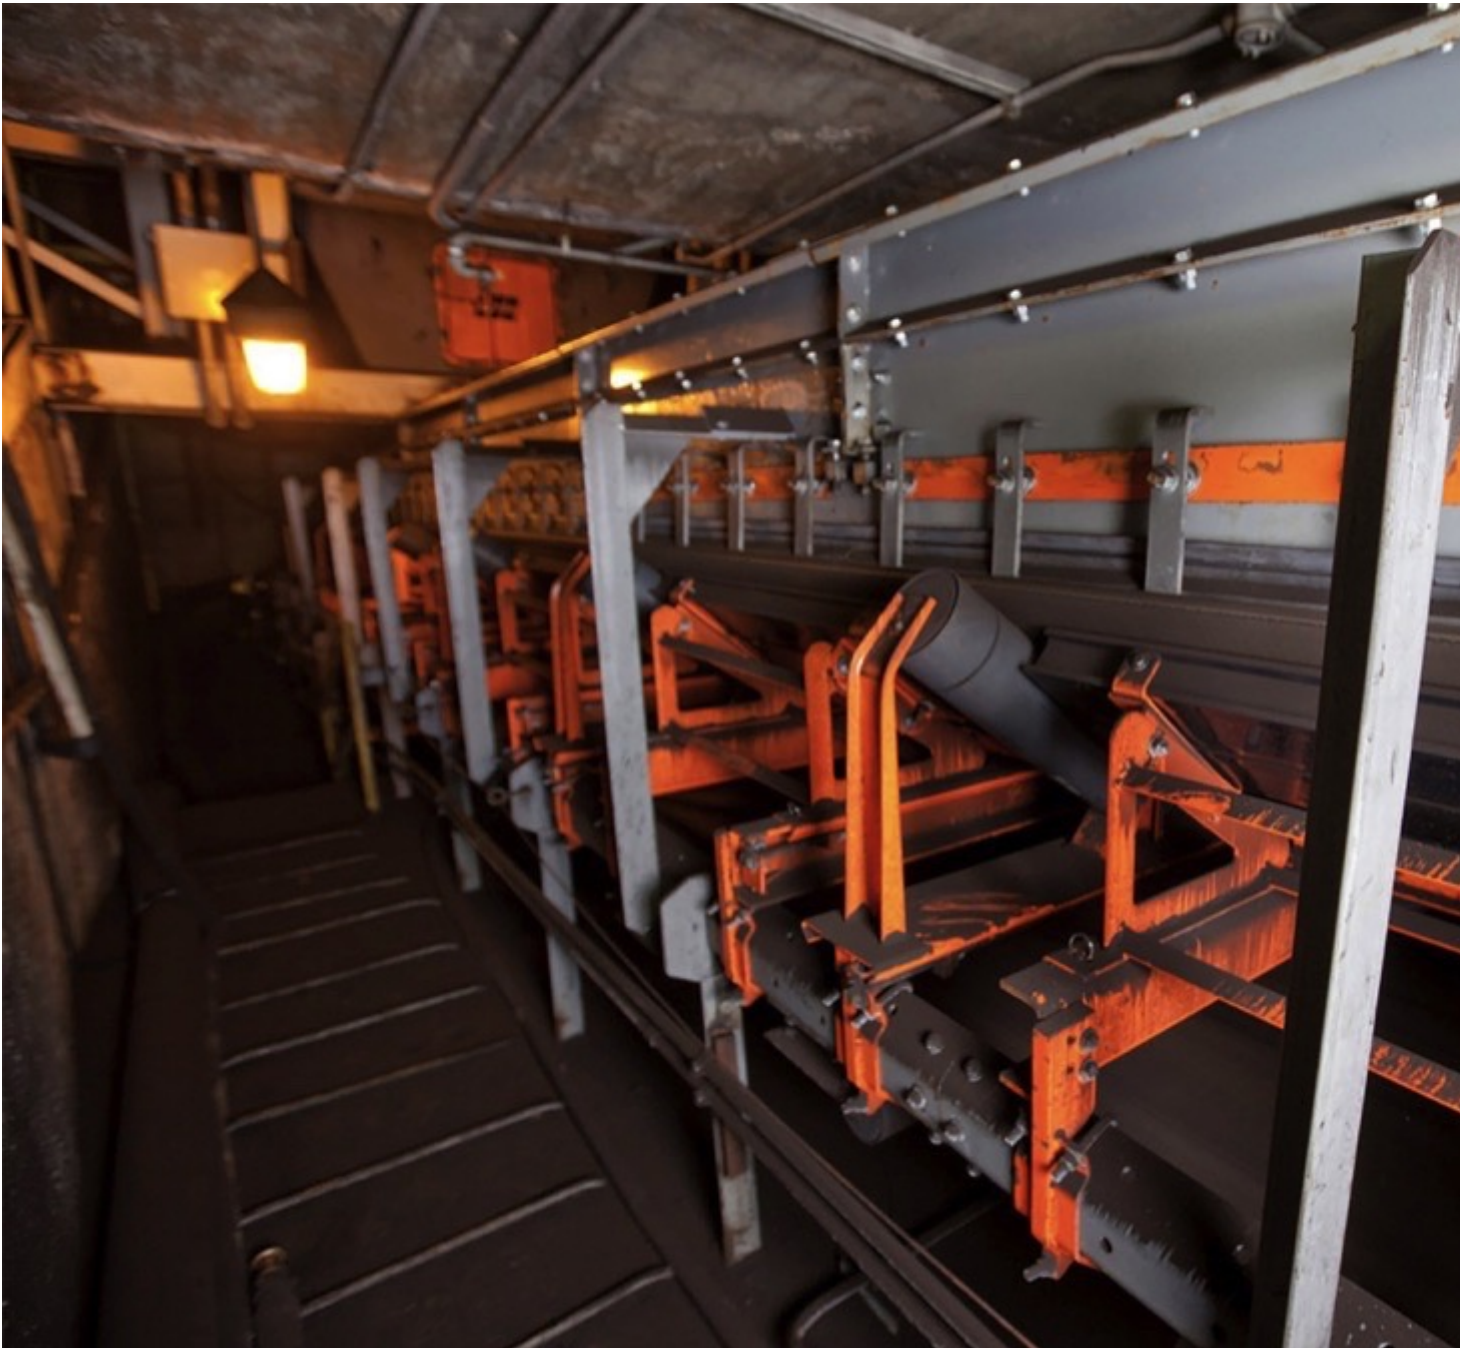
Inspection doors and track-mounted components facilitate maintenance for extended equipment life.

A tight seal is the key to preventing fugitive dust from leaving any chute. Many current setups require workers to crouch or crawl under the system or even enter a confined space to inspect it or perform maintenance, which can result in serious injuries. Inspection of the system needs to be fast, easy and safe. Small inspection doors –either solid or grated – can allow several observation points. Larger doors can offer access points with ample space for service of specific wear parts.

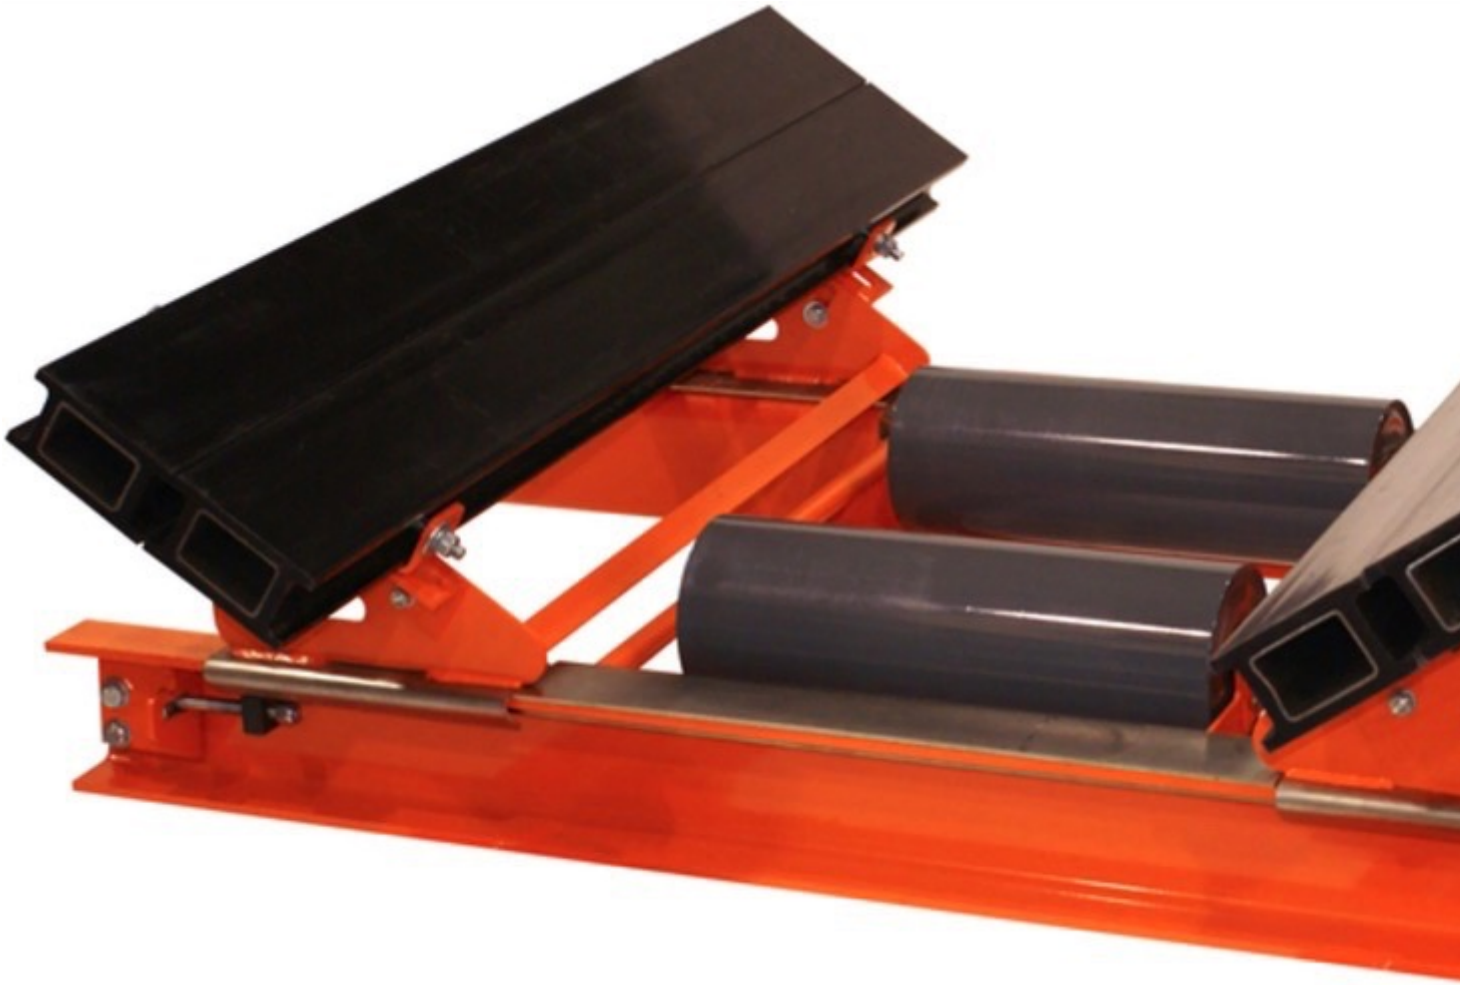
Track-mounted designs allow components to slide in and out easily for maintenance.

Located under the skirtboard and mounted with rugged steel assemblies, the cradles feature large impact-absorbing UHMW polymer “box bars” engineered with smooth surfaces that the belt can slide across with little friction or belt wear. These assemblies can be pulled out by a single worker and – working safely from outside the conveyor and using only a single tool – the box bars can be simply removed and flipped in a matter of minutes to double the service life.

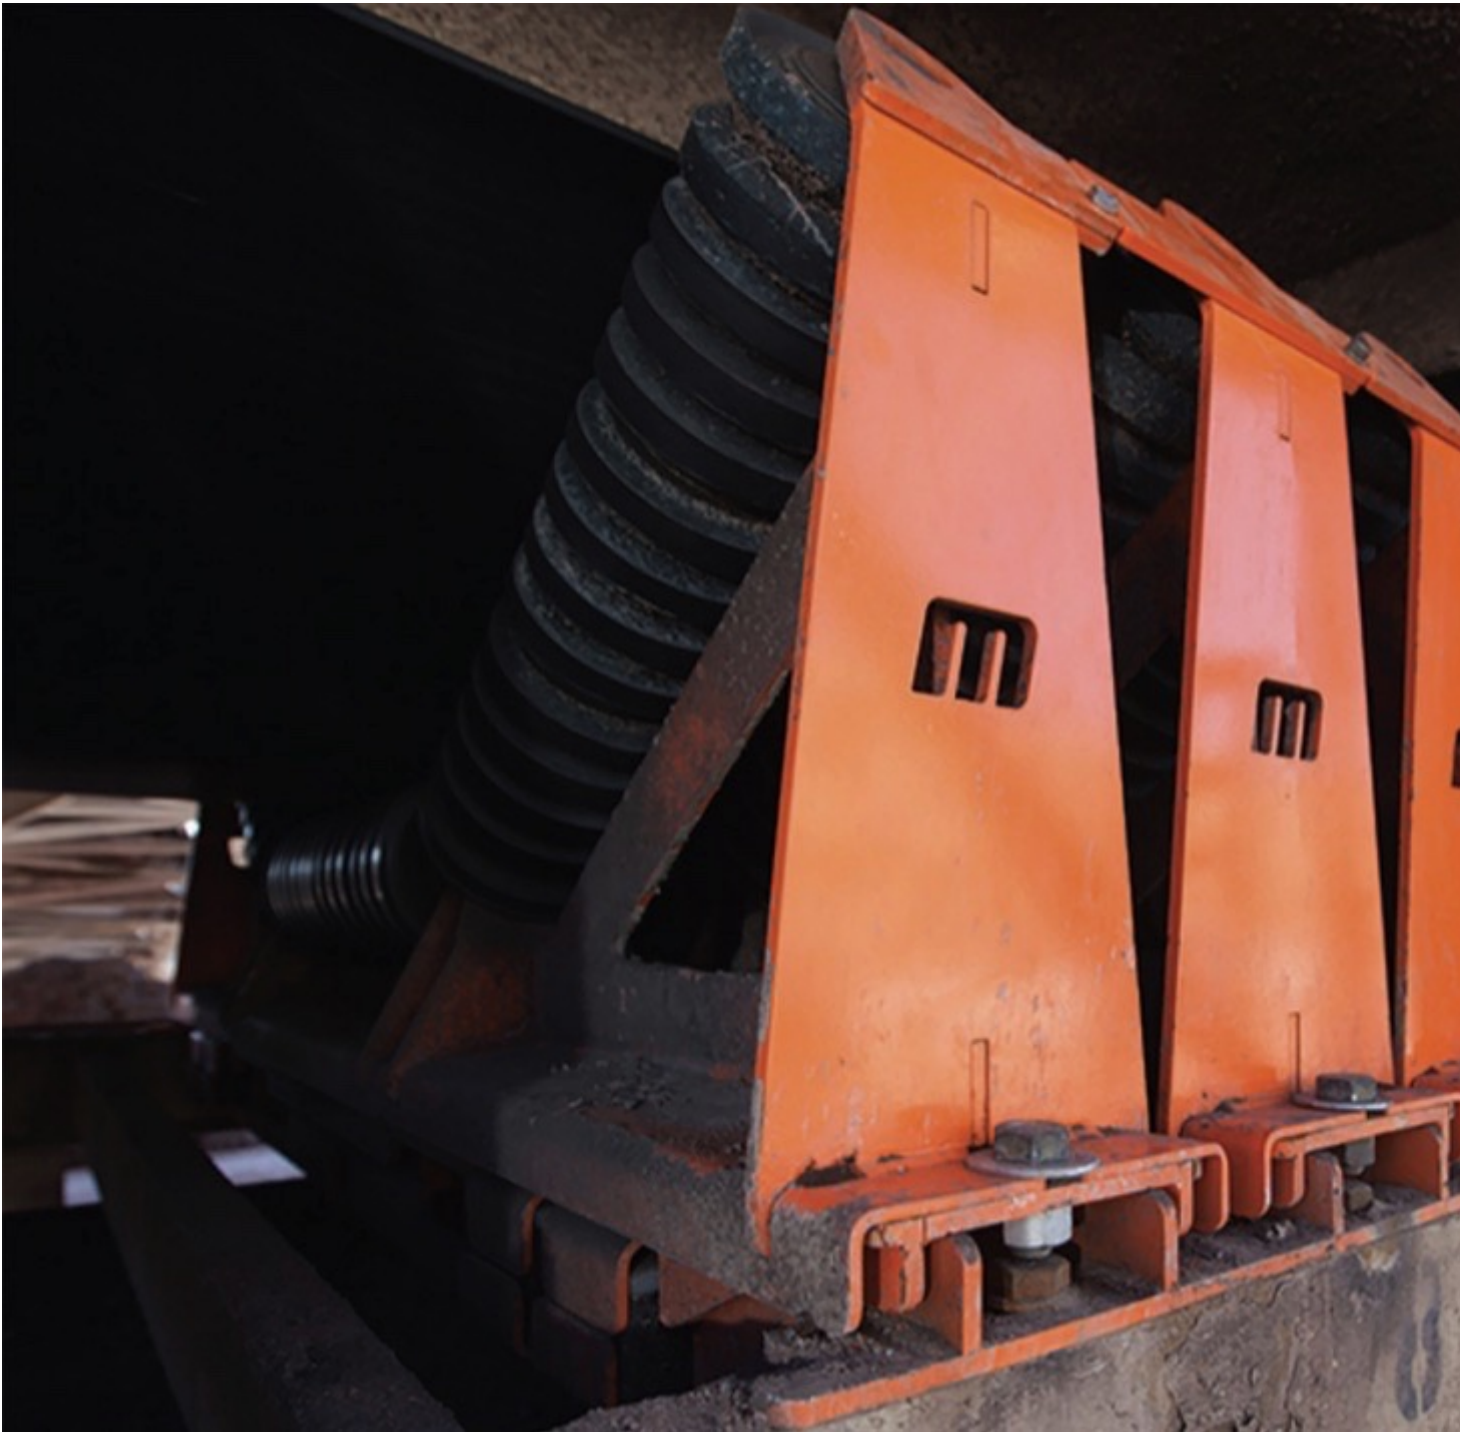
Track-mounted idlers allow easy access for quickly swapping out seized rollers.

Along the cargo path in the settling zone and beyond, retractable idlers support the belt and maintain the trough angle. Exposed to the punishing environment, gritty dust and extreme weather, rollers can seize over time. Often set closely together in the loading zone to avoid belt sag, slide-out/slide-in roller frames permit workers to perform idler service outside of the belt plane without the need to raise the belt or remove adjacent idlers.

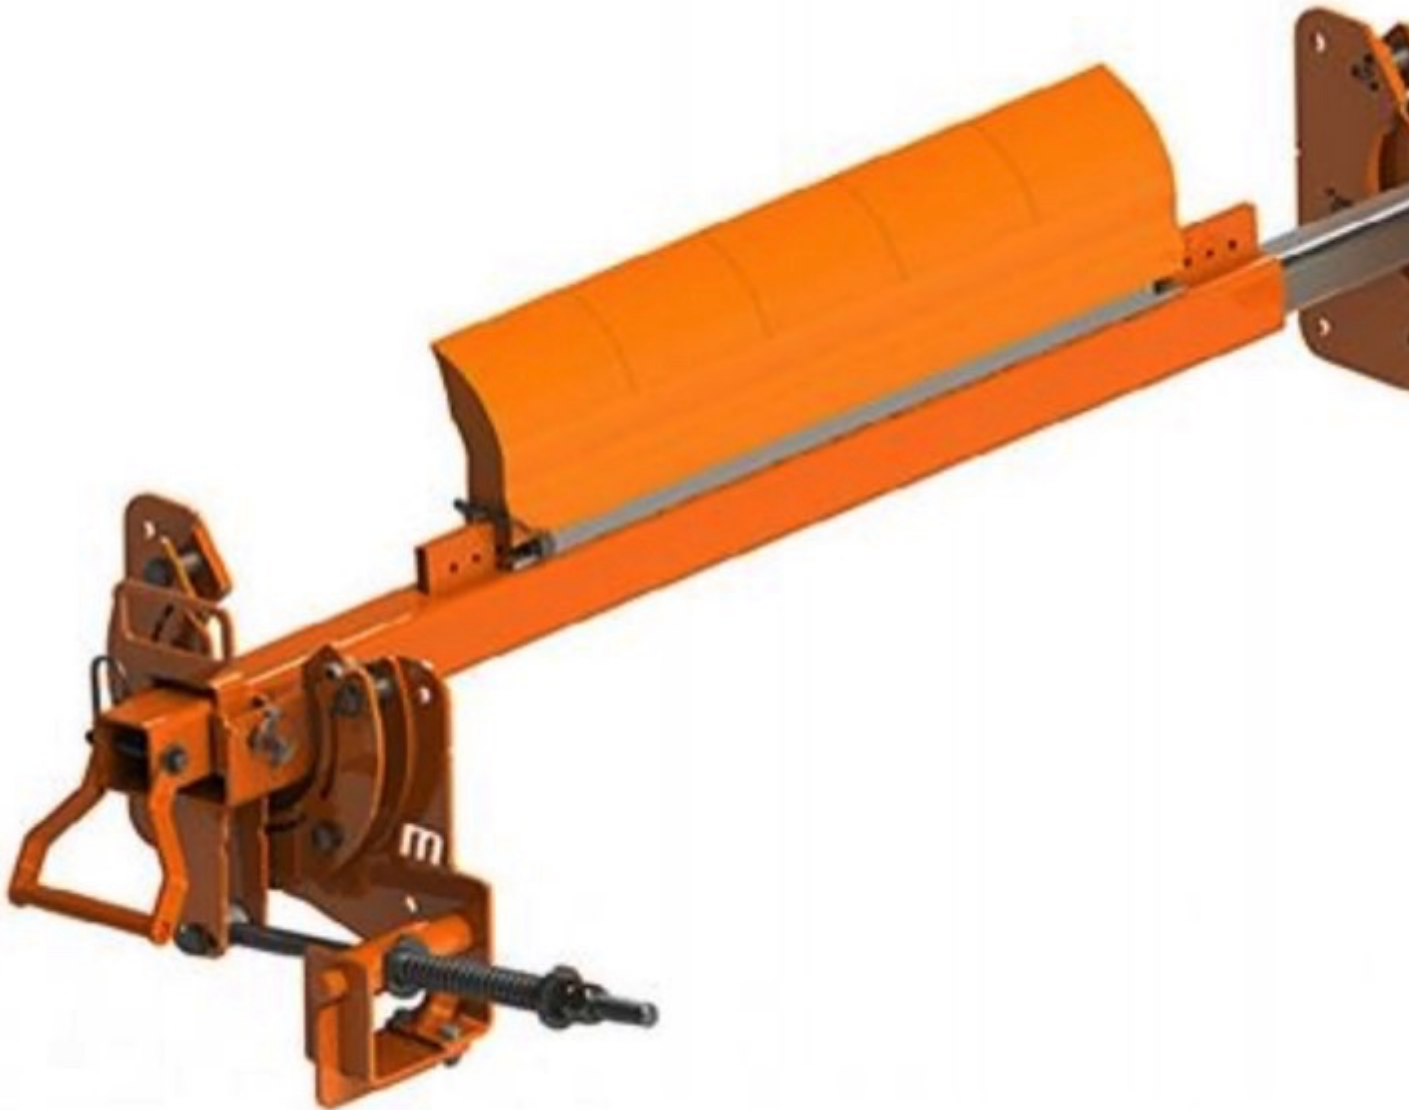
Belt cleaners can also be designed to slide out easily for fast replacement by a single worker.

Primary cleaners – located on the underside of the head pulley – are mounted on rotating assemblies designed to retain the proper tension between the blade and the belt. Secondary cleaners are located behind the head pulley and raised slightly above the belt line for tension. Specially-designed units can slide in and out by simply pulling a lever and releasing a pin. This allows blade maintenance to be performed outside of the system by a single worker in under an hour.

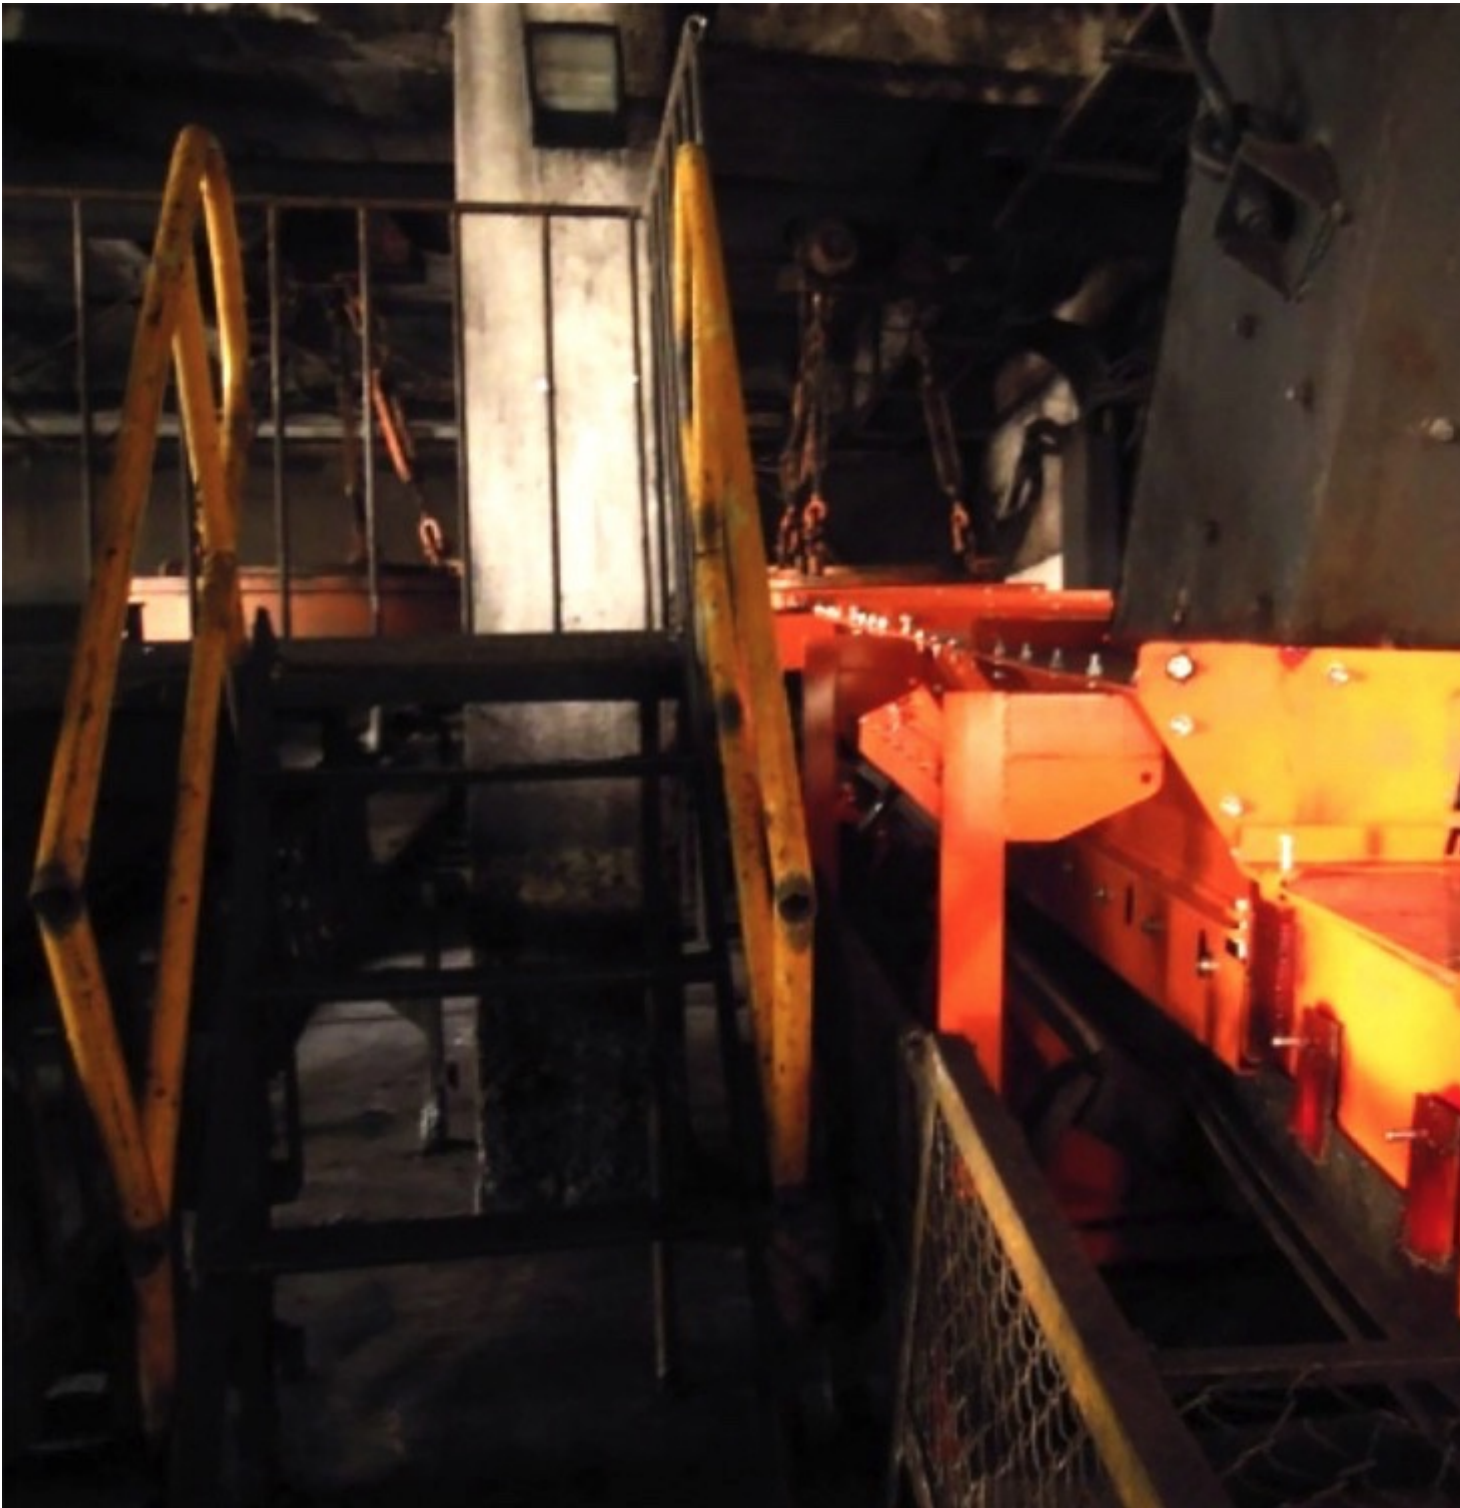
A hatch over the tail pulley allows staff to easily detect entrapped material.
