White Paper

Martin Engineering: Reduce Conveyor Maintenance Time through better Access

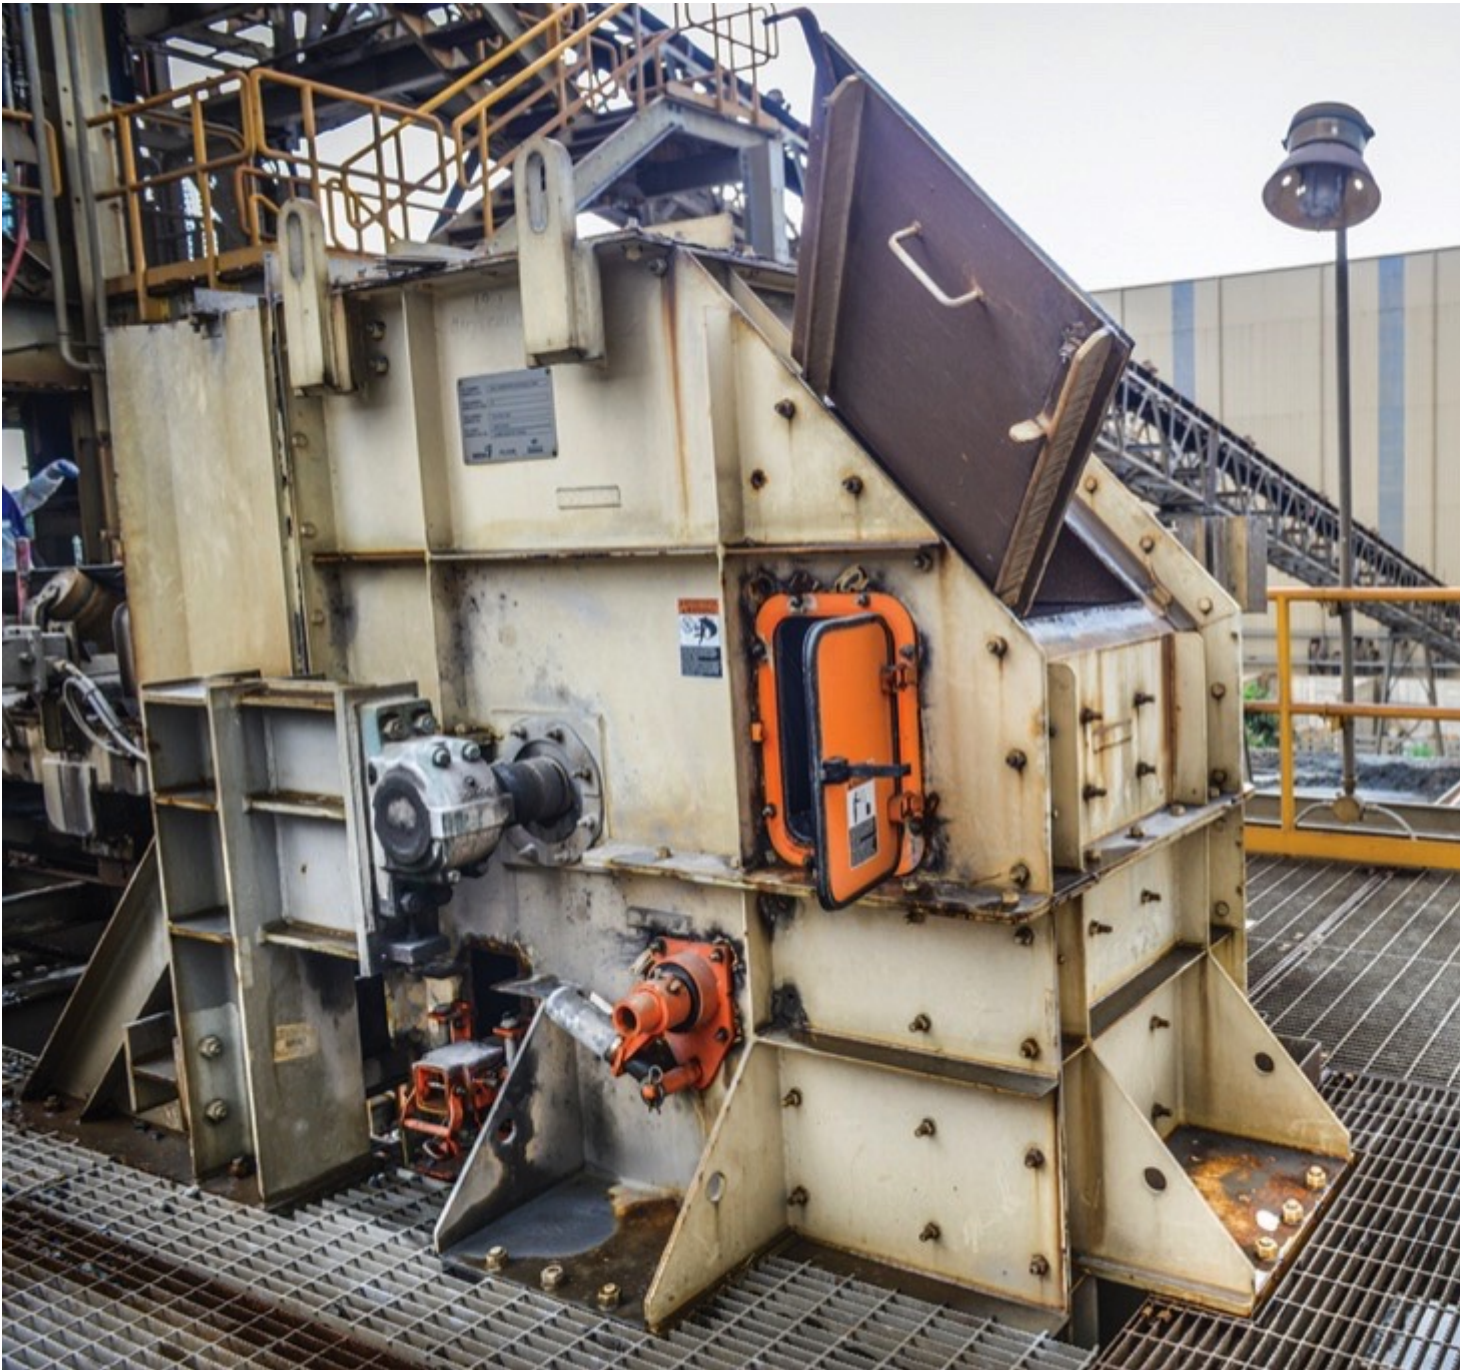
“Access” can mean observation points, entry doors and workspace for service.

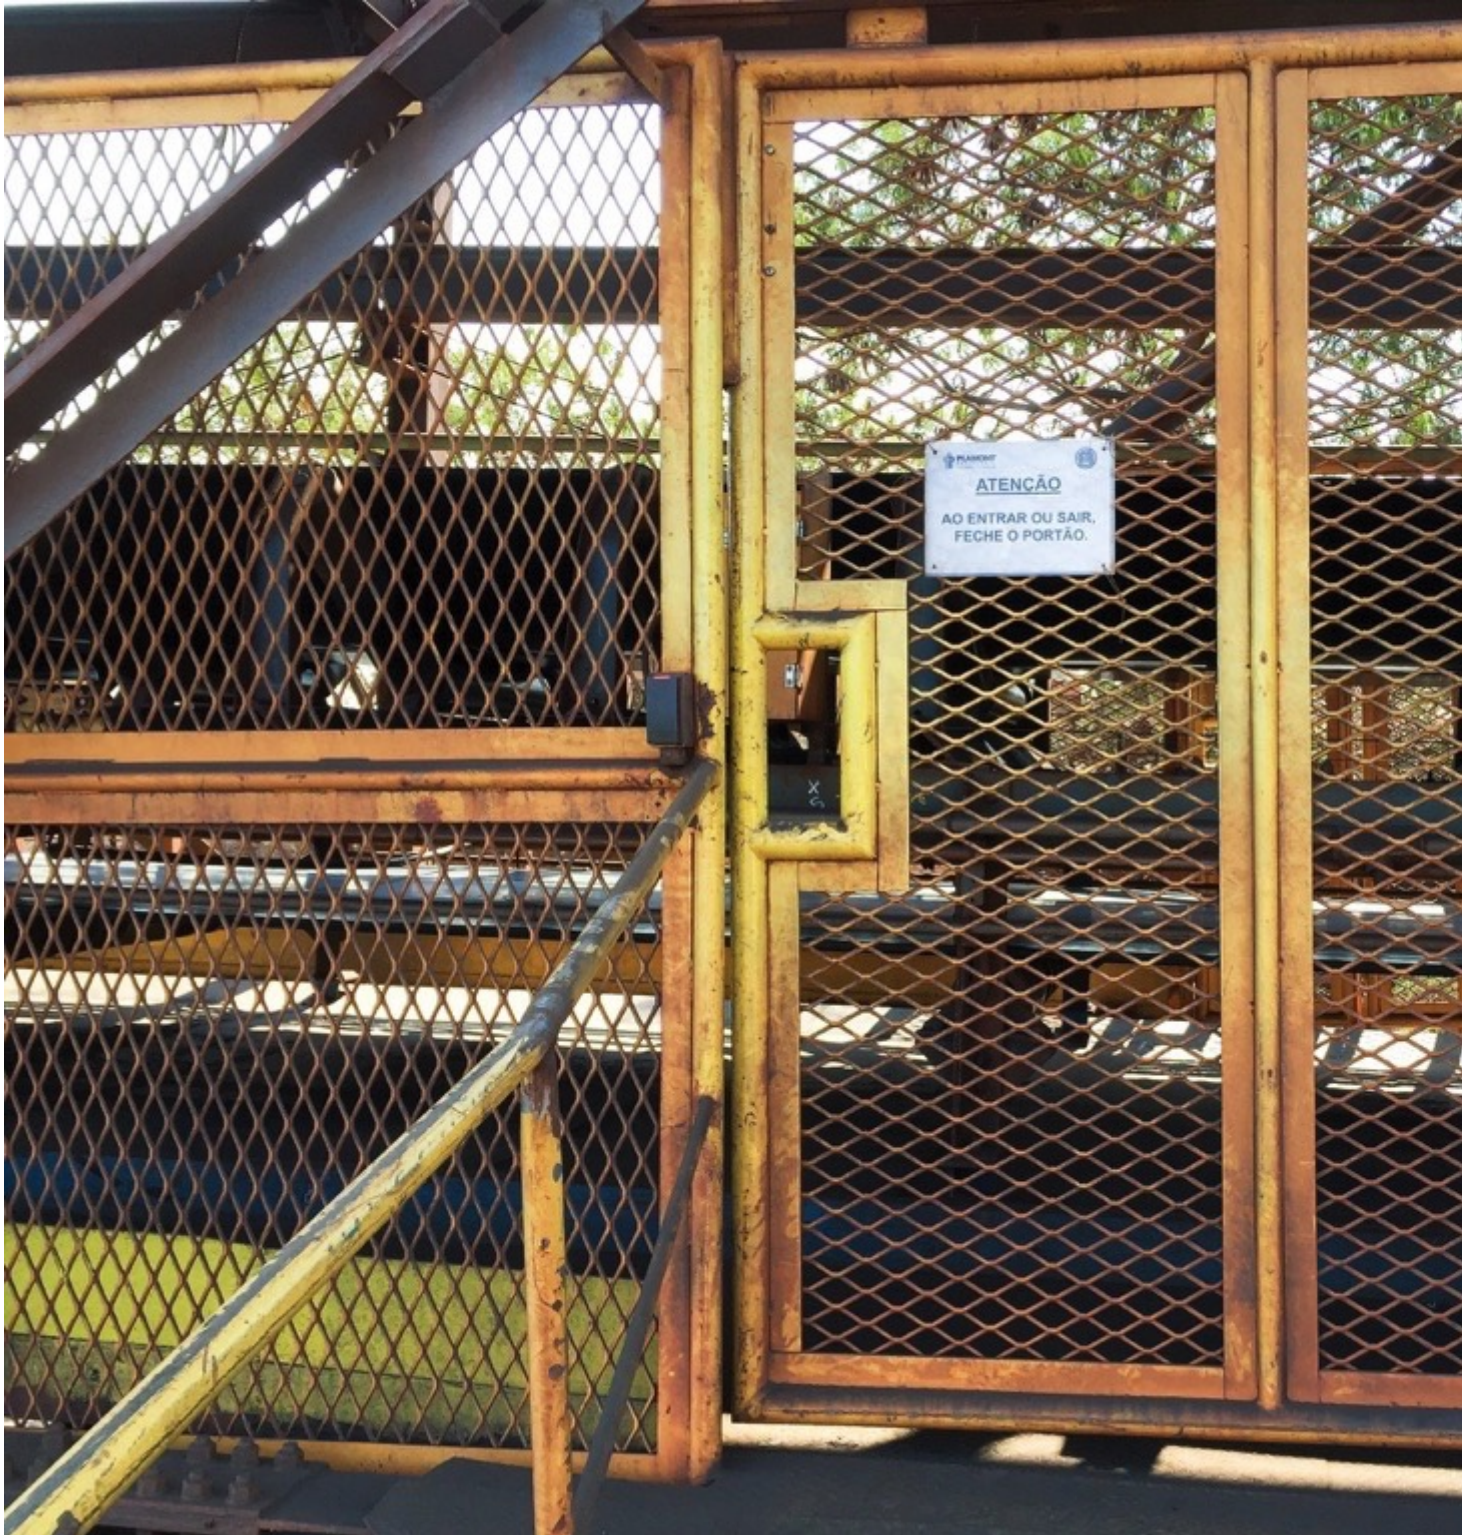
A gate to a conveyor walkway,
controlled with an RFID sensor.

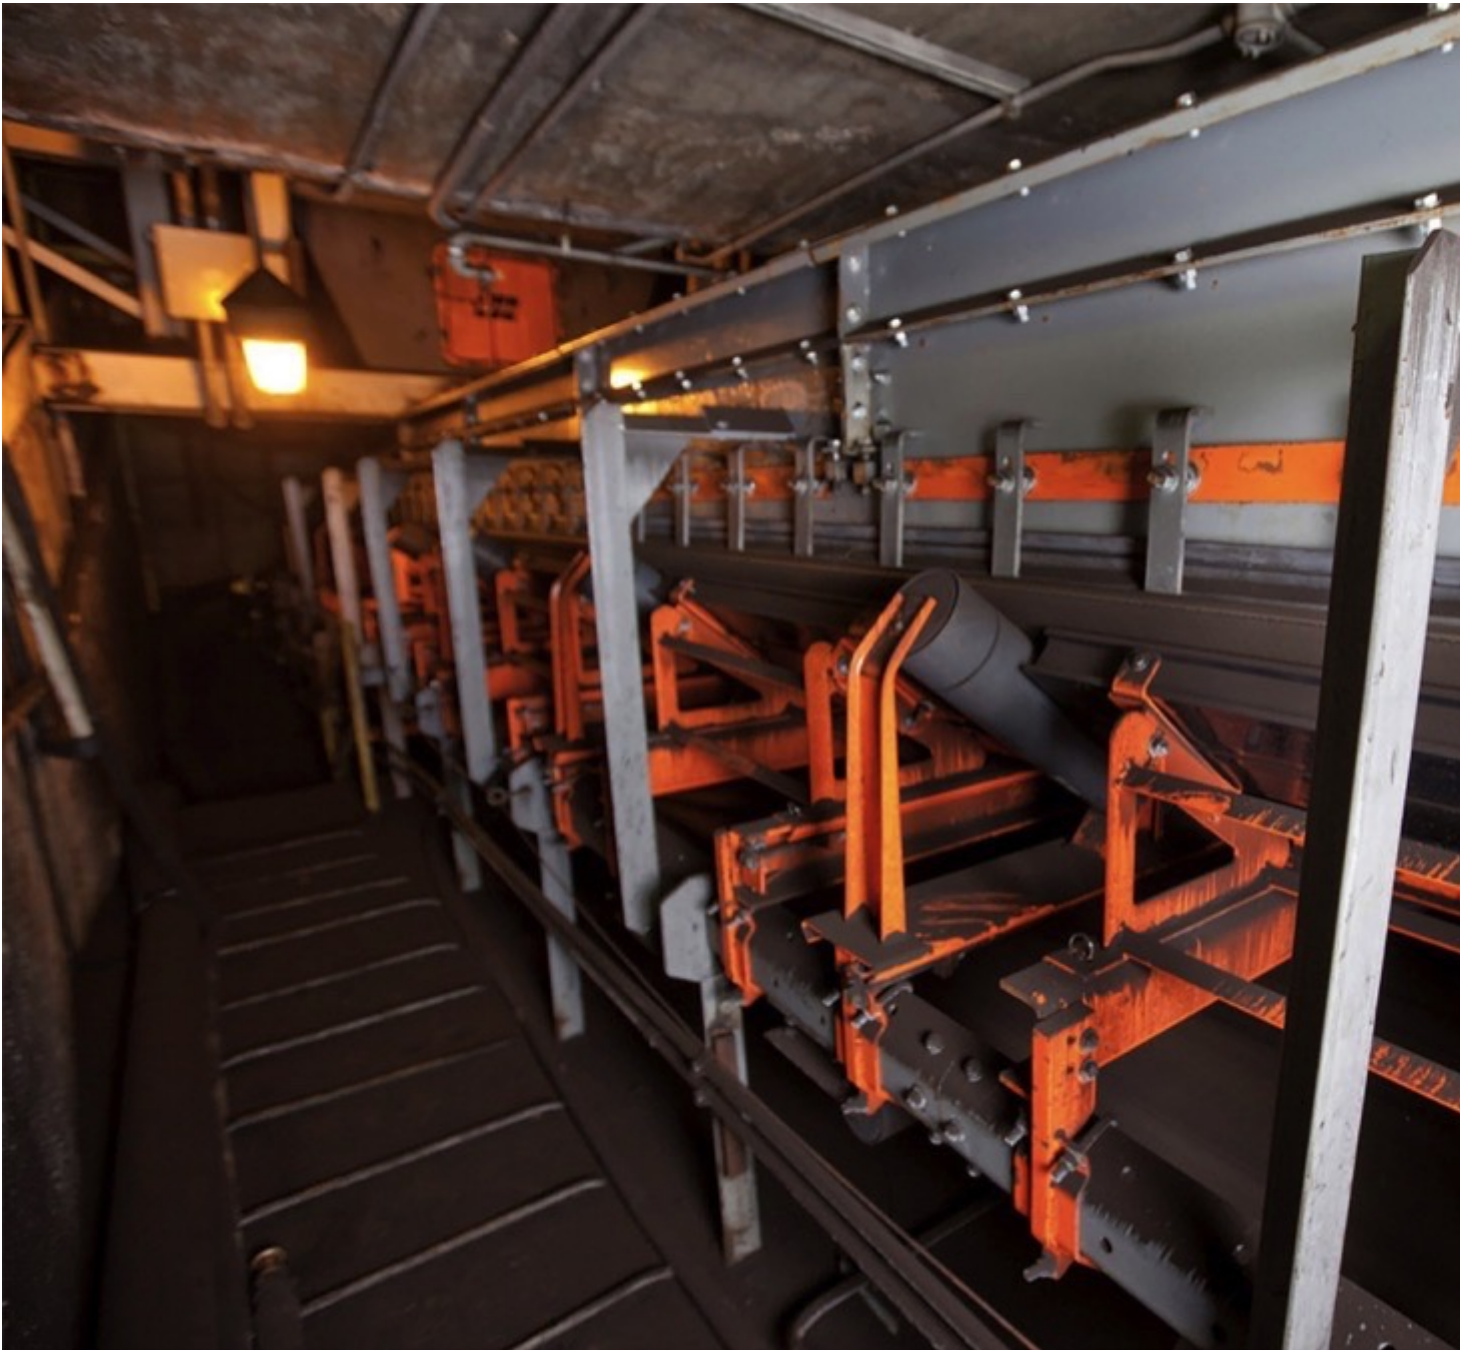
Inspection doors and track-mounted components facilitate maintenance for extended equipment life.

A tight seal is the key to preventing fugitive dust from leaving any chute. Many current setups require workers to crouch or crawl under the system or even enter a confined space to inspect it or perform maintenance, which can result in serious injuries. Inspection of the system needs to be fast, easy and safe. Small inspection doors –either solid or grated – can allow several observation points. Larger doors can offer access points with ample space for service of specific wear parts.

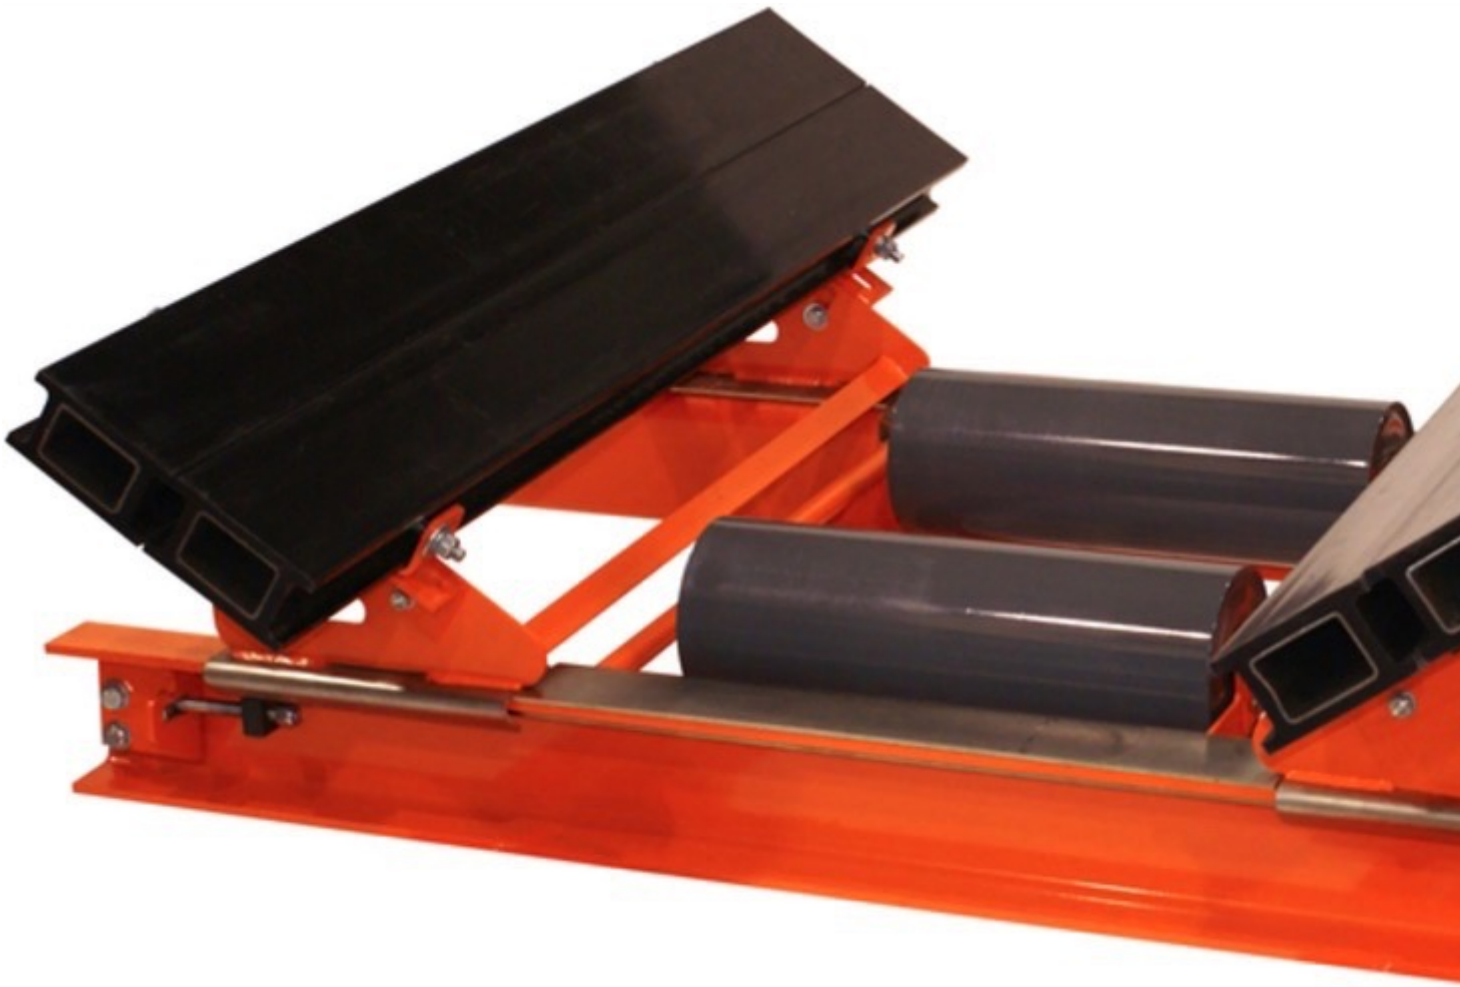
Track-mounted designs allow components to slide in and out easily for maintenance.

Located under the skirtboard and mounted with rugged steel assemblies, the cradles feature large impact-absorbing UHMW polymer “box bars” engineered with smooth surfaces that the belt can slide across with little friction or belt wear. These assemblies can be pulled out by a single worker and – working safely from outside the conveyor and using only a single tool – the box bars can be simply removed and flipped in a matter of minutes to double the service life.

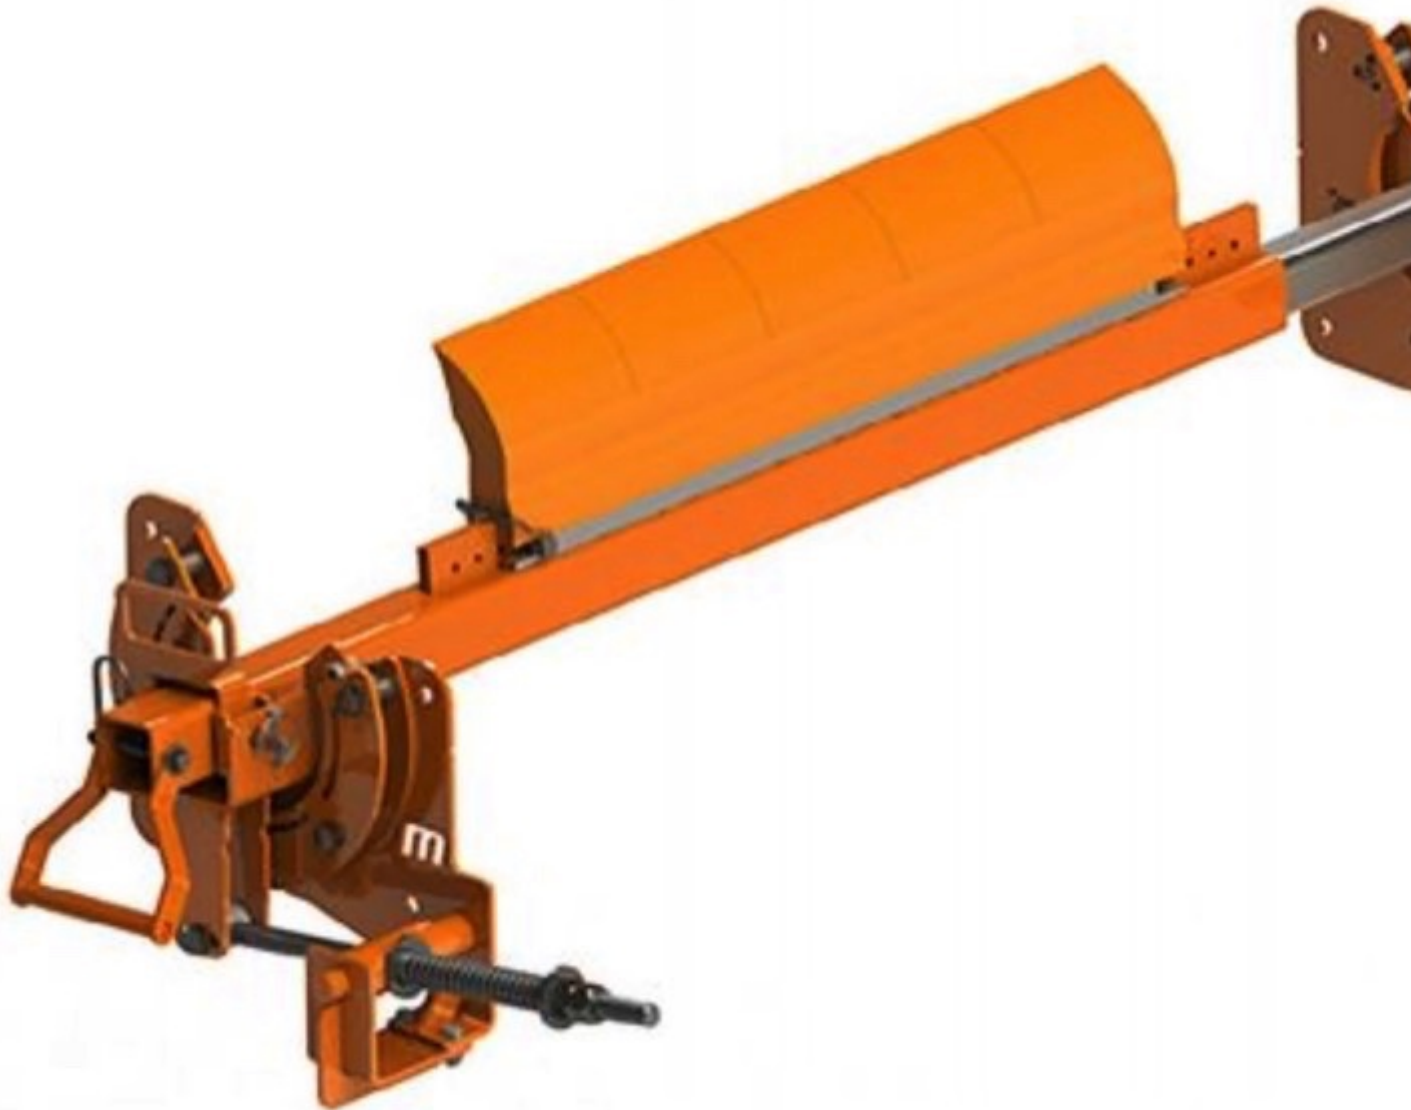
Belt cleaners can also be designed to slide out easily for fast replacement by a single worker.

Primary cleaners – located on the underside of the head pulley – are mounted on rotating assemblies designed to retain the proper tension between the blade and the belt. Secondary cleaners are located behind the head pulley and raised slightly above the belt line for tension. Specially-designed units can slide in and out by simply pulling a lever and releasing a pin. This allows blade maintenance to be performed outside of the system by a single worker in under an hour.
