Case Study

## **Limestone in a Silo: OK - but out? Resolving Material Accumulation in Cement Plant Limestone Silo**

[Published in bulk solids handling, Vol. 37 \(2017\) No. 1](#)

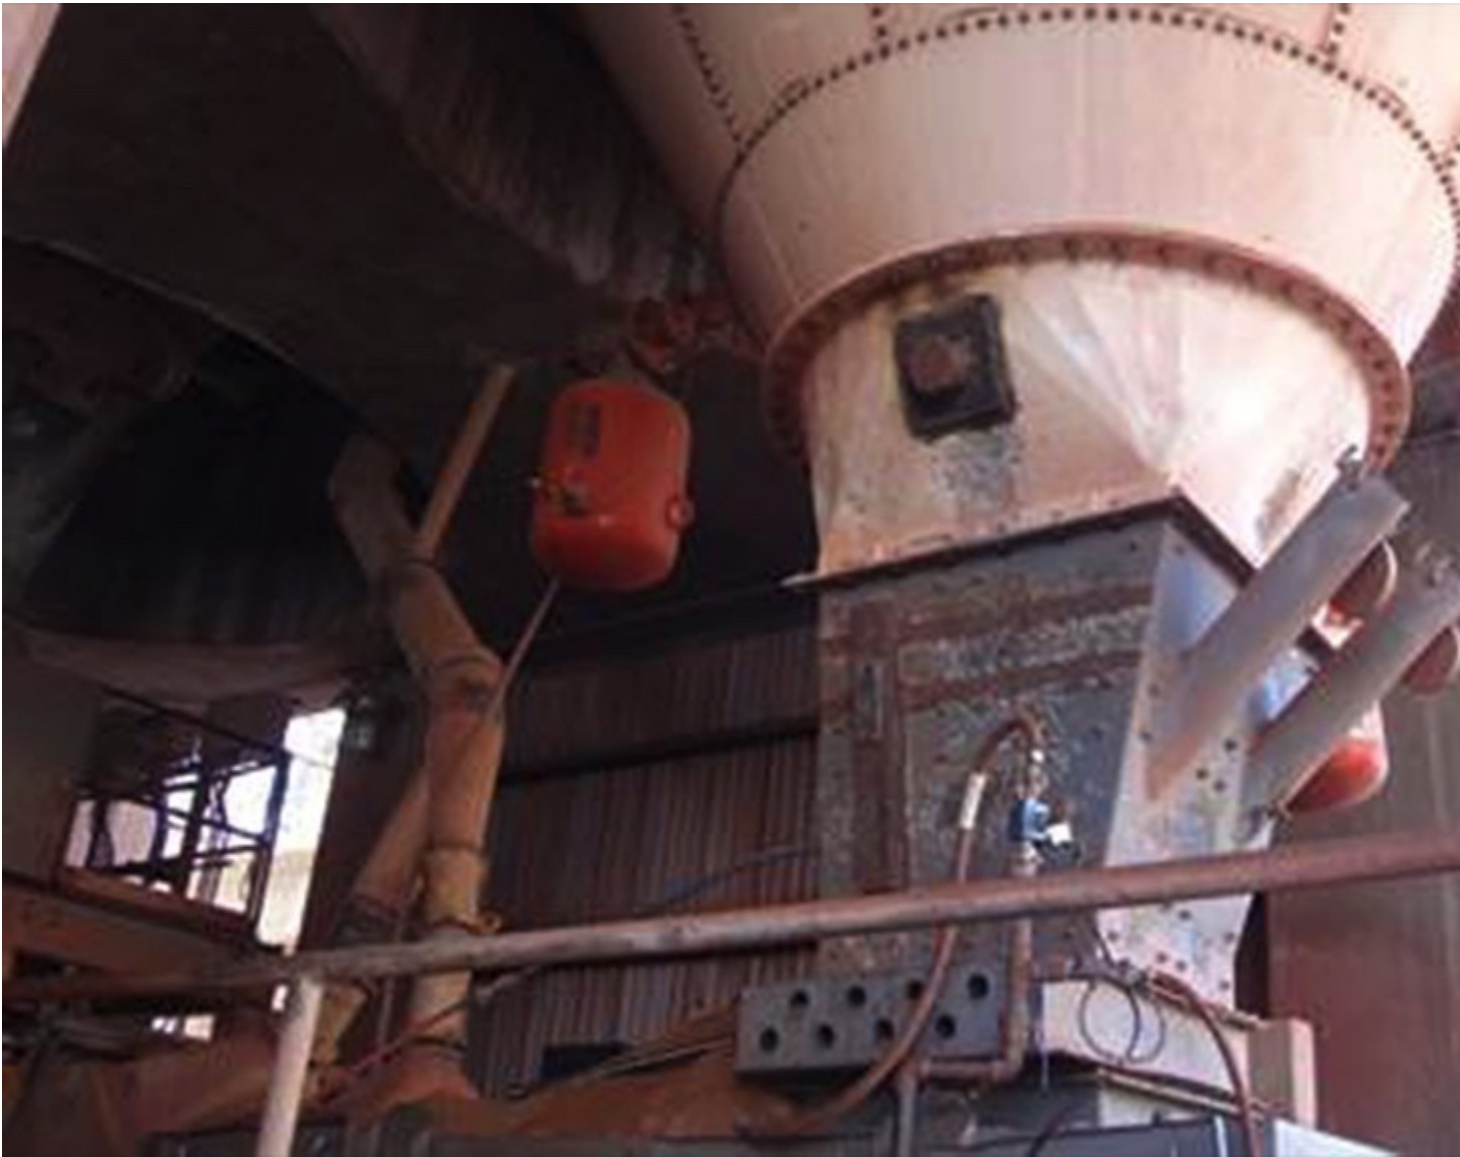
Martin XHV air cannons at Drake cement in their original perpendicular firing configuration (Pictures: © Martin Engineering)

Rather than the two cannons at the bottom of the limestone silo firing across the cargo flow, five cannons were strategically placed around the vessel. Installed with a wide 4-in (101 mm) valve, three 70-liter (88 lb/40kg) Tornado air cannons were placed on the lower incline of the cone at a 30° downward angle against the

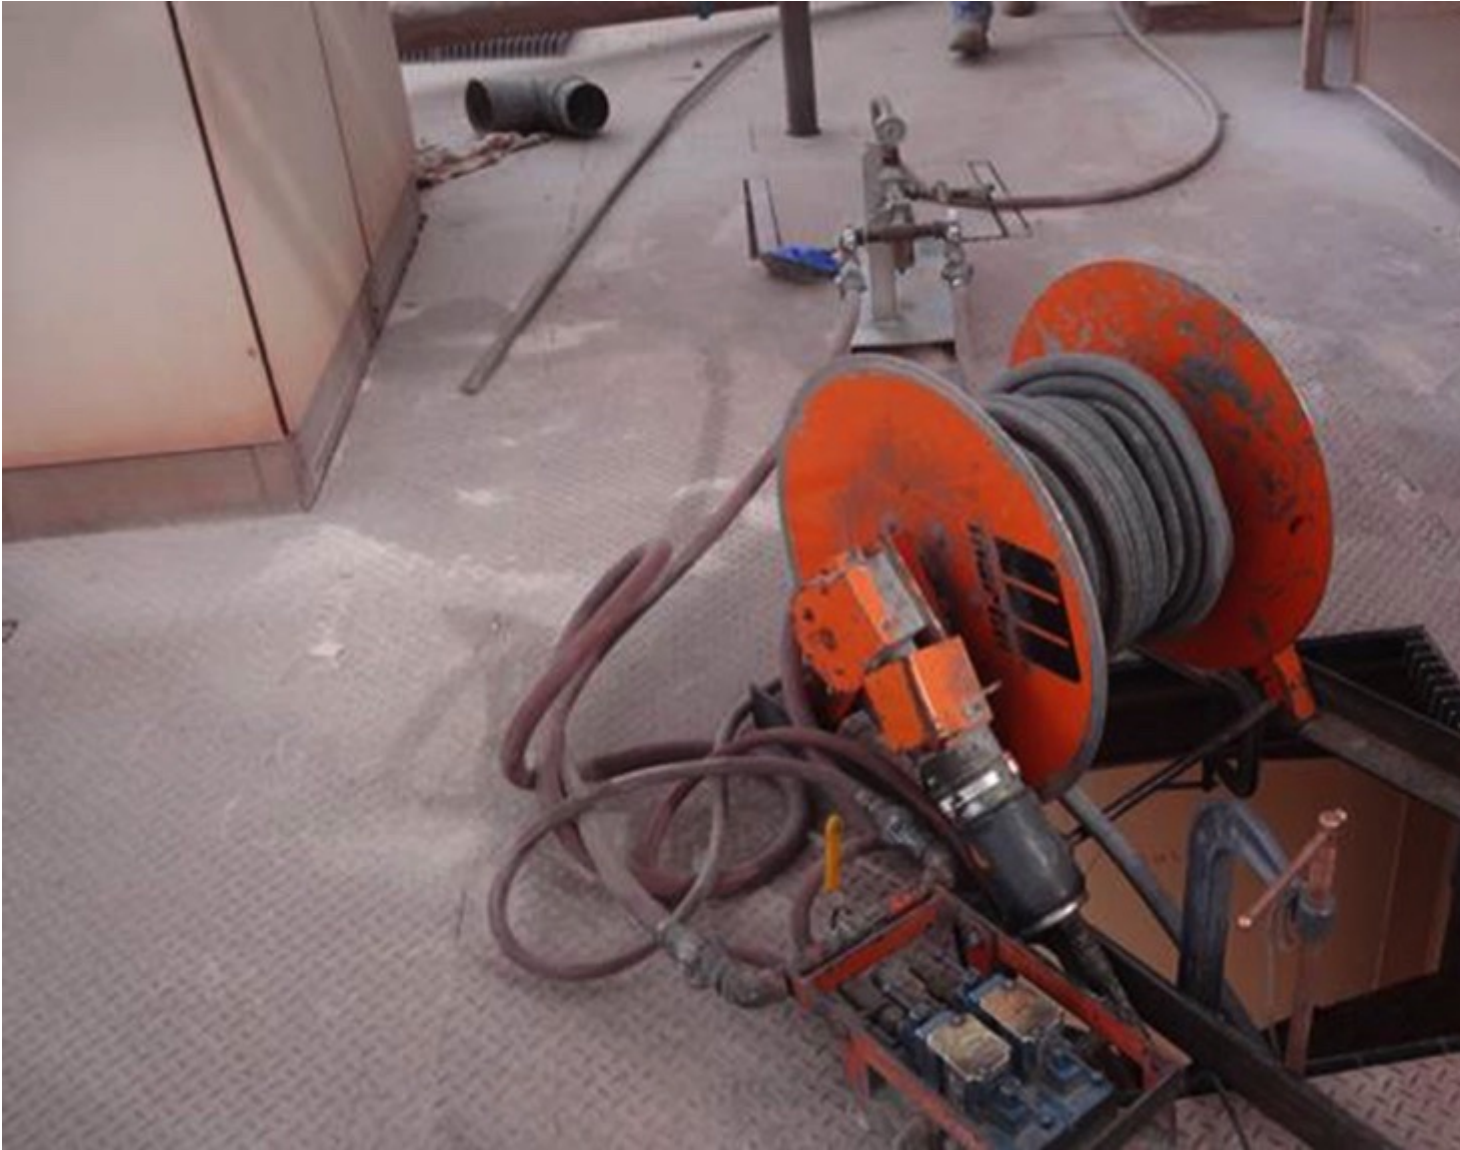
The remotely controlled heavy duty whip is set up above the manhole at the top of the silo.

The experienced two-man crew immediately set up a Martin heavy duty whip. Powered by compressed air, the device can be equipped with a variety of flails and cutting edges to knock down accumulated material without damaging the silo’s walls or support structure. The coiled modular boom extends up to 28 ft (8.5 m) and can clean vessels as wide as 60 ft (18 m) in diameter and 225 ft (68.5 m) tall. Operating from the bottom of the silo up, the team completely cleaned out

the densely clogged silo in only 11 hours while the plant resumed production.

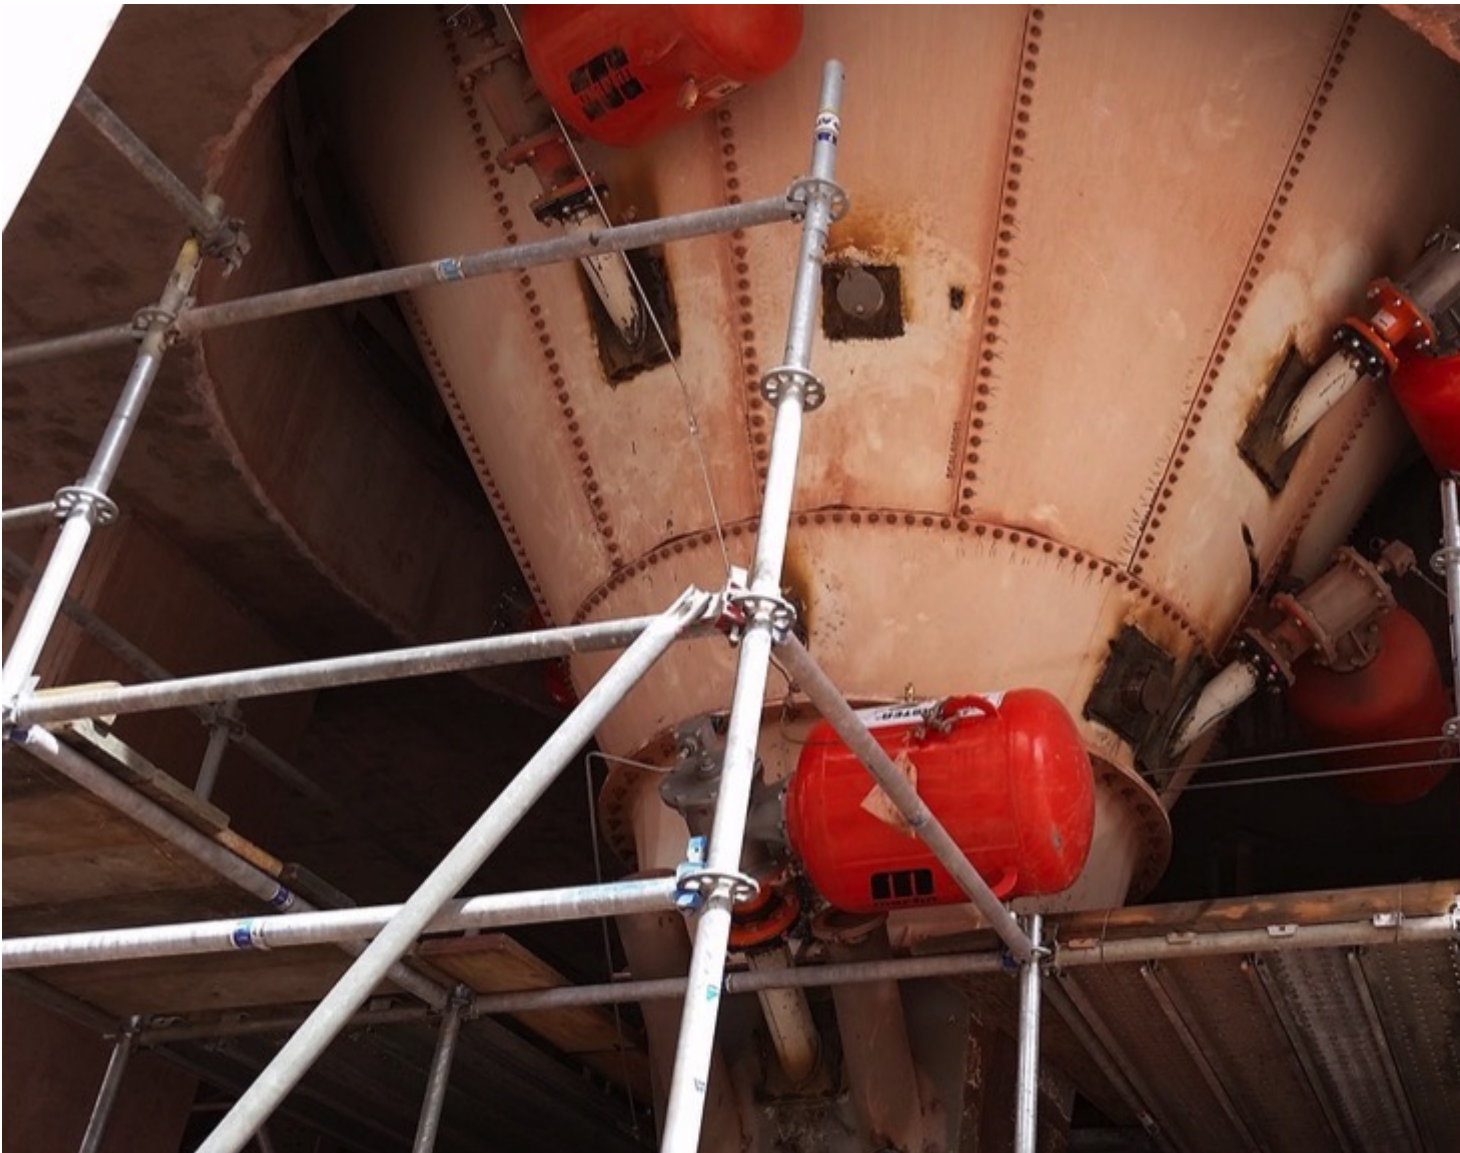
The lower silo cannons strategically placed around the 60° incline.

60° slope in the 6 and 12 o'clock positions (one side of the silo was inaccessible). In the 3 o'clock position, one air cannon was situated at the 2-ft-wide shaft, and another was added to the upper silo to aid in loosening material. The cannons deliver a strong pressurized blast of air down the wall of the silo, dislodging adhered material and introduces it back into the process flow. "This type of air cannon configuration has shown to be highly effective in promoting flow and preventing clogging," Brown pointed out. "It has the benefit of directing the air cannon's blast to dislodge the material, delivering a more powerful shot on accumulation that's stuck to the vessel wall." A programmable logic control (PLC) system centrally placed in the facility coordinates and monitors the timing and firing sequence of each unit at all locations, including the limestone silo. This made expanding the system easier, since the cannons use a positive-acting valve that is triggered by a solenoid panel set a safe and convenient distance - up to 200 ft (61 m) - from the cannons. Connected to the plant's compressed air system, the improved air path of the Tornado fills the reservoir 3-4 times faster than typical designs. The positive-acting valve opens in response to a surge of air sent by the solenoid, amplifying the discharge force by 20% and reducing the chance of misfires. During the wet winter and monsoon months, the cannons were activated approximately every hour, but throughout the rest of the year the system has a firing sequence of only 4-5 times per day. "We also added a layer of protection that the silo didn't have before by installing an automated weight sensor," Venegas explained. "If the silo exceeds 40 t of downward pressure, logistical software detects the buildup and fires the cannons. This sequence can also be manually activated at the weigh feeder, the solenoid panel or in the control room."
