Case Study

GKD: Sewage Treatment Plant enjoys greater Planning Reliability for its Belt Press

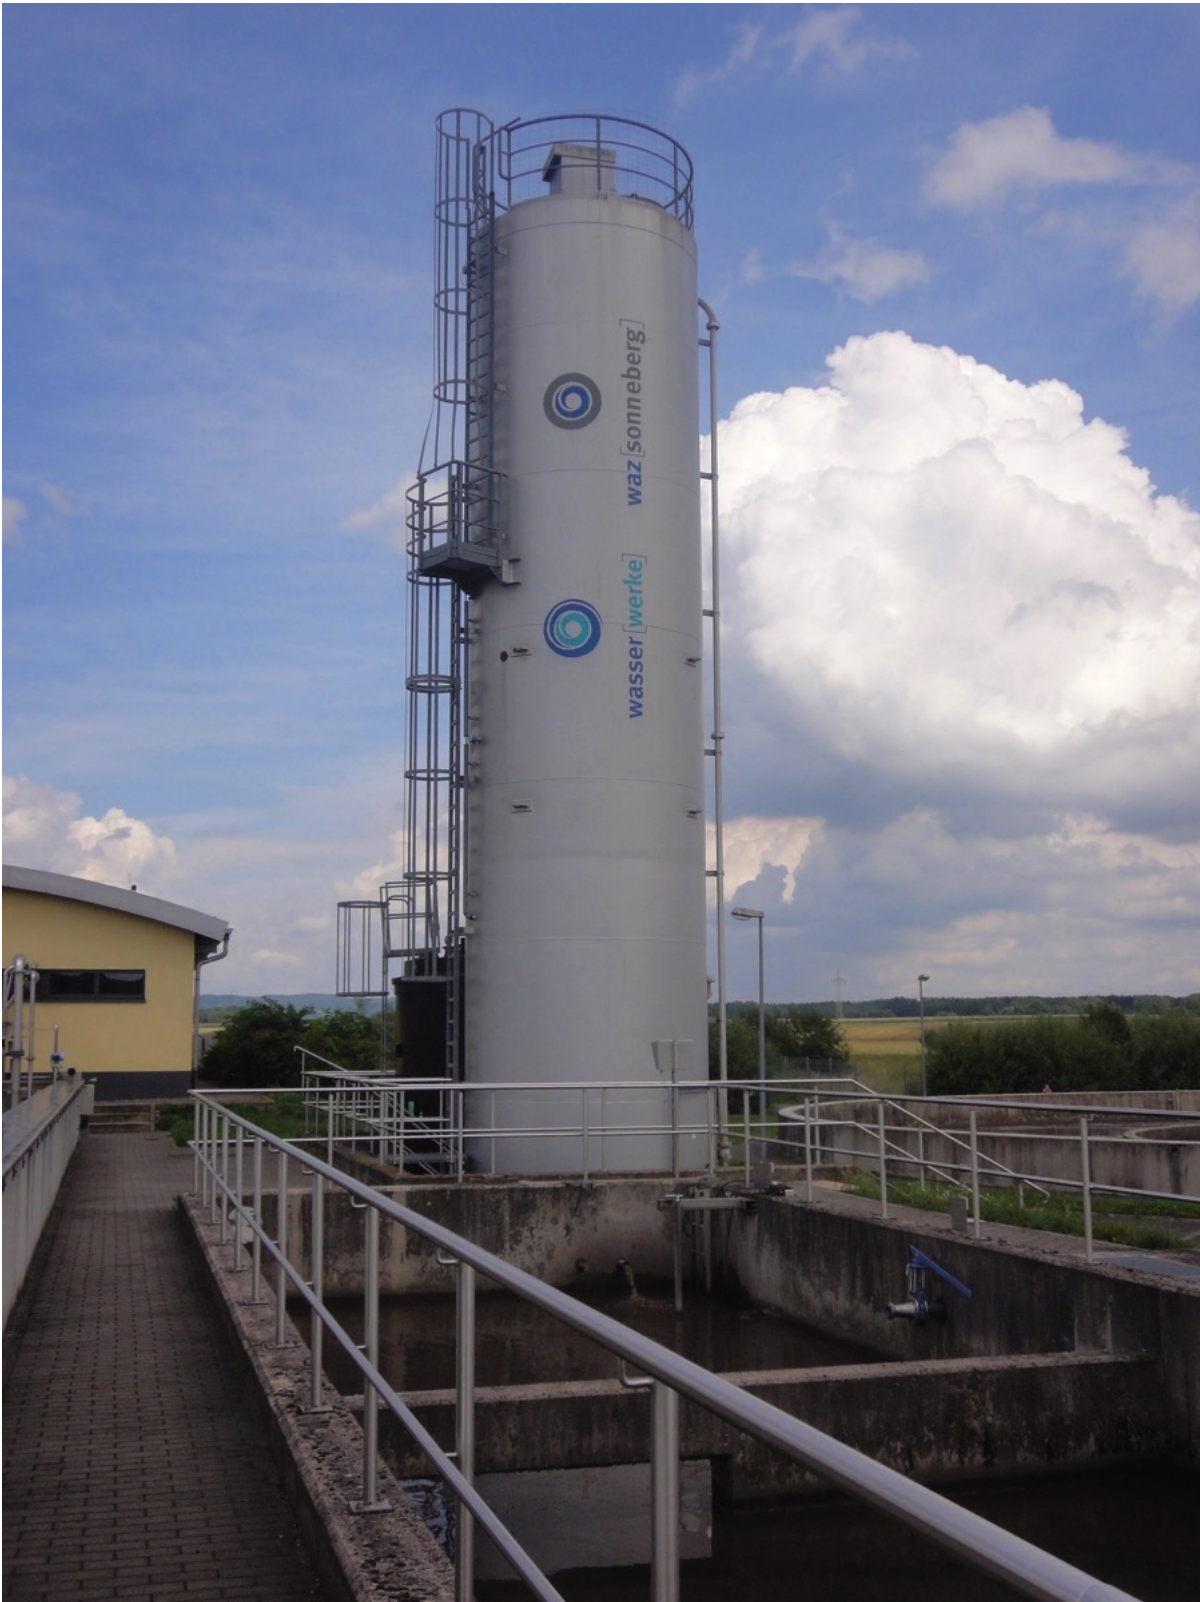
Lime hydrate must be added to the wastewater due to the very soft nature of the water in Sonneberg. (Picture: ©GKD)

bacteria and associated formation of bulking sludge stimulated by the large volume of fecal sludge. In two aeration tanks, designed as circulation basins measuring 95 meters in length and boasting an effective volume of 13,540 cubic meters, the nitrogen contained in the waste water is removed and the sludge aerobically stabilized. A blower station with five rotary piston blowers guarantees pressure ventilation of the basin. Two blowers supply each basin, while the fifth serves as a reserve unit and is also used to cover peak loads. The blowers are operated intermittently. The organic carbon is removed and the nitrogen nitrified during the ventilation phases. Denitrification is performed in the non-ventilated phases. To stabilize it, lime hydrate must be added to the wastewater in the second phase of the selector basin due to the very soft nature of the water in Sonneberg. It is metered from a 70 cubic meter lime silo that is heated in winter.

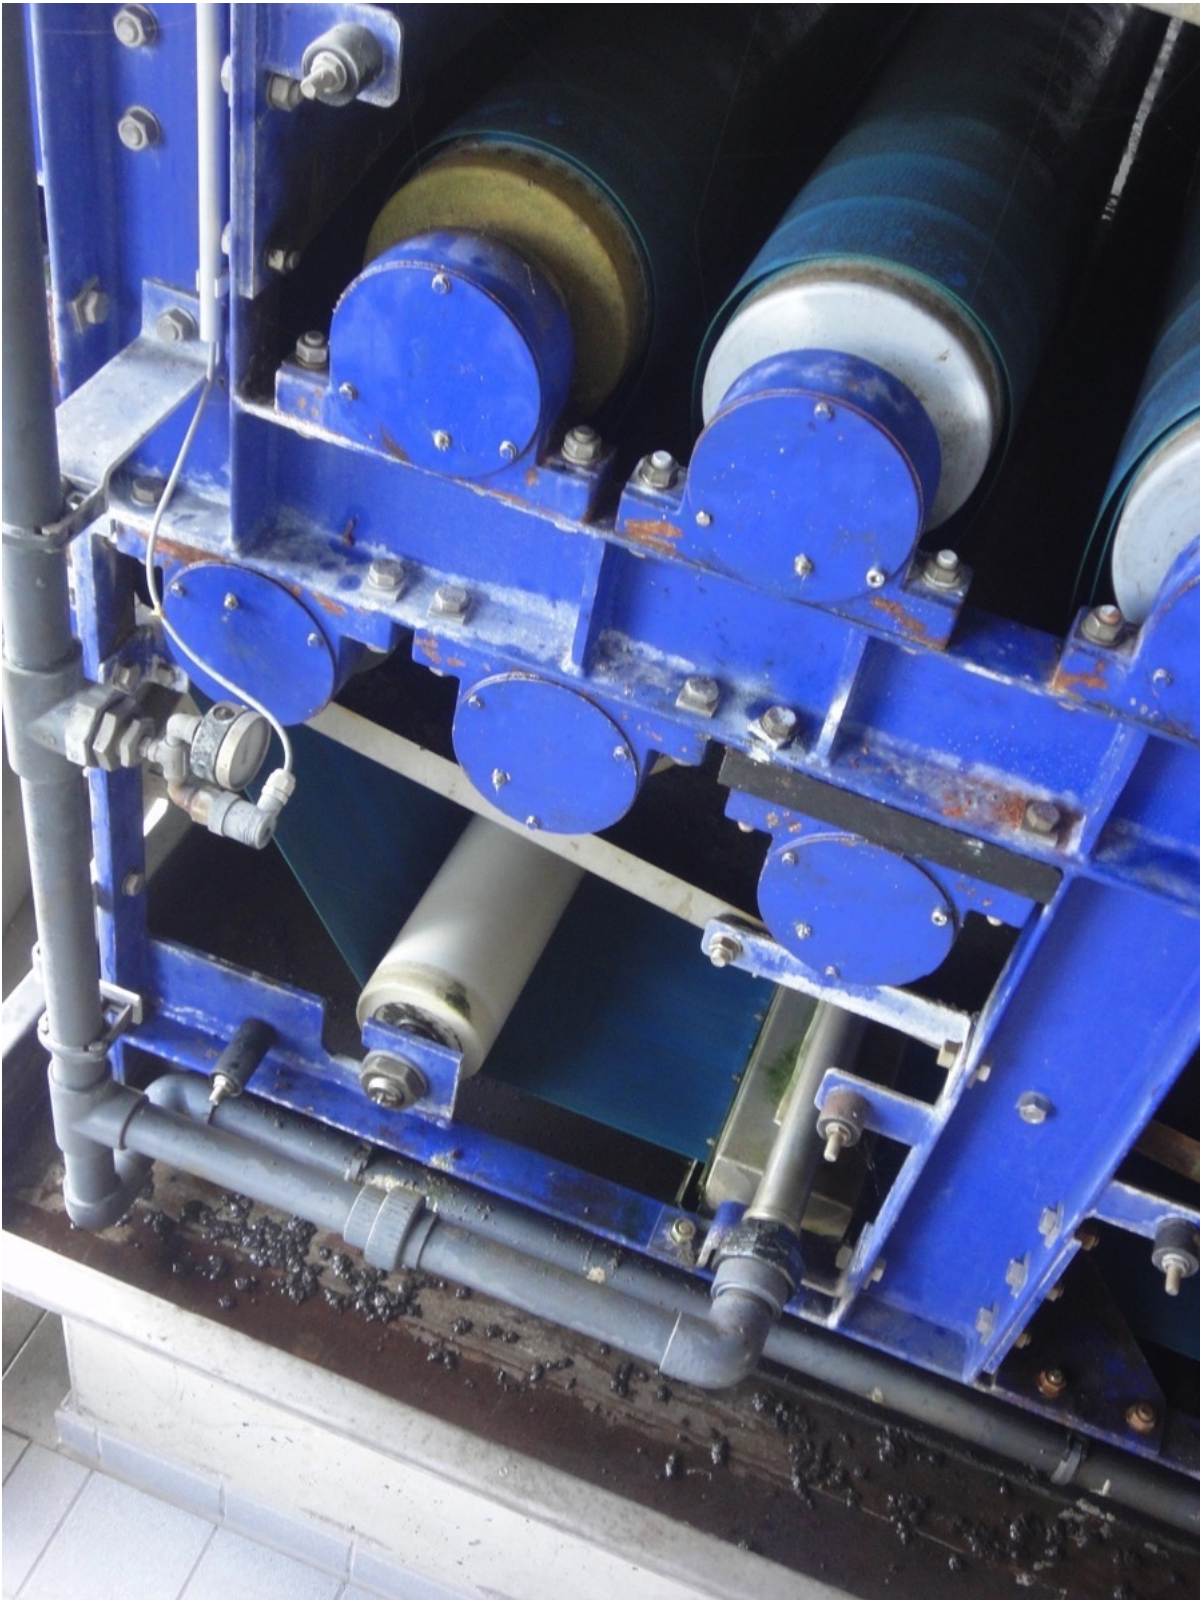
In the pressing area the sludge passes through eleven rollers between the upper and lower belt with belt pressure of 8 bar. (Picture: ©GKD)

After the thickened sludge has been deposited in the belt press infeed area, two scrapers distribute it evenly across the Type 1003 GKD filter belt, which then transports it to the pressing area. Here, the sludge passes through eleven rollers between the upper and lower belt with belt pressure of 8 bar. The belts are subjected to high loads as a result of the forces applied. The woven seams in particular were therefore a much feared weak point in Sonneberg for a long time. This was because the belts previously used at the Sonneberg sewage treatment plant regularly suffered from damaged seams due to the loads they must handle. In fact, these belts were repeatedly torn apart in an uncontrolled way, causing costly downtimes. Plant manager Bernd Hubner remembers: "The most important part of the belt is the seam. With the old belts, sudden failure of these seams led to a great deal of work and costs caused by the sludge that was still in the press. Yet despite the higher personnel costs associated with this work, the significantly longer downtime in comparison with a scheduled belt change was what actually had the greatest negative impact."

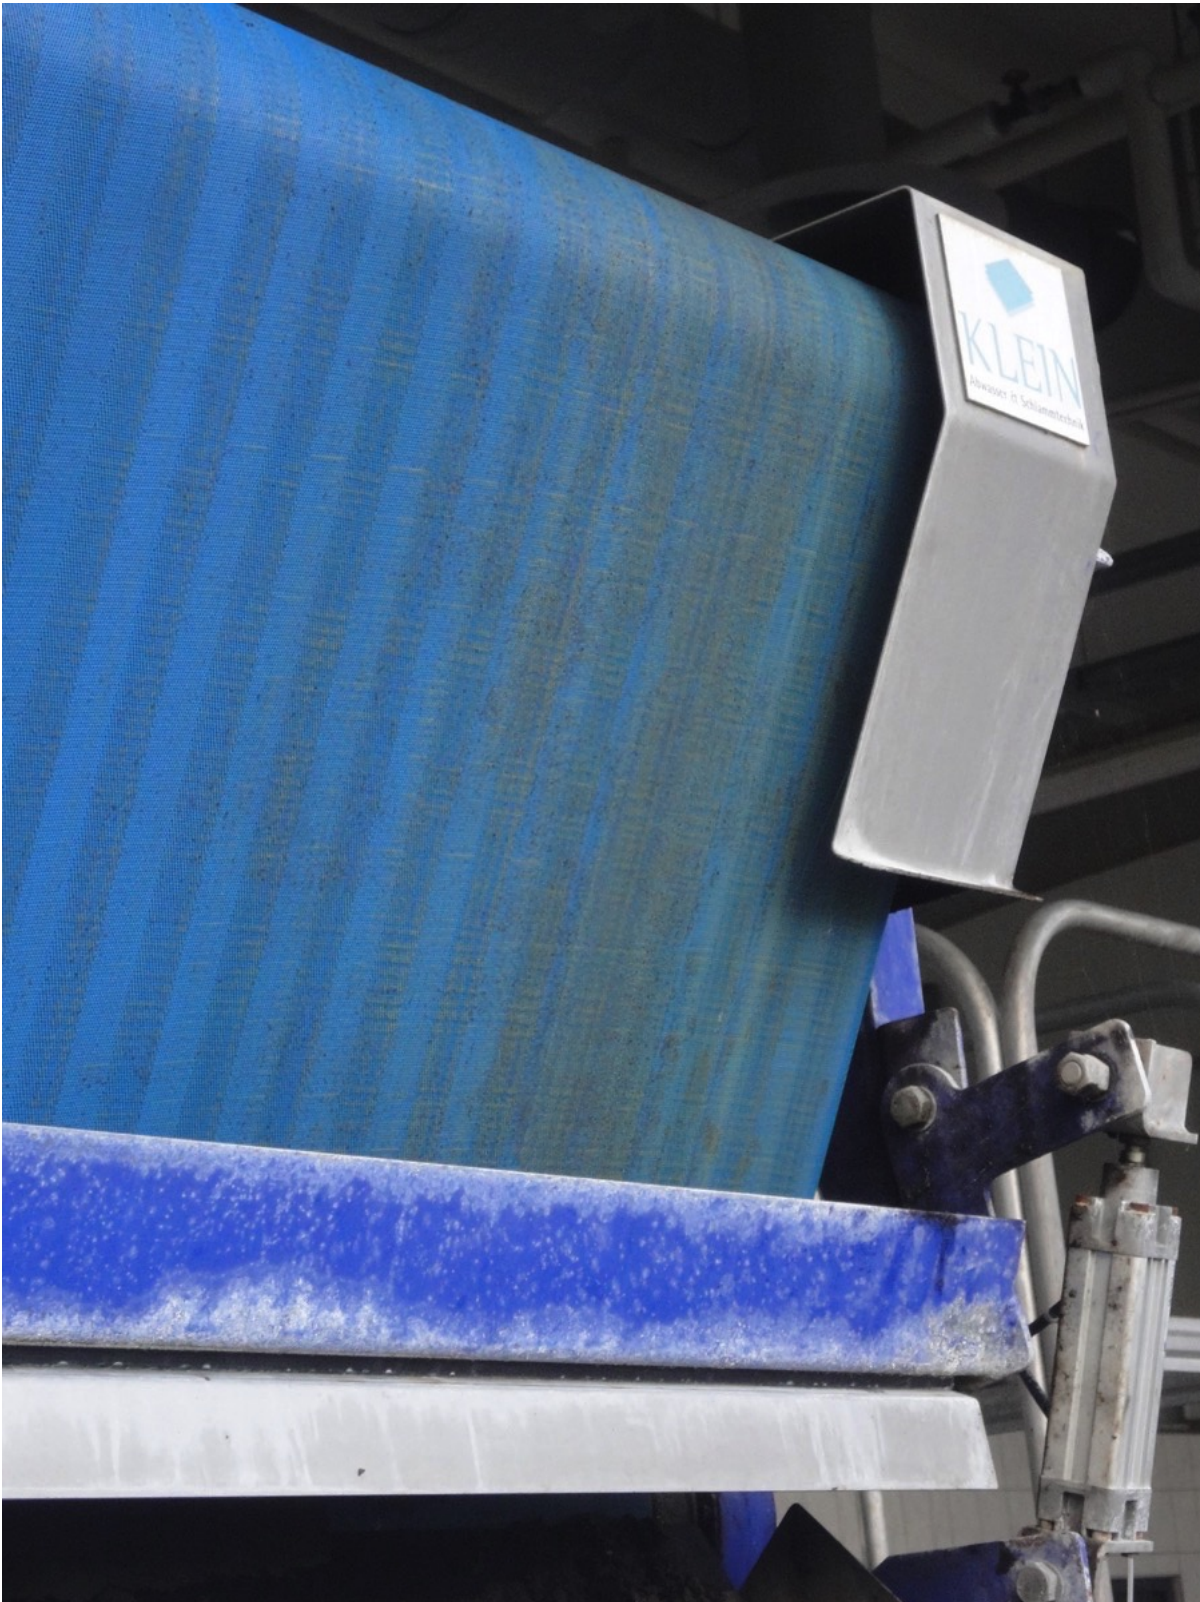
The wear indicator integrated into the GKD-belt Type 1003 allows distinct conclusions regarding the service life to be drawn. (Picture: ©GKD)

The yellow inner core of the 15.25 meter long and 2.50 meter wide GKD polyester belt displays the degree of mechanical wear – similarly to the wear indicators on car tires. This allows damage caused by defective plant components or process-related wear to be detected early on.
