# Service Problems with Steel Bins

R.A. Russell, Australia

## Summary

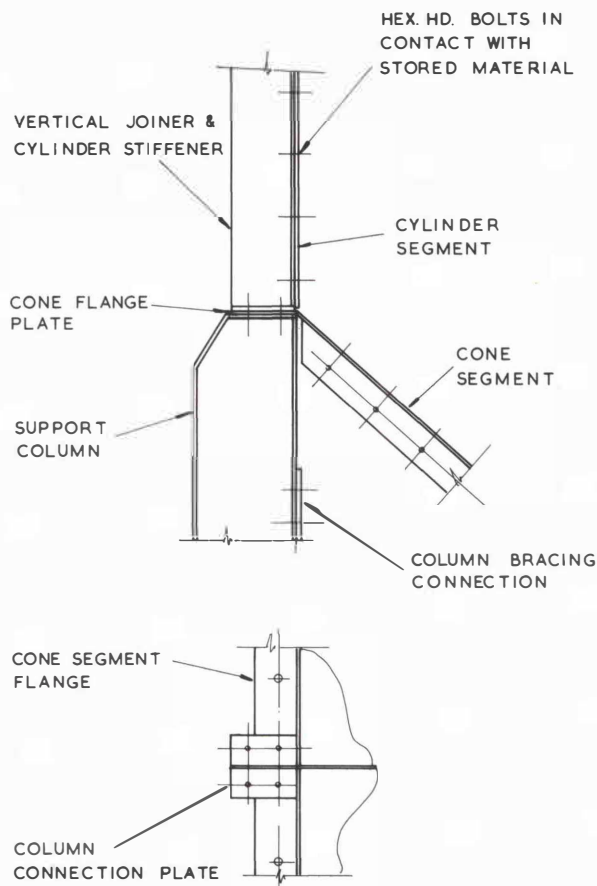
Fig. 3a

In the area over the column connections and in the ring beam section this flange plate was not stiffened at its outer edge and therefore buckled under the concentrated column loading (Fig. 3a).
