Whitepaper

## **Avoiding the Rip off - A Guide to Chevron Conveyor Belts**

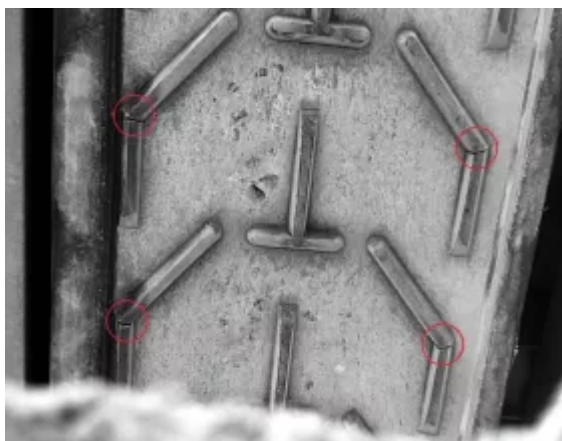
Fig. 1: A common problem – profiles that split and eventually detach from the base belt.

One of the most common problems experienced by many operators affects high chevron belting because the chevron profiles can become partly detached or ripped off entirely.

However, this directly creates the 'Achilles heel' of all chevron belts made in this way. This is because the contact point where the two different rubber compounds join then becomes a point of weakness. The chevron profiles constantly stretch and flex under tension each time they run around a pulley or drum. Unless the bond between the base belt carcass and the chevron profile is absolutely flawless then sooner or later dynamic stress fractures will start to occur, causing the profile to split. Especially on belts conveying hard, heavy lumps of material, the constant impact weakens the joint between the base belt and the chevron. Either way, eventually the chevron will part company with the rest of the belt.

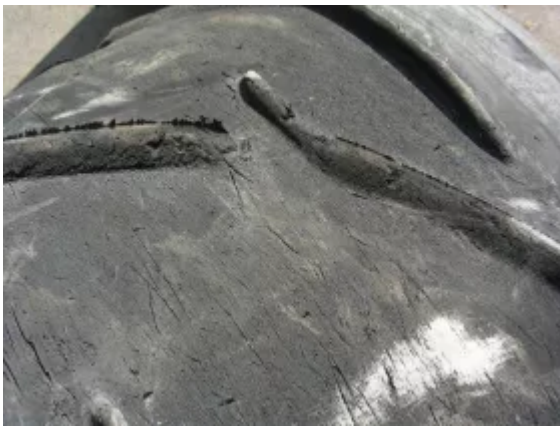
Fig. 2: Chevrons as high as 25mm or 32mm can wear almost completely flat in a remarkably short time.

Research and experience has shown that the rubber used to make the chevrons in the two-step production process almost invariably has much lower resistance to abrasive wear than would normally be acceptable. It is not unusual, especially among so-called 'economy' belts imported from Asia, that even chevrons as high as 25mm or 32mm can wear almost completely flat in a remarkably short time.

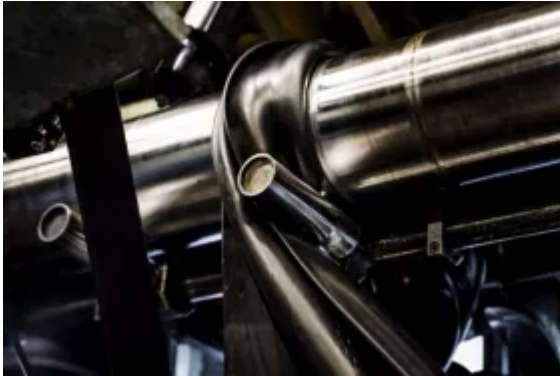
Fig. 3: A 'single structure' chevron belt needs a highly specialised rubber.

These properties include wear resistance, tensile strength and durability while at the same time also being sufficiently malleable to allow the rubber to flow smoothly and evenly into the moulds. The rubber then needs to be able to vulcanise virtually simultaneously within the mould AND the base belt structure. Not only that, the compound also needs to be fully resistant to the effects of ozone and ultra violet light (for longevity of working life) and conform to European REACH regulations so that the end product is also safe to handle.

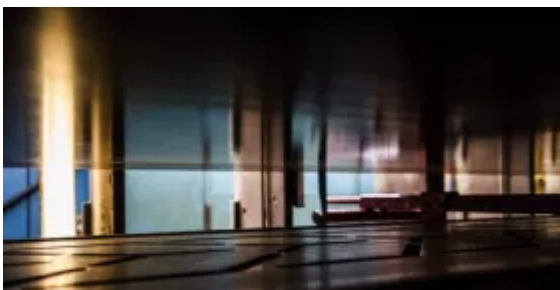
Fig. 4: The mould plate used to make a 'Single homogenous structure' chevron belt.

To create a single homogenous structure the base belt (at this stage comprising of only uncured rubber) is placed in the vulcanising press between the base plate of the press and a chevron mould plate positioned immediately below it. The base belt will already also have a specific quantity of uncured rubber on the top cover surface in addition to the volume of rubber needed to achieve the minimum thickness of the top cover of the base belt once it has been vulcanised.

The actual amount of 'extra' rubber needed depends on the design and depth of the chevron pattern. The compression of the upper and lower plates then forces the additional rubber to flow into and fill the mould cavities. Vulcanisation of both the base belt structure and the rubber-filled moulds then takes place simultaneously to form a single homogenous unit.

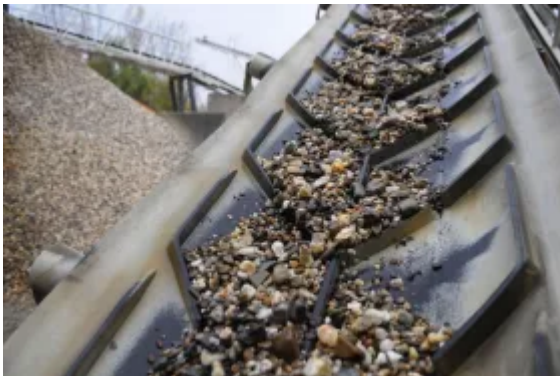
Fig. 5: Chevron belts with a single homogenous structure are stronger and longer-lasting by far.

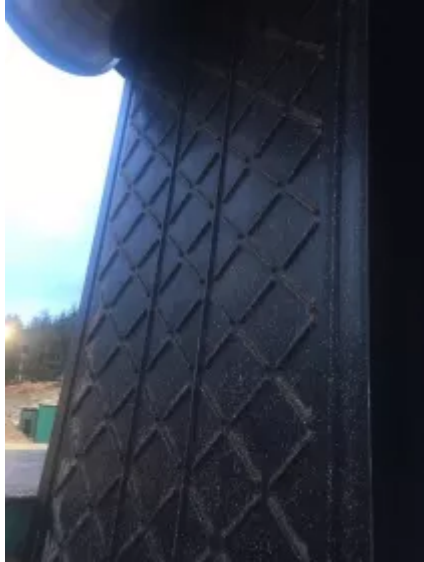
Fig. 6: Still going strong – a five-year old Dunlop Multiprof belt in action.

Unlike their chevron counterparts, making single, homogenous structures is relatively easy to achieve with low profiles because the rubber only has to flow a small amount compared to high chevron profiles. Yet again, the key influencer as far as performance and value is concerned is the quality of the rubber. In this case it is ability of the rubber to resist wear (abrasion) and to resist the effects of ozone & ultra violet that are the most crucial. As far as European-based quality led manufacturers like Dunlop are concerned, achieving working lifetimes as long as five years is more than possible.

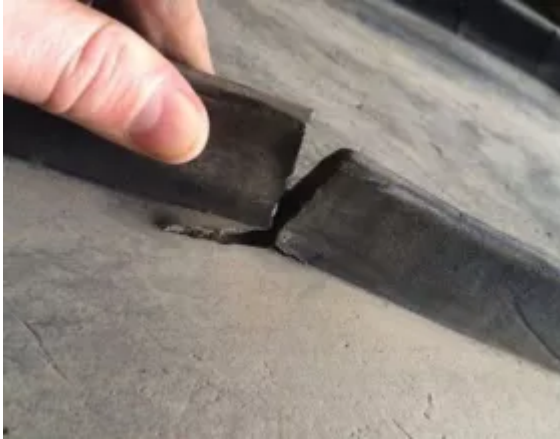
Fig. 7: Splitting the difference in price and quality.

The rubber used for conveyor belts usually constitutes at least 70% of the material mass and therefore it is the single biggest element of cost when manufacturing a conveyor belt. Consequently, in the highly price-competitive conveyor belt market, for those who want to compete for orders based on price rather than performance and operational longevity, it becomes the single biggest opportunity for manufacturers to minimise costs. In fairness, the market for OEM's of mobile plant equipment is also very competitive. This often means that any desire to pay a higher price for a higher quality, more durable conveyor belt is set aside in the effort to keep the selling price of their machines as competitive as possible.

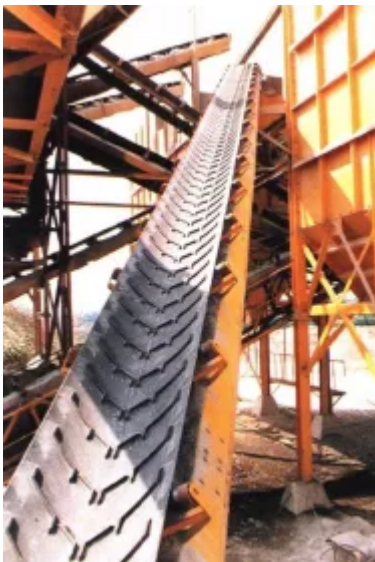
Fig. 8: Unfortunately, Conveyor belts used on mobile equipment are viewed by a great many as readily disposable components.

The harsh reality is that conveyor belts used on mobile equipment are viewed by a great many as readily disposable components that are not a reflection of the reliability of the machine itself, even though the need to regular repair and replace worn and damaged belts is expensive both in terms of lost productivity and day-to-day running costs. A cynic might also say that for some manufacturers, belt suppliers and engineers, regularly replacing belts is a highly lucrative business that would not be nearly so profitable if the belts were a lot more durable and lasted a lot longer. Fortunately, for the higher-quality belt manufacturers, not everyone thinks that way.
