Anwenderbericht

BEUMER assists Cement Manufacturer in Modernisation of Bucket Elevators

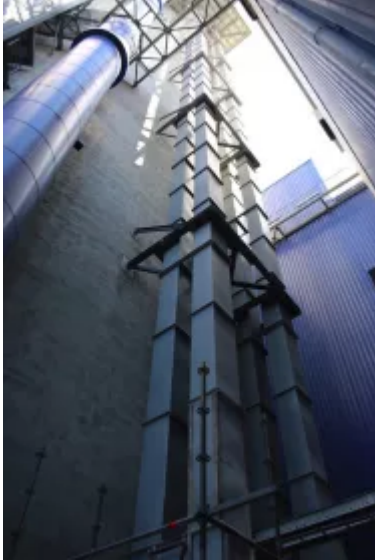
With this modernisation, the cement manufacturer was able to increase the conveying capacity of the bucket elevators for the cement silo feed.

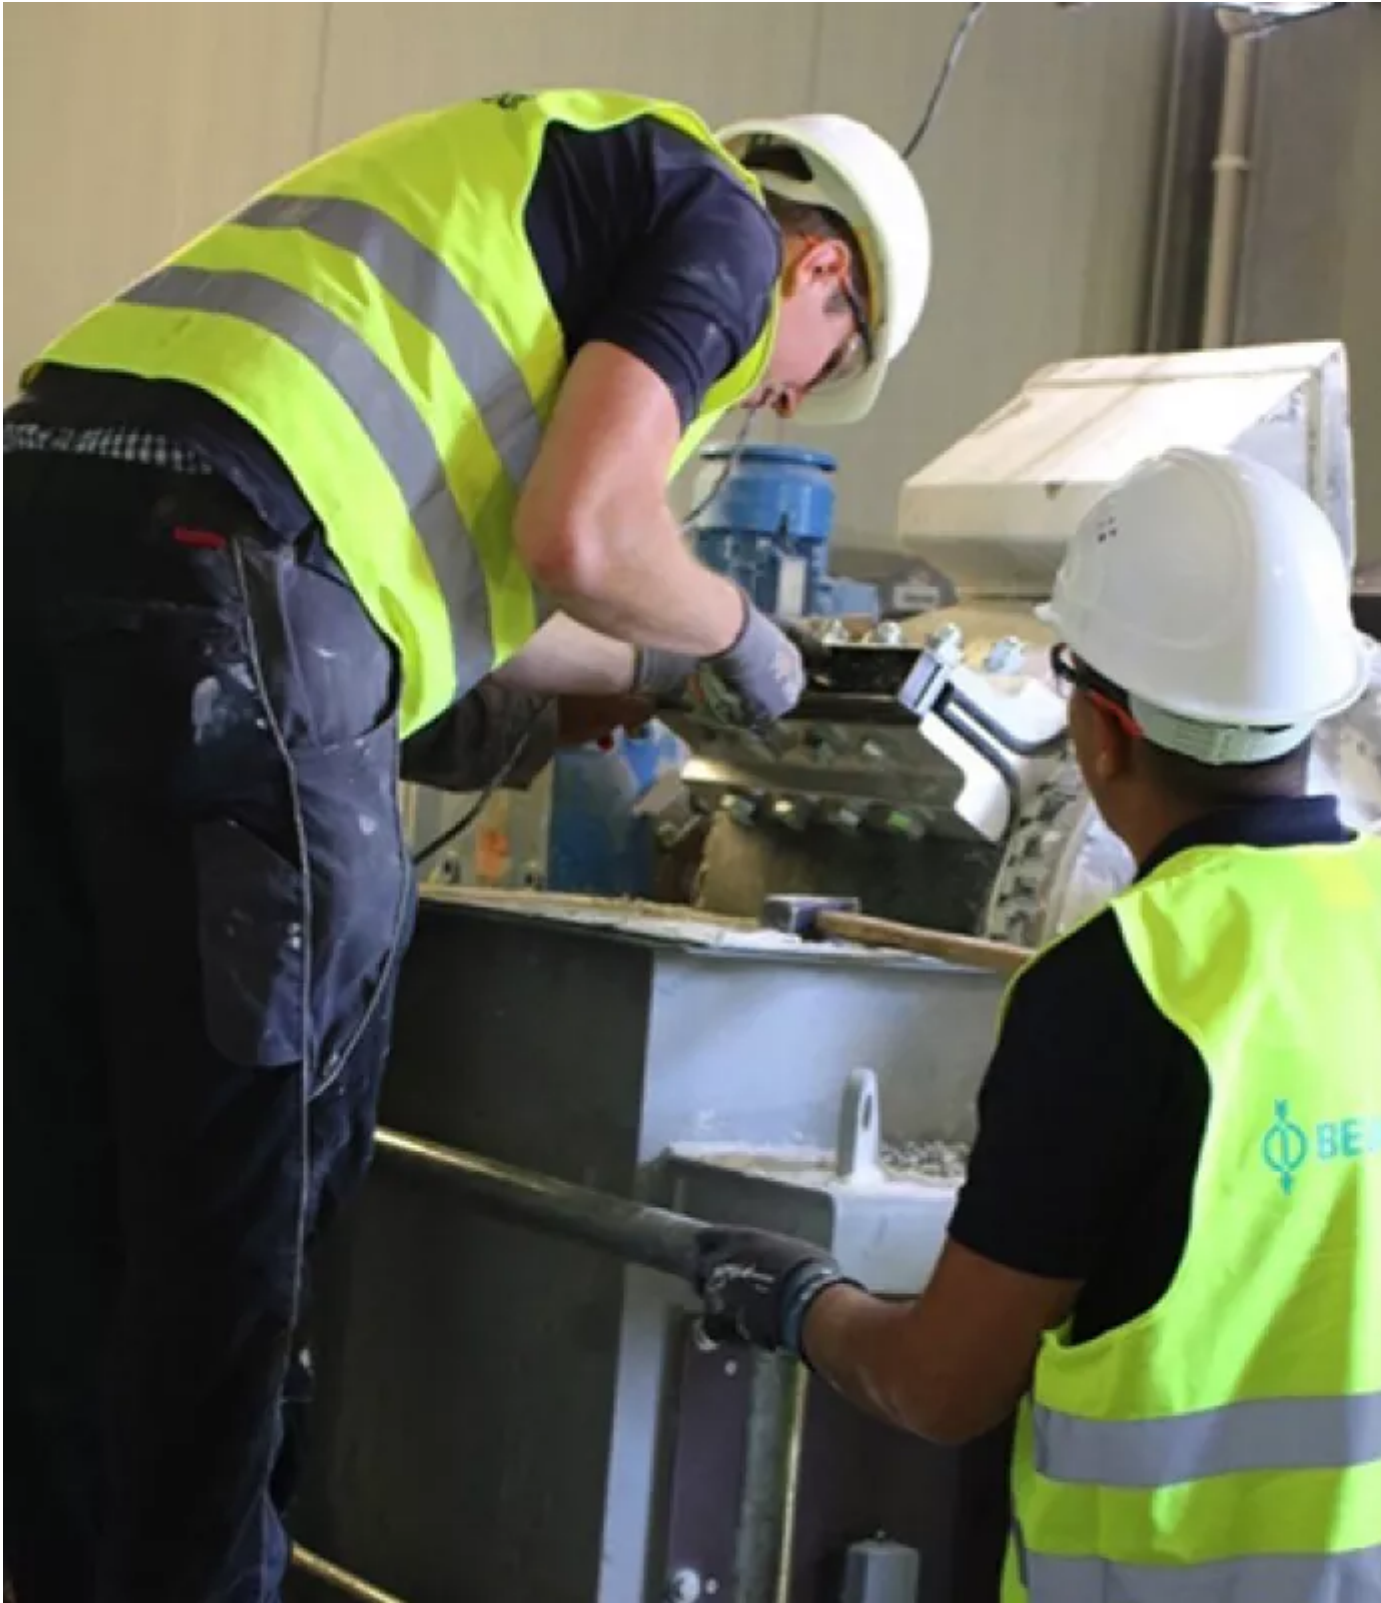
The ends of the steel cords are divided into individual strands in the U-shaped part of connection, twisted and cast with white metal.

Another important factor is the belt clamping connection: The rubber of the steel cord ends is first removed on all BEUMER steel cord belts.

The technicians divide the ends into individual strands in the U-shaped part of the belt clamping connection, twist and cast it with white metal.

“After casting, the junction is completely cured after a very short time and the belt is ready for use”.

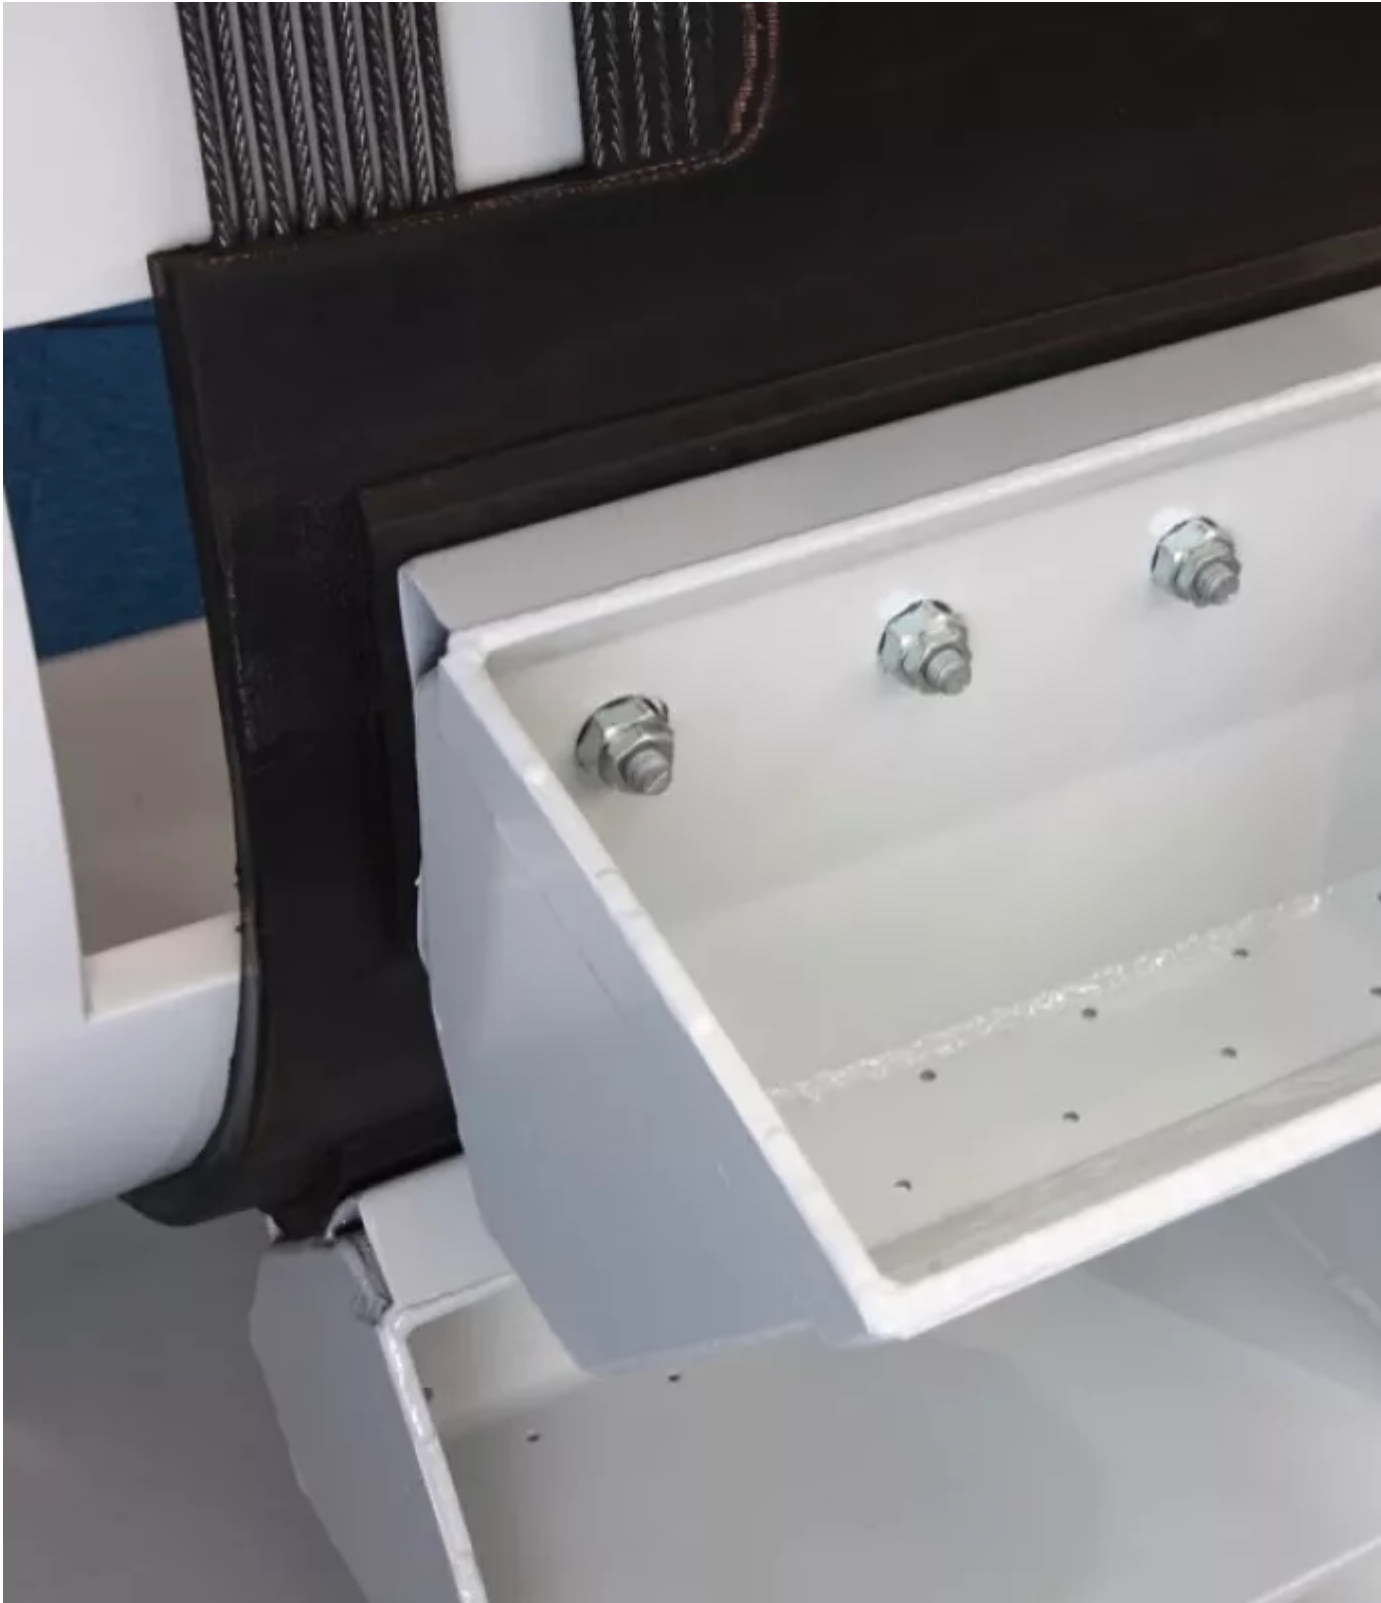
The drive pulleys are equipped with segmented laggings. A steady running of the belt (BEUMER Group GmbH & Co KG)

In order to enable a steady running of the belt and to extend the service life in view of the abrasive material, the BEUMER team exchanged the existing segmented laggings of the drive pulley by specially adapted ones equipped with ceramic. These are crowned for a steady straight run.

The design, which is easy to maintain, enables to quickly replace the single segments of the segmented lagging through the inspection hatches. Thus, it is no longer necessary to exchange the complete drive pulley. The segmented laggings

are rubberised, with linings made of full ceramics or steel. The choice depends on the material conveyed.

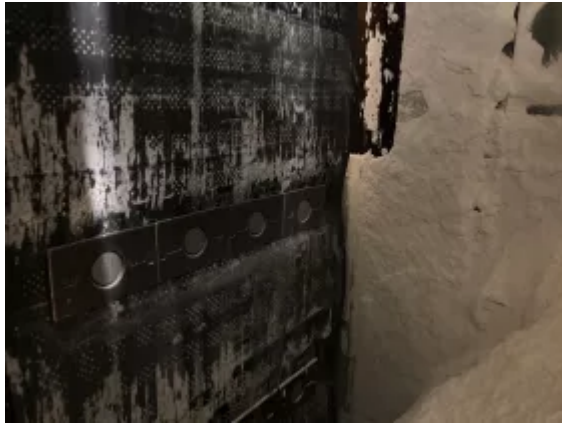
The buckets are mounted with forged segments and screws on the back side of the belt.

The buckets are adapted to the crowned shape of the drive pulley and thus lie flat on, which considerably increases the service life of the belt. Their shape allows for smoother running and therefore less noise generation.

The proven BEUMER HD technology impresses with a special bucket connection: In order to prevent coarse-grained material from penetrating between bucket and belt, the bucket is provided with an elongated back plate, which can be mounted flush to the bucket elevator belt.

In addition, with the HD technology, the buckets are mounted firmly to the back of the belt with forged segments and screws. "All the screws would have to get lost for a bucket to tear out," explains Papenkort.

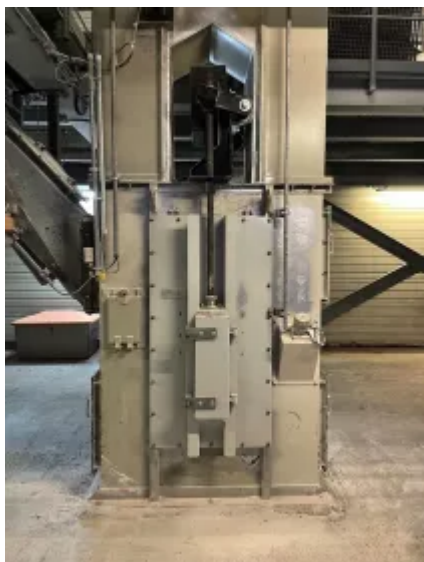
The parallel take-up device ensures that the take-up pulley is limited to parallel movement.

In order to achieve a permanently correct tensioning of the belt, BEUMER mounted an external parallel take-up device without product contact in Duisburg, which ensures that the take-up pulley is limited to parallel movement. The tension bearing is designed as inner bearing in a completely encapsulated construction. The bearing housings are filled with oil.

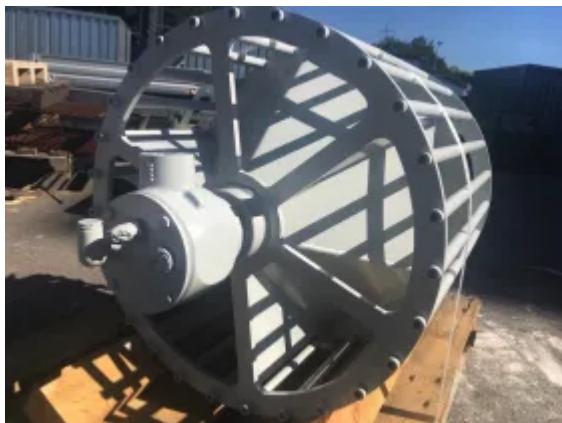
To avoid caking, the take-up pulley is designed as cage-type foot pulley and is provided with a double deflection cone. For this order, the screwed and hardened version of the cage-type foot pulley has been used.

“A part of our HD technology is the cage-type foot pulley which is easy to maintain. The bars are hardened due to the abrasive material conveyed and screwed into the cage-type foot pulley to enable a rapid replacement. The take-up pulley is equipped with a double deflection cone, which reliably prevents damage to the belt caused by jammed bulk materials,” explains Papenkort.
