Anwenderbericht

## **State of the Art Hazard Monitoring for State of the Art Flour Mill**

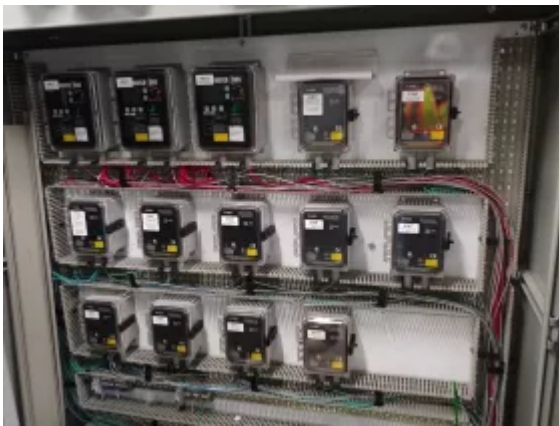
Panel of IE-Nodes

4B's newest hazard monitoring system, the Industrial Ethernet Node (IE-Node) was the perfect fit. It features EtherNet/IP communications that work directly with the customer's Allen Bradley PLC without any gateways while being approved for Class II, Division 1 Group E, F & G hazardous dust environments. It provides inputs for continuous bearing temperature sensors, belt alignment sensors, and speed sensors.

The customer selected the IE-Nodes because they are technologically superior to other options on the market and improve the flexibility of installation all at an attractive price. The IE-Nodes each have 10 inputs and can be expanded to 16 to provide even more flexibility in applications where the site needed additional sensors. All of the sensors can be fully tested with 4B's Speedmaster and ADB Tester and the system has the unique ability to have multiple speed inputs for the PLC to monitor the speed ratio on equipment operating with VFDs.

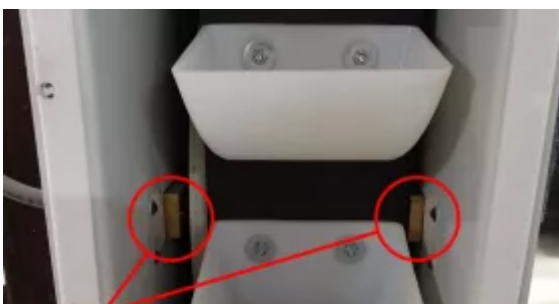
## Brass Rub Blocks installed

The customer selected NTC Adjustable Depth Bearing (ADB) temperature sensors, 2" x 4" rectangular brass rub blocks with stainless steel hinged inspection doors for belt misalignment, and whirligigs with 4-20 mA Milli-Speed sensors for monitoring belt slippage. 4B provided training for both the end user and installer to highlight the best practices for wiring and maintaining the system.
