Anwenderbericht

Coal Storage Flow Problems - Improving Flow in a 4000 tonnes Coal Bunker using Insert Technology

[Published in bulk solids handling, Vol. 32 \(2012\) No. 6](#)

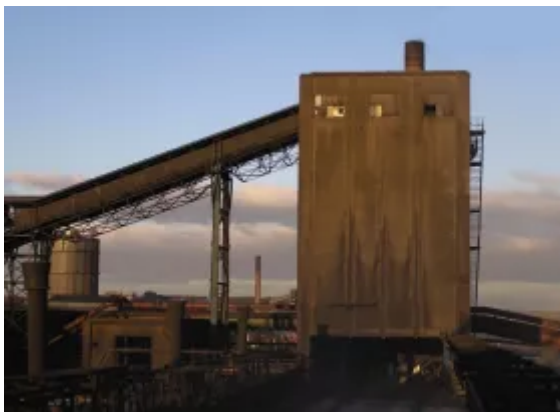
Fig. 1: Service bunker at Appleby Coke Ovens in Scunthorpe, United Kingdom. (Pictures: Ajax Equipment Ltd.)

The concrete service bunker (Fig. 1) was built in 1937 and is divided into two rectangular sections, one section holding 3000 tonnes of coal and the other holding 1000 tonnes of coal. It is about 17.5 metres tall and the 1000 tonnes section is 8 metres \times 13 metres, whilst the 3000-tonne section is 20 metres \times 13 metres. Coal is fed into the top of the bunker where it is distributed to one of the two sections and stored ready for discharge under gravity. Coal is discharged via a number of rows of outlets at the base of the bunkers into the charge cars.

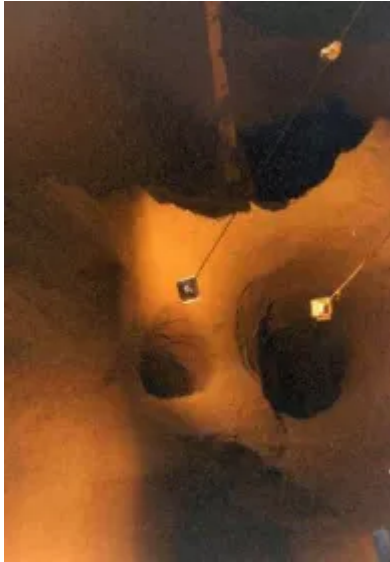
Fig. 2: Rat holes formed in the bunker.

Although the huge bunker has a potential capacity of 4000 tonnes, the true useable capacity of the 3000-tonne section was nearer to 1500 tonnes. This was due to the phenomenon of 'rat holing' (Fig. 2) where a significant quantity of the contents was effectively trapped around the periphery of the bunker with only the central core of coal directly above the outlets flowing from the bunker into the charge cars. This meant that only a modest portion of the silo's contents was retrievable – that which can flow through the 640-millimetre diameter outlet via a flow channel that flares to approximately 1 metre diameter over a depth of up to 10 metres. The bunker geometry and construction caused the residue to remain even when the central flowing channel is emptied (ratholing). Occasionally the narrow flow channel itself would arch, preventing flow completely.

The overall effect was to adversely affect production reliability and planning, and health and safety and operating costs issues. To overcome the rat holing effect, Ajax Equipment carried out a detailed review of the bunker design along with flow property tests and practical trials.

Inserts offered the opportunity to generate slip more easily at the walls, converting the axial-symmetric flow to planar flow type – a more favourable, flow form – and shielding the outlet region to reduce consolidating stresses. As a result the material flows more readily and there is a reduction in the tendency to form a stable arch or rat hole.

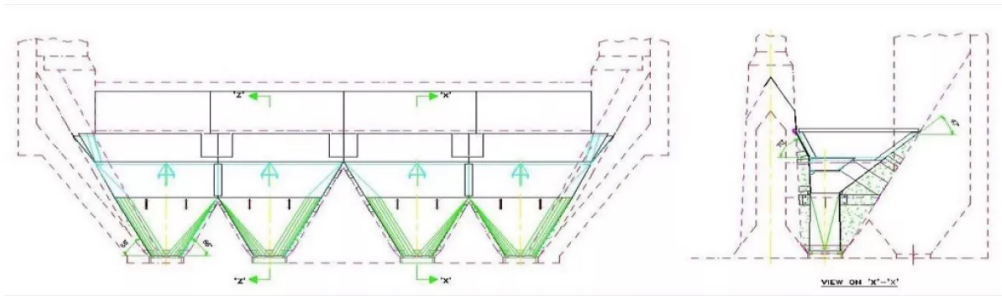
Fig. 3: Drawing of bunker with insert system.

The second mass flow stage expanded the flow channel to a reliable flow width and connected a full row of four outlets together. To destabilise any large rat hole or cliff which might form, a third stage was added which would not mass flow but instead provide self-clearing of the remaining hopper contents. Due to the offset outlet construction, a set of inserts was fitted to reduce compacting pressures in the outlet region and encourage flow from the shallow side of the hopper (Fig. 3).

At Scunthorpe, a three-stage design with an insert was devised by Ajax. The first mass flow sections were internal hoppers which comprised of plane flow converging to the existing outlets. These hopper sections actually diverged slightly in the opposite plane to give the best chance of squeezing through the outlet – a technique called Sigma Two relief. The form of these sections was developed so that two adjacent outlet sections actually joined together to provide the one slot.

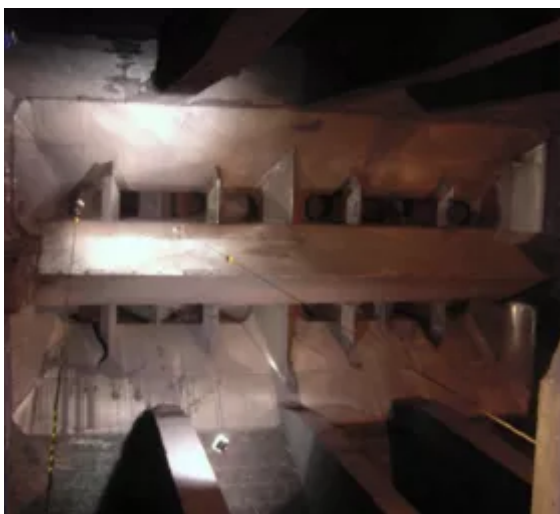
Fig. 4: Two rows of inserts installed in the 1000 tonne section.

The first row of inserts made such a huge difference to the flow of coal from the bunker; that a financial case was put together to line a further three rows of outlets. There are now two rows of inserts in the 3000-tonne section and two rows in the 1000-tonne section (Fig.4).

Prior to fitting the inserts poking for coal was required at least once per shift from November to March. This is no longer necessary. Moreover, there have been no reportable injuries sustained from poking activities from the service bunker since

When poking for coal there was a tendency for the charge-cars to be under filled. This resulted in the ovens not being filled to the required standard, lower coke yield and subsequent refractory damage to oven chambers. Since the inserts have been installed, better filling of the charge-cars has occurred resulting in improved oven filling and a higher coke yield. The live capacity of the 1000-tonne section is now approaching 80 percent.
