## **Misalignment Prohibited - Keeping Conveyor Belts on Track at a Newcastle Coal Terminal**

[Published in bulk solids handling, Vol. 32 \(2012\) No. 1](#)

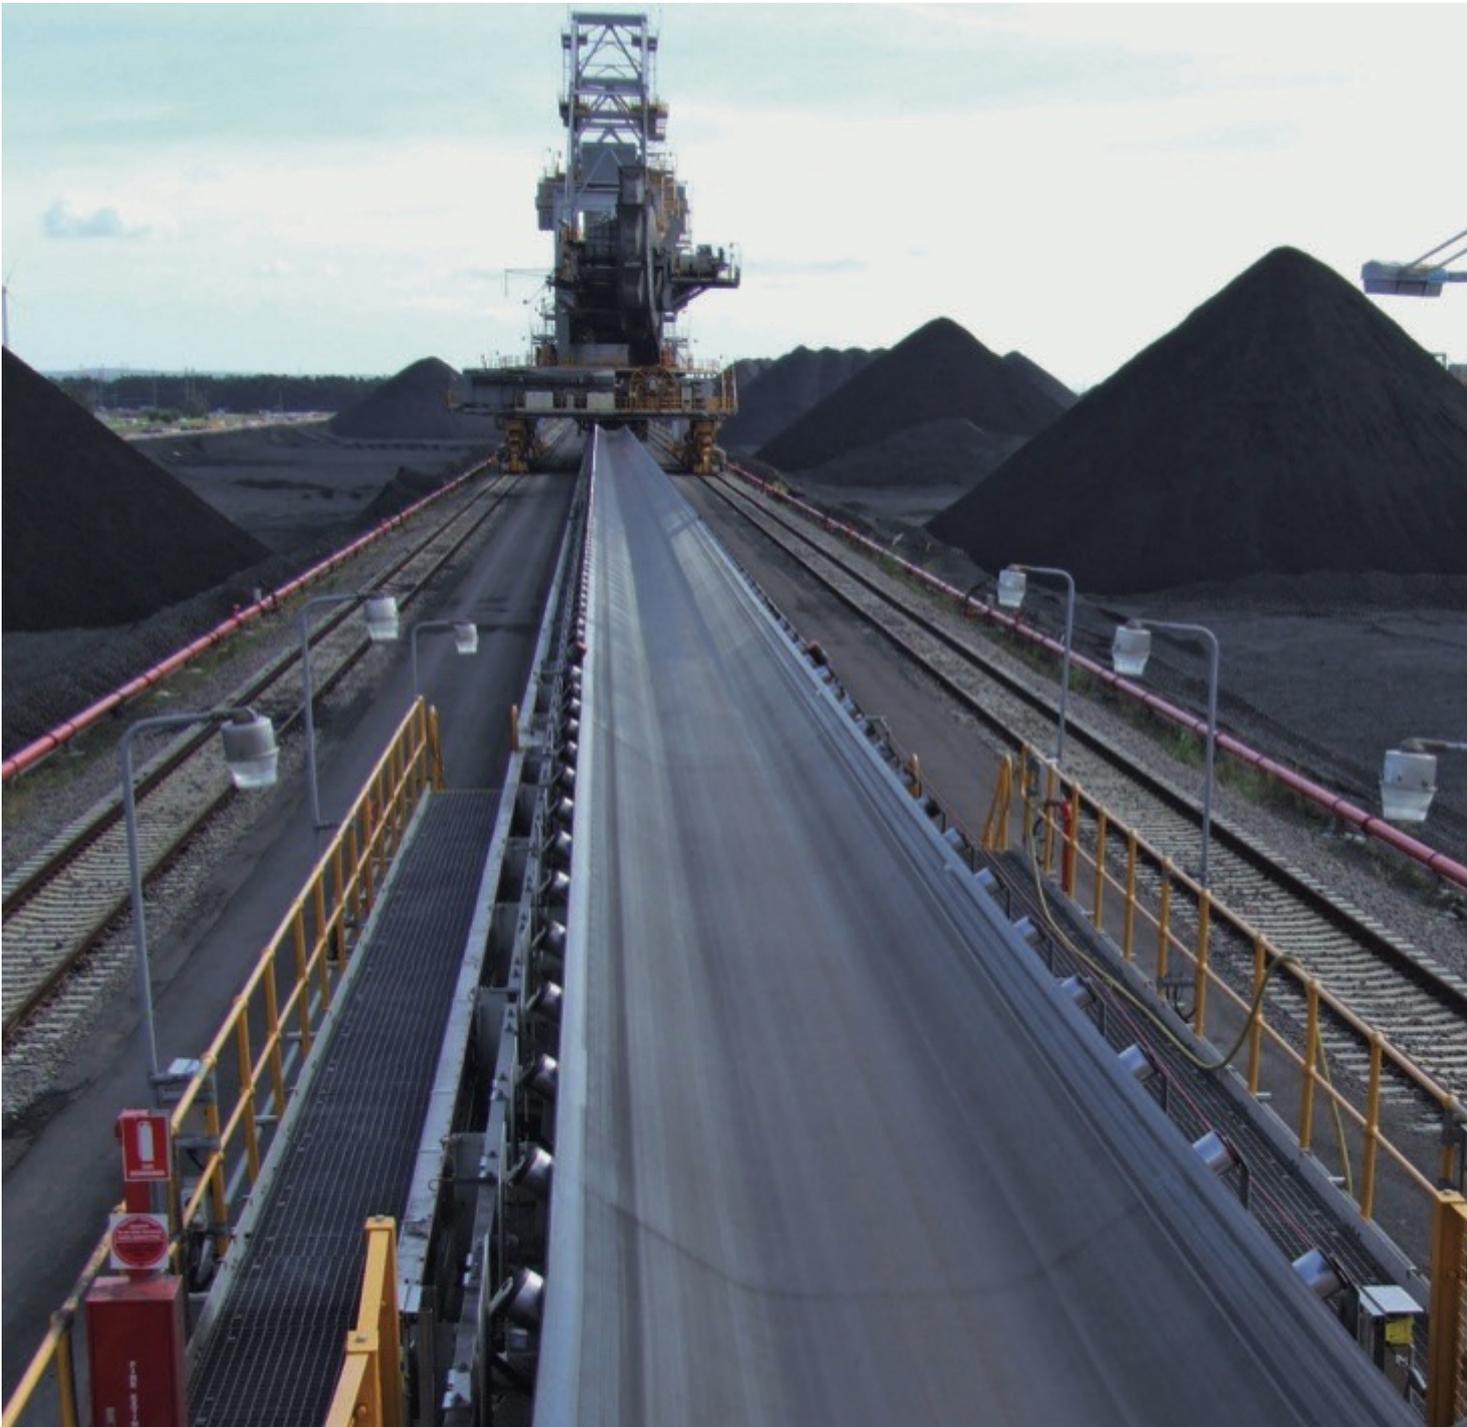
Fig. 1: At NCIG's coal terminal the principal conveyor belts are 2.5 metres wide, working with high tonnages, where current capacities can reach up to 33 million tonnes a year.

This is a coal terminal where the principal conveyor belts are 2.5 metres wide, working with high tonnages, where current capacities can reach up to 33 million tonnes per year. Planned expansion (already approved by the government) is expected to nearly double this capacity to 57 million tonnes per year. Thus, delays due to conveyor belt shutdowns can be pretty expensive – not only because of maintenance costs, but also due to costly demurrage from delays in shipment. There are currently nine main conveyors within the terminal. All major belts are vulcanized, and made to Imas at 1400 standards. The drive pulleys are ceramic and the non-drive pulleys are made of polyurethane. Idlers are made from aluminum and were chosen because of their light weight (approx. 20 kilograms each). Conveyor lengths range from 75 to 1371 metres. Ralph notes that tracking issues varied in the different conveyors and were exacerbated by weather conditions, especially during periods of rain.

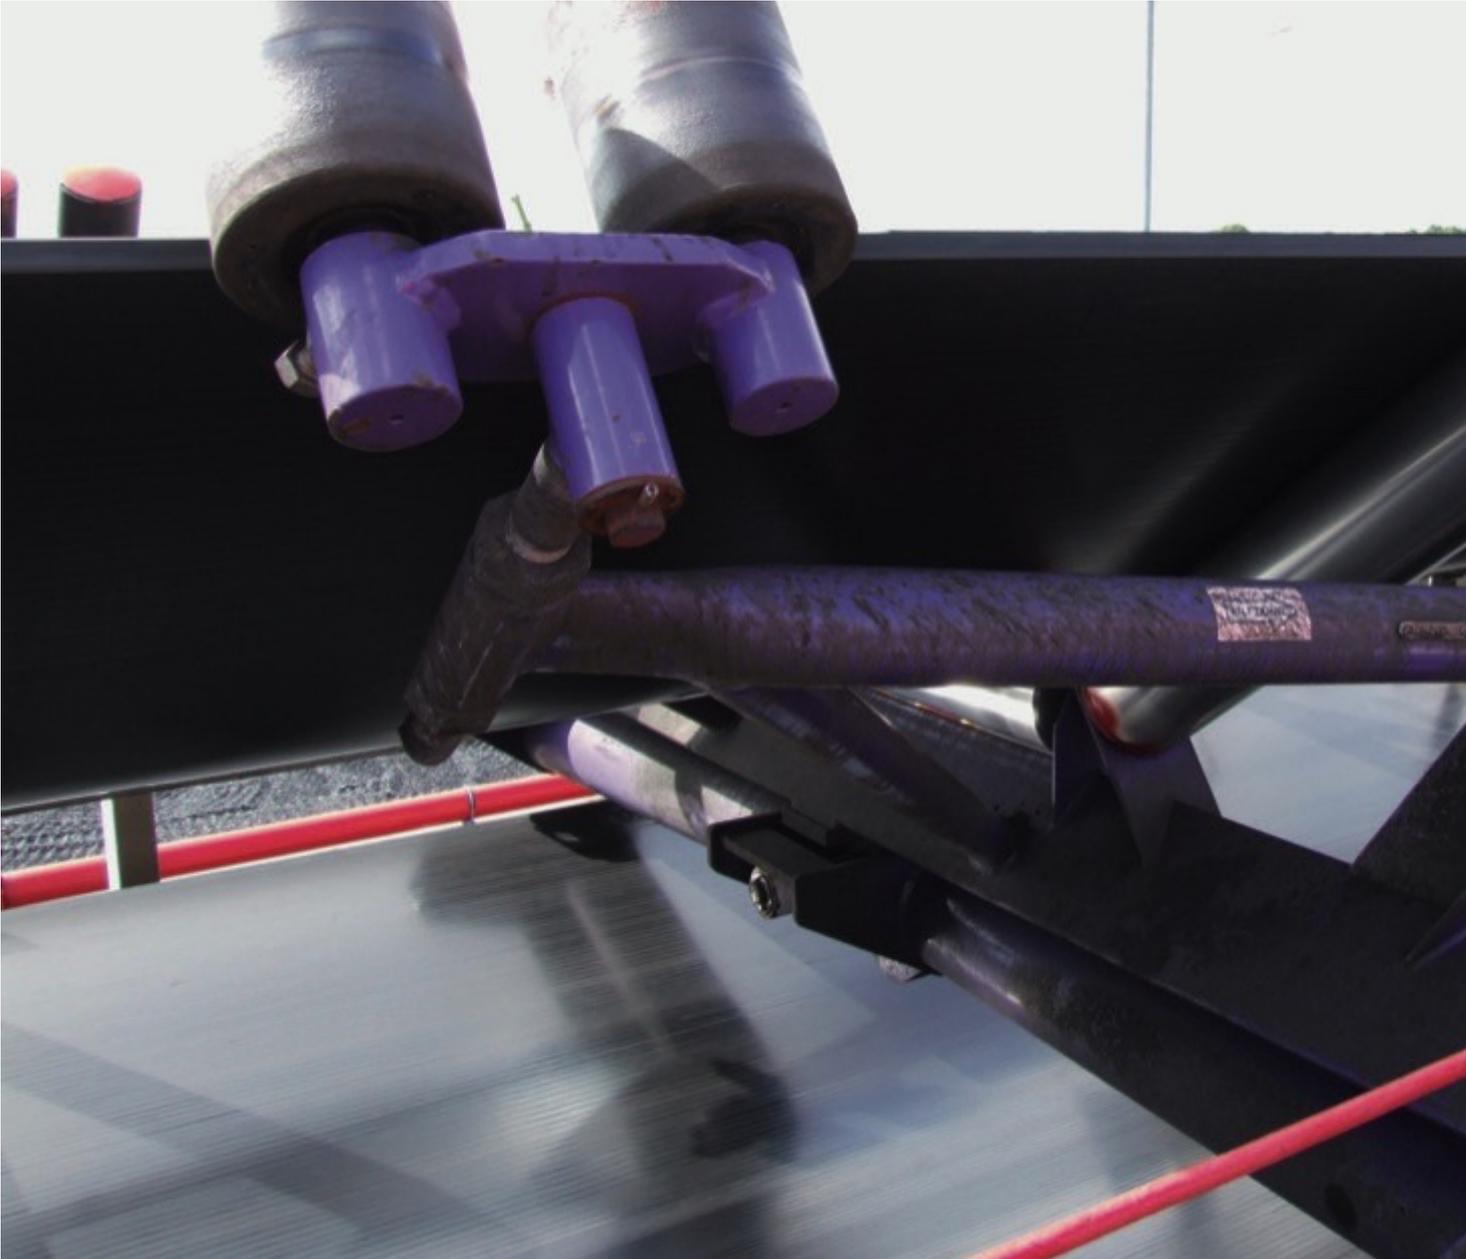
Fig. 2: Heavy duty PT Max belt trainers were used to resolve the recurring tracking problems at the terminal.

return side PT Max belt trainers from Flexco were installed. They were the first two units installed, which resolved one problem area. Following this successful remedy, an additional two units were installed on the top side. An additional three return side and one top side units are currently on order to work on other problem areas.

The Flexco PT Max is a heavy duty belt trainer that features a patented "pivot and tilt" design. This unique feature allows the unit to react instantly and compensate for belt misalignment. Conventional belt trainers tend to only pivot, but PT Max trainers also tilt to bring belts back in line faster. Sensor rollers allow for a predetermined degree of misalignment, typically less than 25 millimetres. Once the conveyor belt moves beyond this limit, twin sensor rollers engage the belt edge, causing the top frame to initiate a pivot and tilt action. The pivoting action immediately triggers a corresponding tilting action which increases the tension in the belt on the side that is mistracking, consequently reducing the tension on the opposite side. The resulting uneven tension causes the belt to move back to centre. The PT Max works on belts that mistrack to one side or both sides. And, the trainer works well in both dry and wet conditions, as noted in the earlier trial by NCIG. The system pivots on a unique, fully-enclosed spherical bearing made of surgical stainless steel, that doesn't require lubrication. The bearing life of each of these belt trainers is backed by a five-year "No-Risk" performance guarantee.
