Don't get tired repairing Tyres - OTR Tire Repair: A Look behind the Scenes

[Published in bulk solids handling, Vol. 34 \(2014\) No. 5](#)

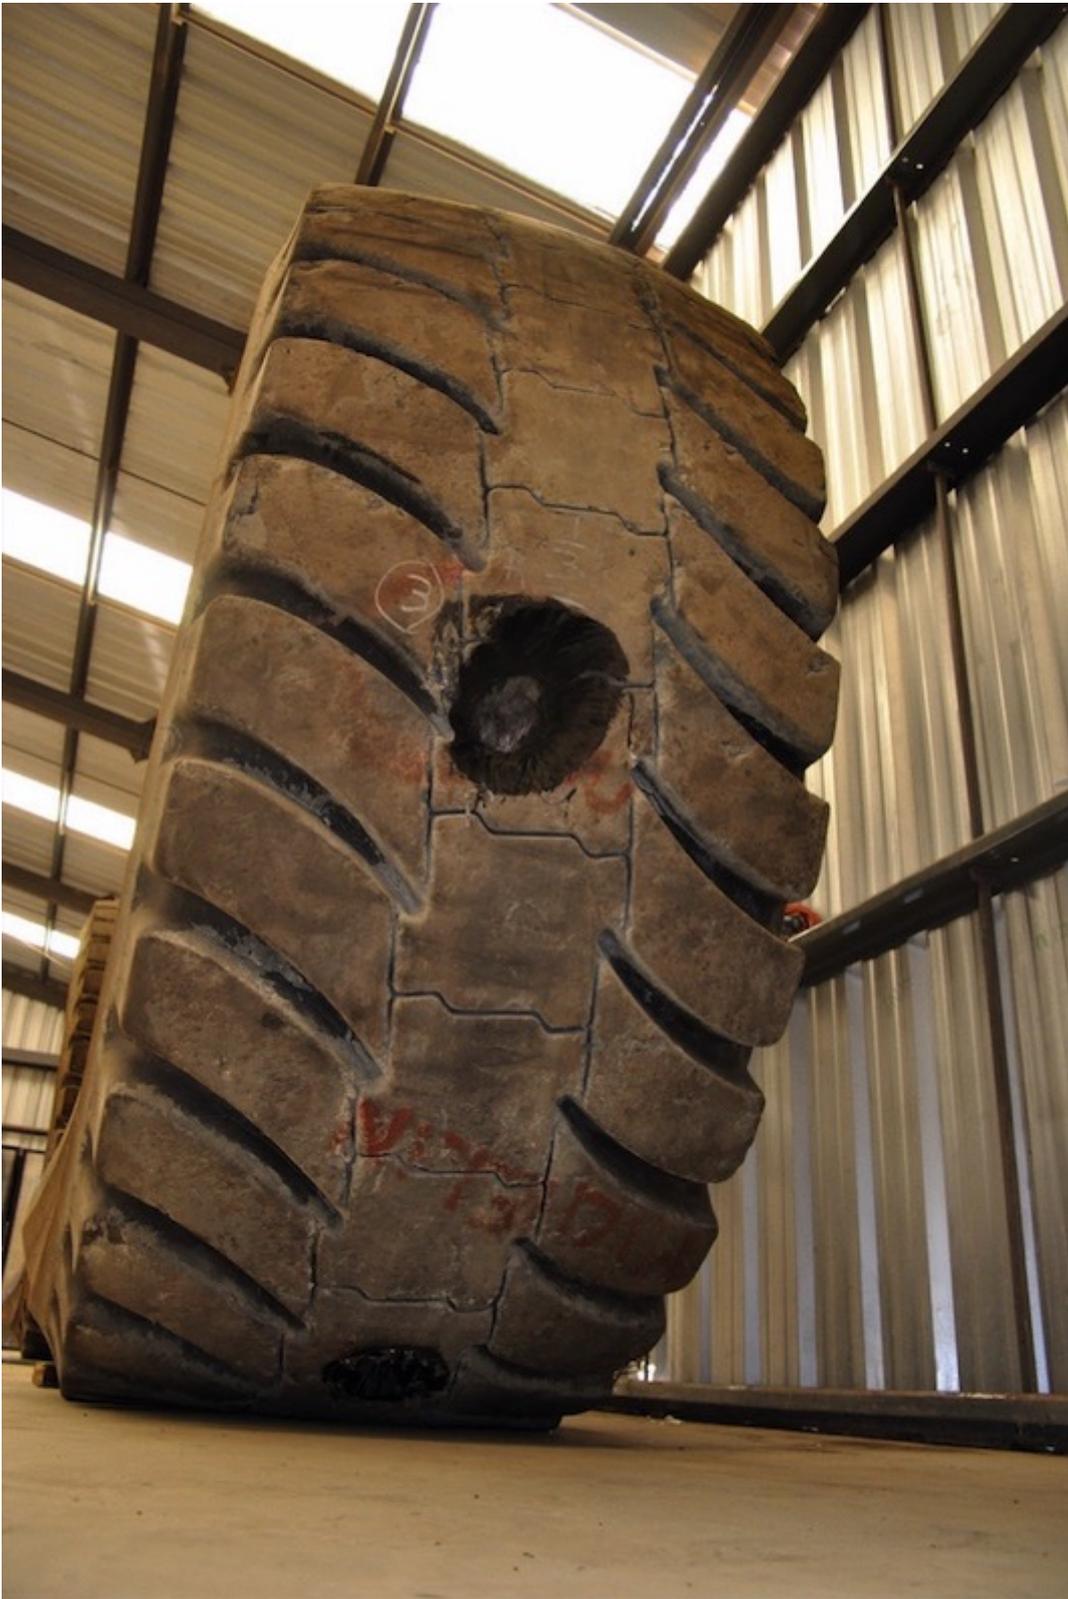
Damage on a 63-inch-tyre prepared for repair in the OTR-workshop.

Damage can generally occur at three different places on the tire - the tread, the tire shoulder and the sidewall. Much of the damage to OTR tires is due to penetration by stones or rock splinters, something that cannot be avoided in spite of taking good care of the road surface. Fist-sized stones that become jammed in the profile work their way through the tread with every revolution, even though the tread may be up to 140 mm thick. When the stone penetrates the carcass it causes a gradual loss of air (slow puncture) that can lead to total destruction of the tire if not noticed. Loss of air is also a certain indication of damage when sidewall or tire shoulder cracks are found. To prevent irreparable damage to the tire, the tires have special sensors fitted that given an early visual and acoustic indication of loss of air or temperatures that are too high.

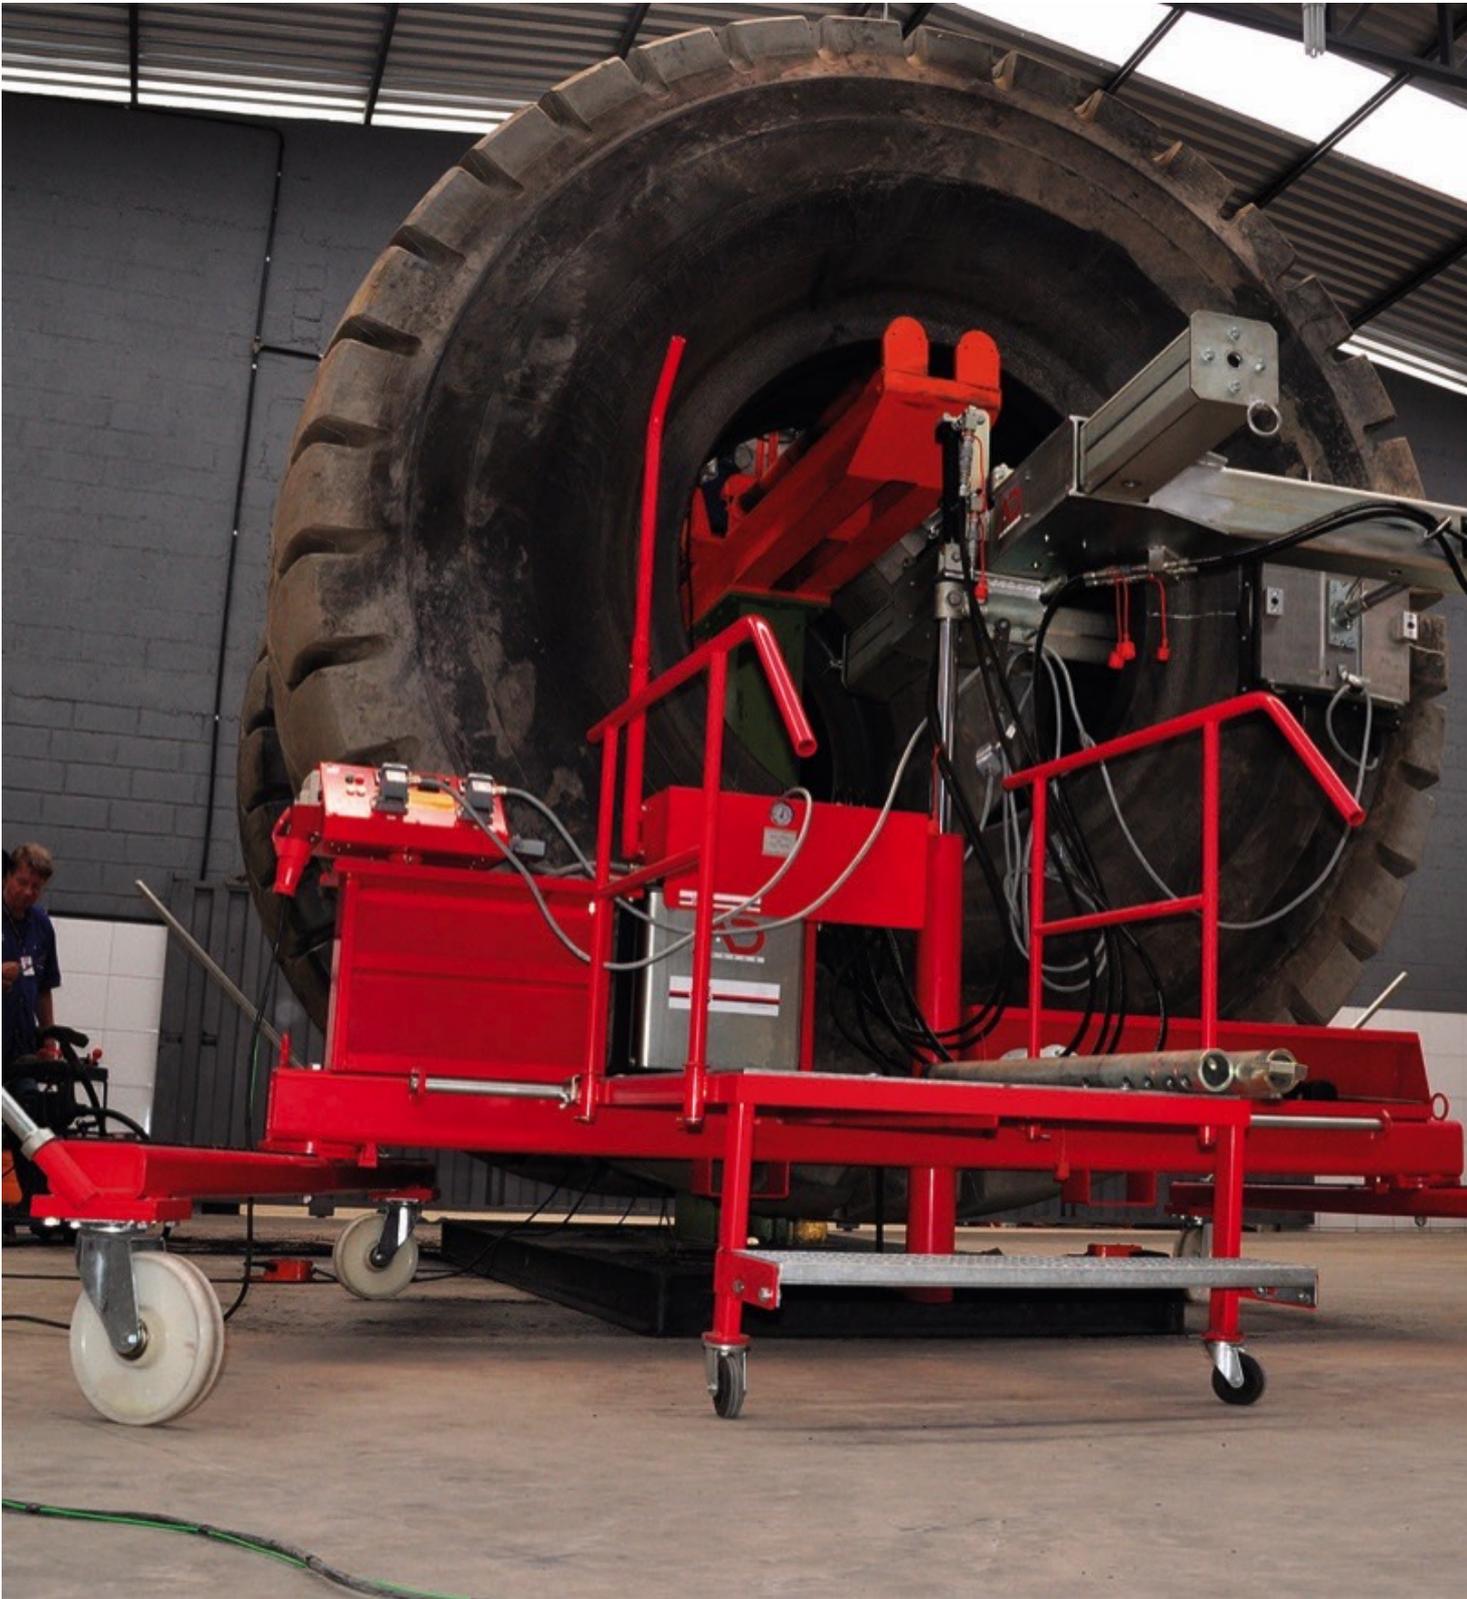
Positioning of the tyre sidewall for the Thermoprocess system.

In the first phase, the damaged tire is cleaned, thoroughly inspected and the degree of damage measured. Loose rubber parts or any damaged carcass wires are removed. The damaged area is roughened and the reinforcement patch placed in position. The damaged area is then filled with MTR repair rubber. If the extent of damage to an OTR tire is great, up to 12 kg of filler may be

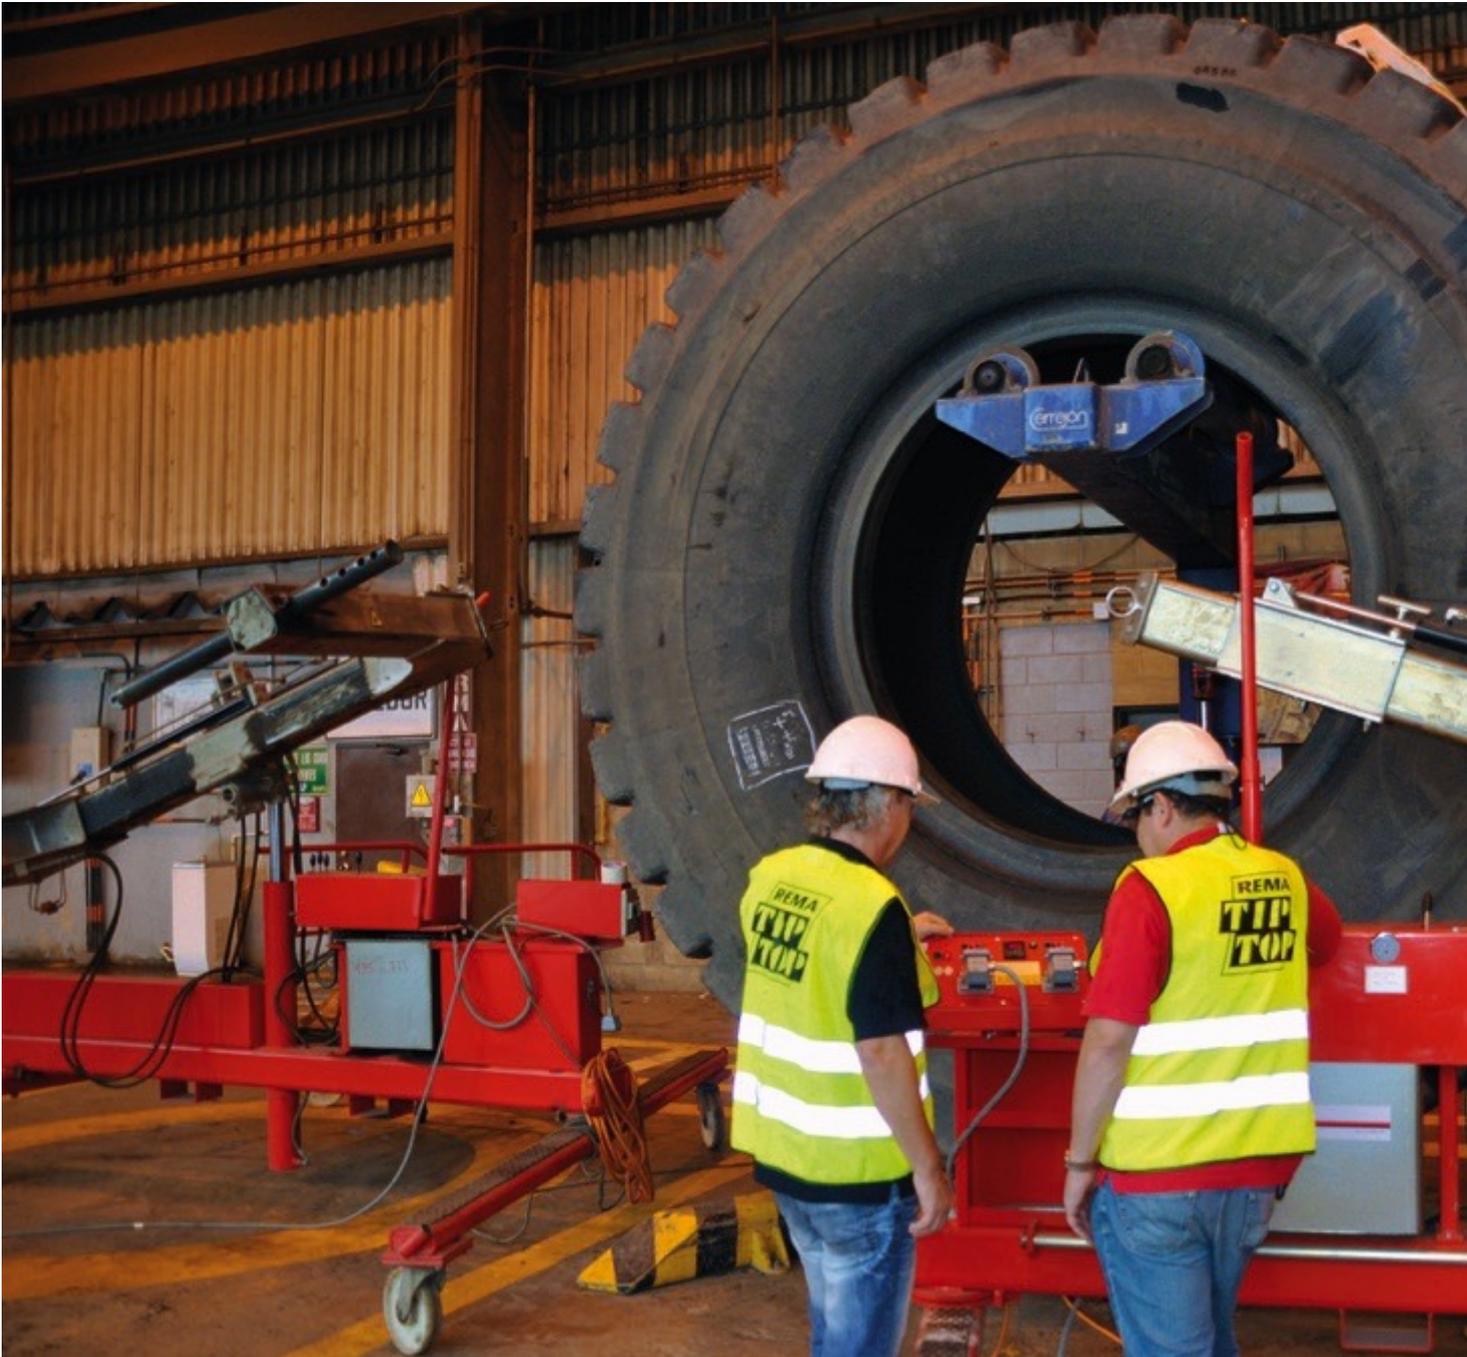
The vulcanizing system in place, also within the tyre.

necessary. This is followed by the process of vulcanization in which the filled rubber mixture is vulcanized in a skive. Two different processes are possible: the 1-way or the 2-way system, each having its own advantages and disadvantages. The advantage of the 1-way process is the fast repair time because the damaged area and the strengthening patch are vulcanized in one working step.

For a tire with sidewall damage this means, for example, that it can again be used after 10 to 12 hours of vulcanization and a 2 to 3 hours cooling-off period. In the 2-way system, in contrast, only the damaged area undergoes hot vulcanization. The reinforcement patch is subsequently cold vulcanized. This process takes

longer but is particularly kind to the tire since the heat is only applied to the damaged area. A considerable difference between both processes is, however, the price of the equipment required. The large heating autoclaves and vulcanizing equipment necessary for the 1-way system are considerably more expensive than machines such as Rema Tip Top's Thermopress used in the 2-way vulcanization process. But what counts most is the final result - and that is equally good for both systems.

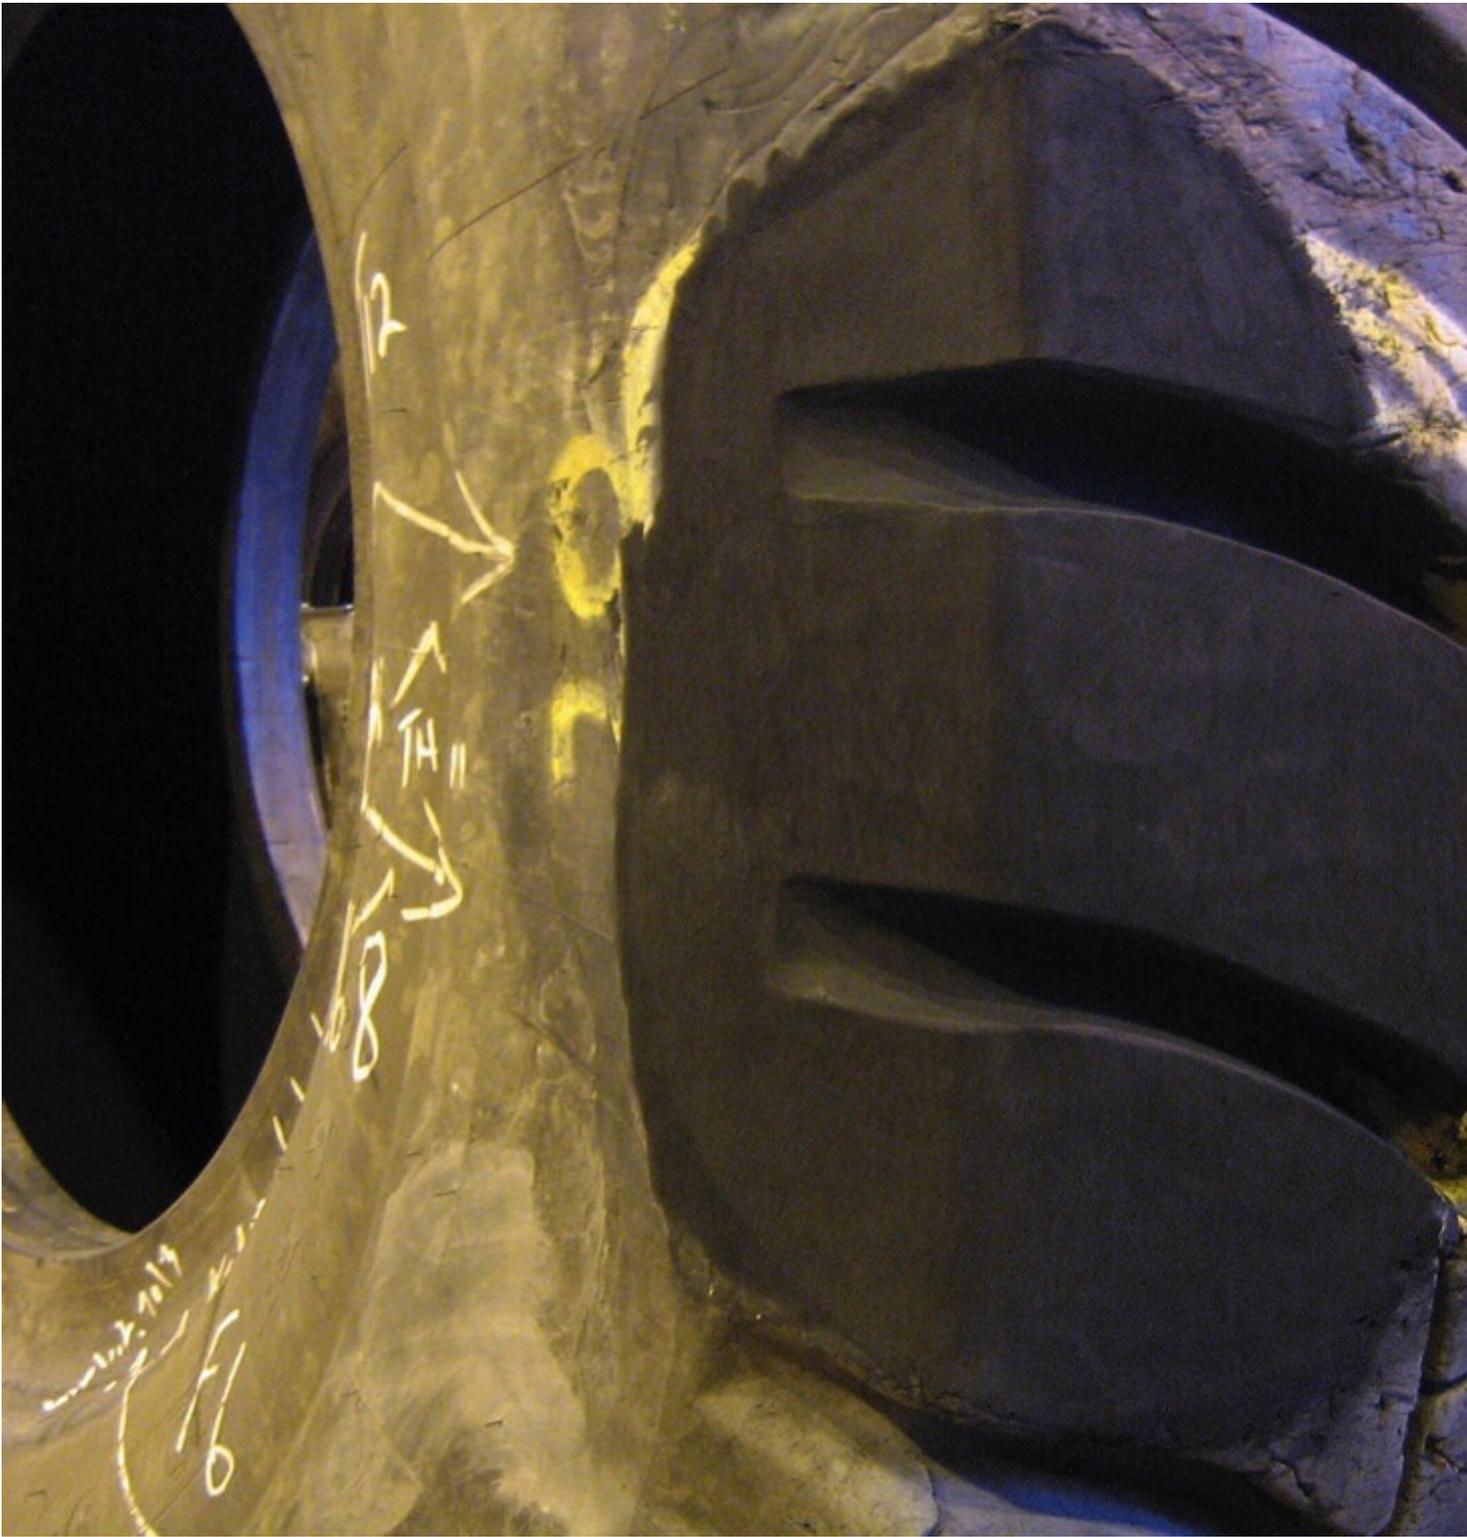
The final result: 63-inch OTR Tyre after repair.
