Whitepaper

Troubleshooting Belt Cleaners - Optimising Productivity rather than fixing Breakdowns

[Published in bulk solids handling, Vol. 34 \(2014\) No. 1](#)

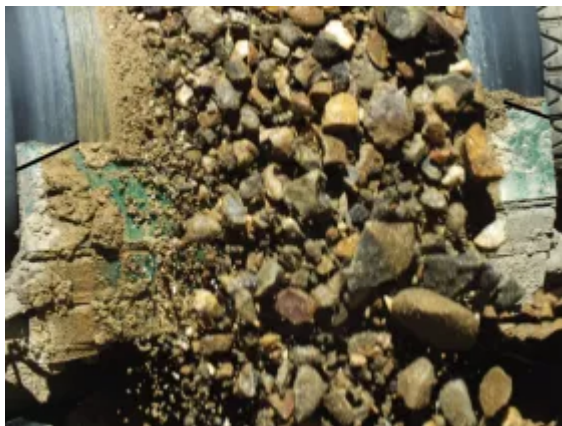
Fig. 1: Typical primary belt cleaner installation. In this picture you also find trim marks for the blade (see below). (Pictures: © Kinder & Co Pty Ltd.)

Over time, a wear pattern occurs, parabolic in appearance similar to a “smile”. This is due to the parts of the blade contacting the clean sections of the belt and not wearing in comparison to the centre, therefore restricting the rest of the blade from adjusting itself closer to the head drum. Combined with the fact that the belt cleaner may be trying to remove conveyed material from the belt rather than left over carry back, causes the issue regularly witnessed and discussed.

In the event of this occurrence, it is suggested that sections be cut off, where the smiling is starting to form (see Fig. 1). This will provide a more even cleaning edge, prolonging the blade’s wear life and increasing overall cleaning efficiency.

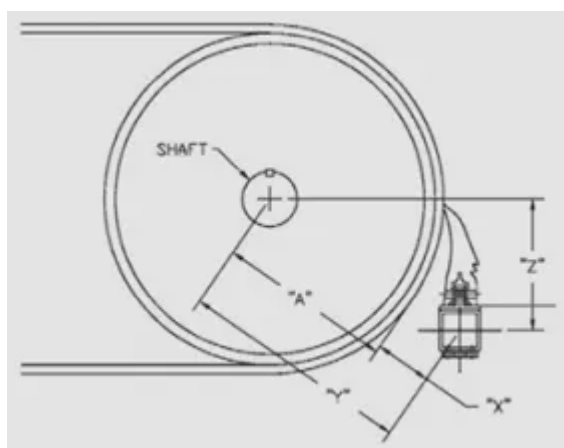
Fig. 2: Correct primary belt cleaner mounting installation: the blade tip should contact the belt below the horizontal line perpendicular to the pulley vertical line.

The incline of the conveyor needs to be considered when the cleaners are mounted. Failure to do so will result in the cleaner not correctly scraping the belt, resulting in sticky material collecting between the blade and the conveyor belt, causing inefficient cleaning and premature wear. In some unfortunate cases, incorrectly mounted blades have been positioned in such a way, that they are helping discharge the product, rather than scraping and cleaning the excess.

It is recommended that the belt cleaner be positioned below the horizontal line perpendicular to the pulley vertical line (see Fig. 2), not necessarily parallel to the stringers or conveyor belt. Material trajectory should also be taken into consideration.
