Whitepaper

Checking a Belts Intactness - Surface Scanner Makes Conveyor Belt Damage Visible

[Published in bulk solids handling, Vol. 36 \(2016\) No. 6](#)

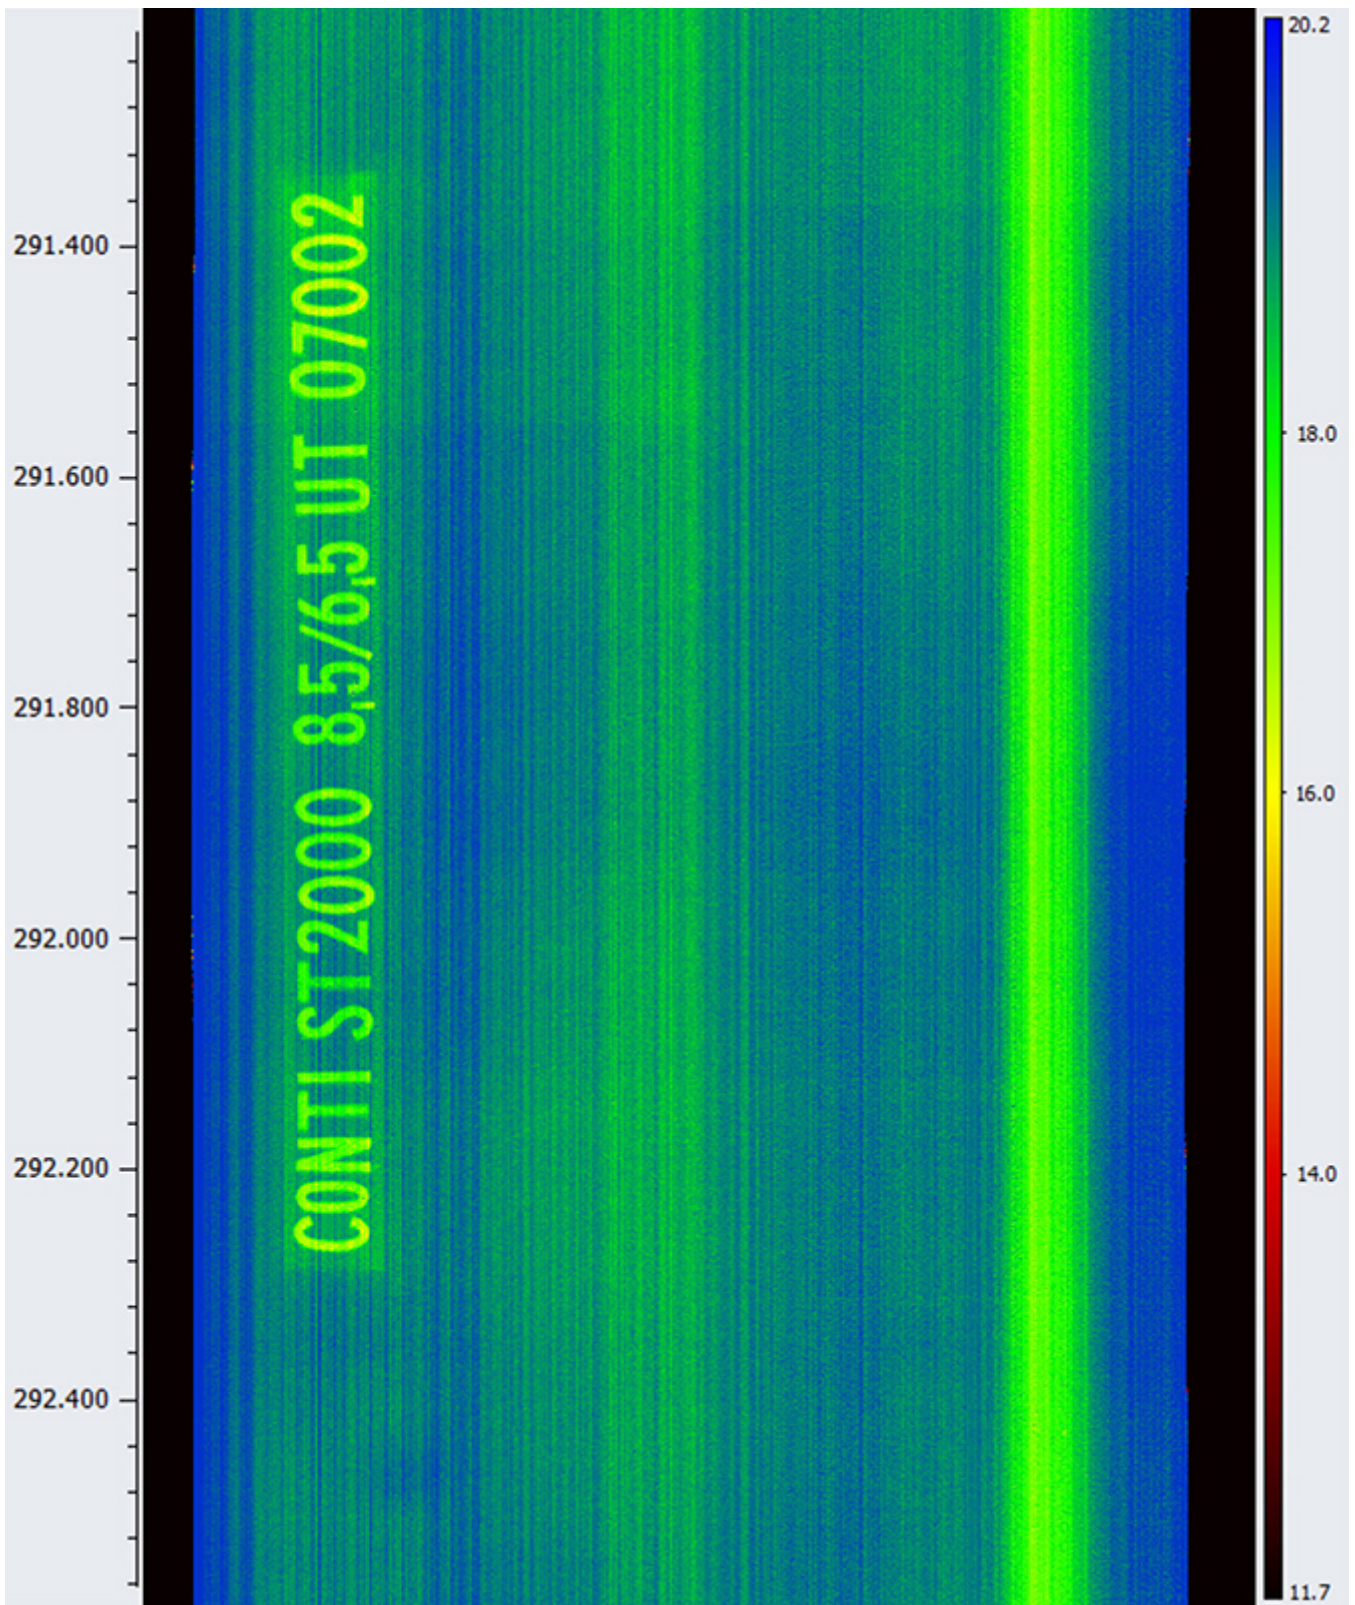
On the basis of the data recorded, Conti SurfaceInspect creates a digital map on which all cover plate damage is visible.
