Bag House Operation Problems: Failure Patterns, Problem Identification and Solutions

[Published in bulk solids handling, Vol. 34 \(2014\) No. 2](#)

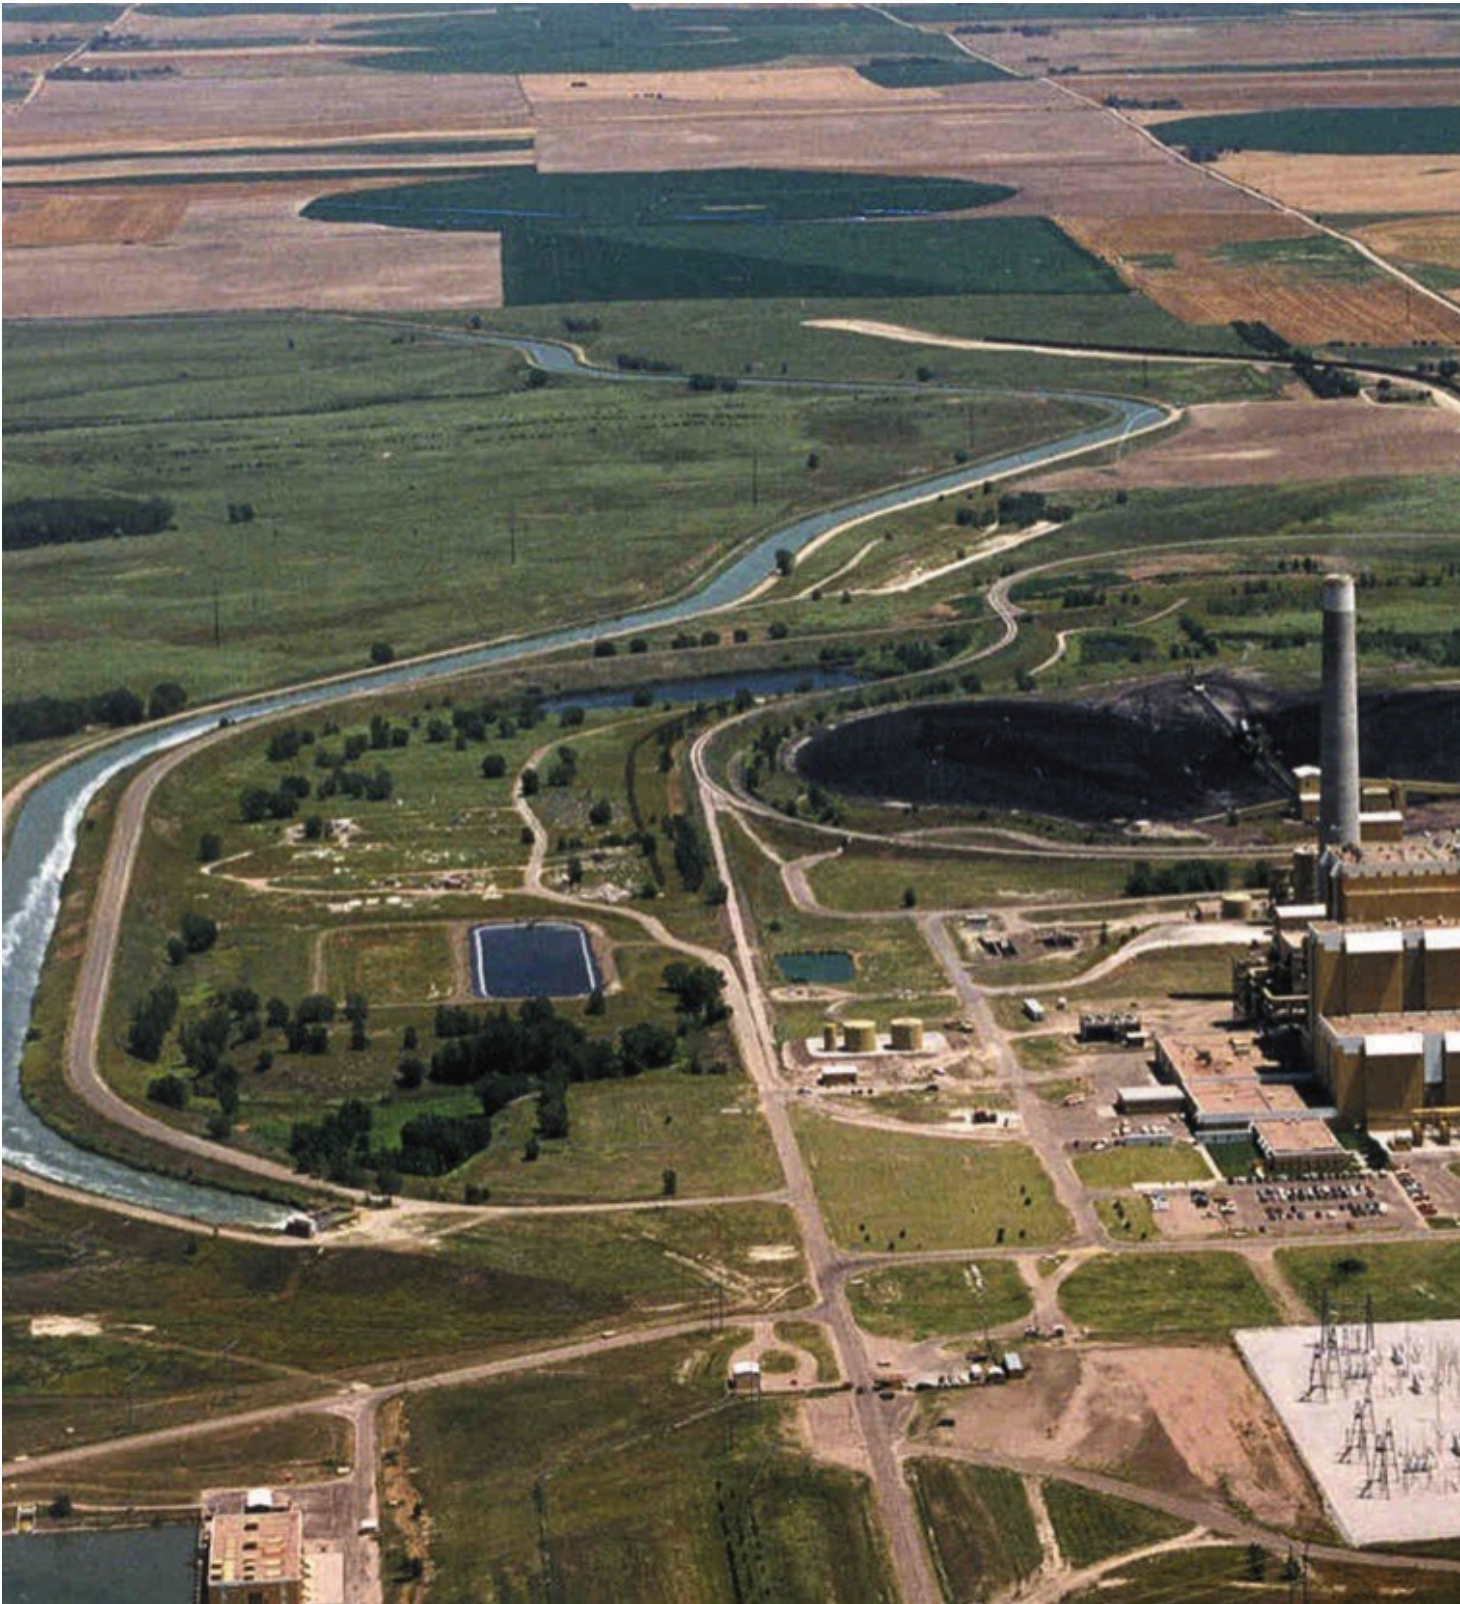
Fig. 1: Today, bag filters find increasing attention also for the filtration of solid fuel power stations. (Pictures: ©Evonik Fibre GmbH)

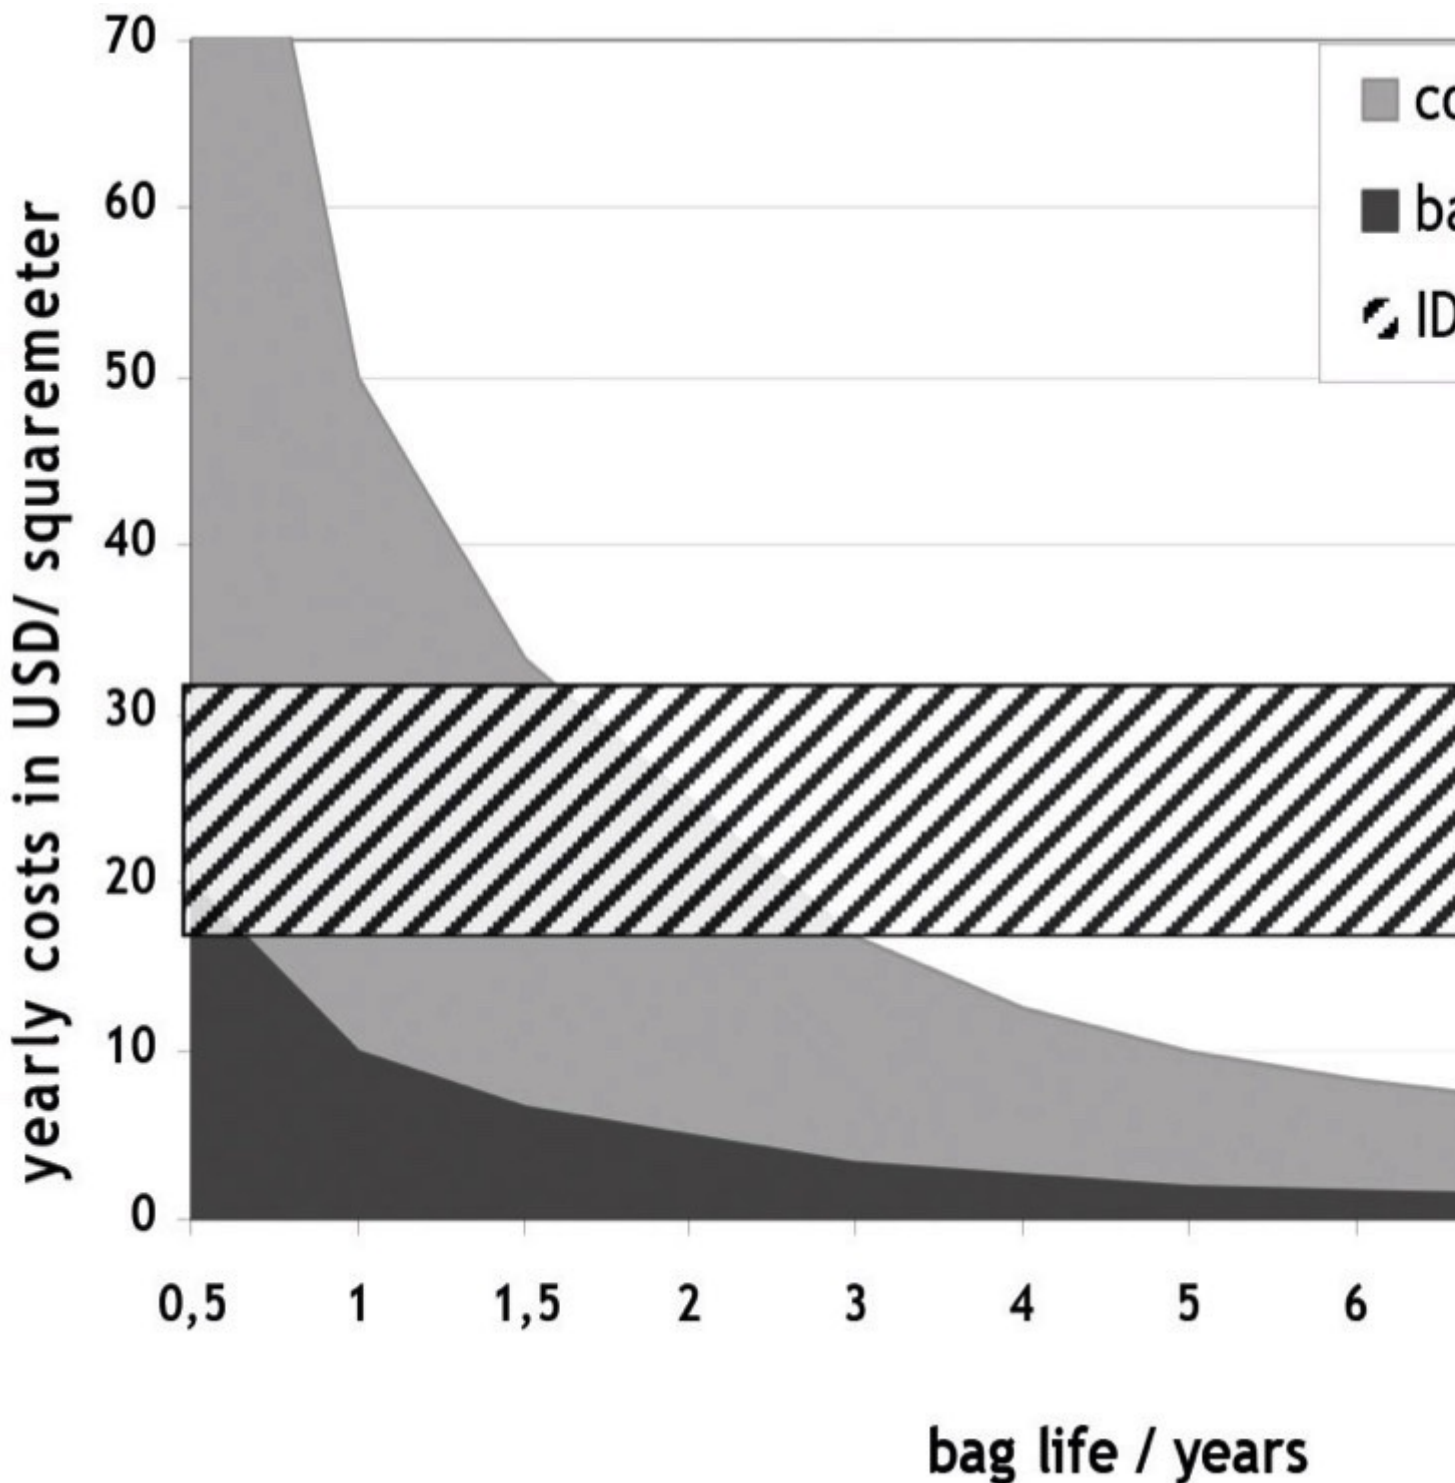
Fig 2: Major bag house operating/maintenance costs.

The operation of a bag house results in expenses for fan power, pressurised air and bag material as well as cost for manpower and the loss of production during maintenance. Bag costs are typically the most obvious and therefore best evaluated cost factor as it is a big investment at the start-up and at the time of complete replacement. In fact it is typically just number 2 after the fan power. With its effect on all other operating costs the choice of bags has to be made properly, including the evaluation of its effect on other costs. In Fig. 2 the operating costs for a bag house are displayed, split in cost for new bags, bag change and disposal and ID fan power. Major differences and therefore a wide range of each single cost factor has to be considered for different applications and bag house layout.

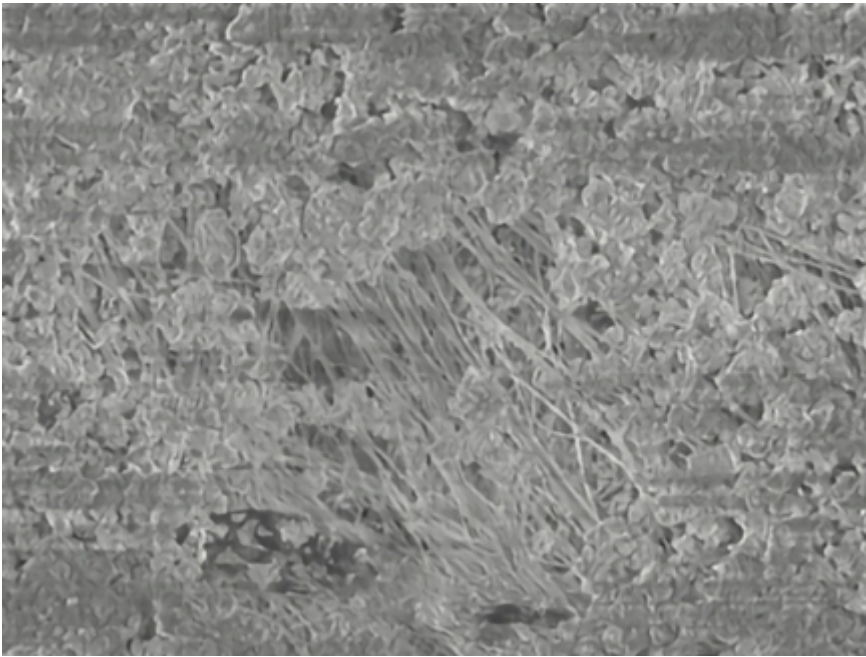
Fig. 3: SEM-picture of a dense dust cake (ammonia salts) on a membrane.

• Some dust components may result in a dense blocking layer. One example is ammonium sulphate. The particular problem is that salts decompose at temperatures around 300°C and crystallisation takes place on the filter media. This results in much stronger bonding between dust and filter material than from inert dust. Membranes appear to have a more pronounced susceptibility in this regards, leading to immediate and permanent problems with increased pressure drop. **Operating conditions** Excessive humidity, (if condensation takes place) can cause sticky behaviour of dust. Condensation in capillary, like between particulate, takes place above the dew point, hygroscopic dust properties further increase the critical temperature. Below a certain humidity the pressure drop will also increase (just slightly, typically without reasonable problems) as binding forces between particles are reduced without contribution of monomolecular water layers on the surface.

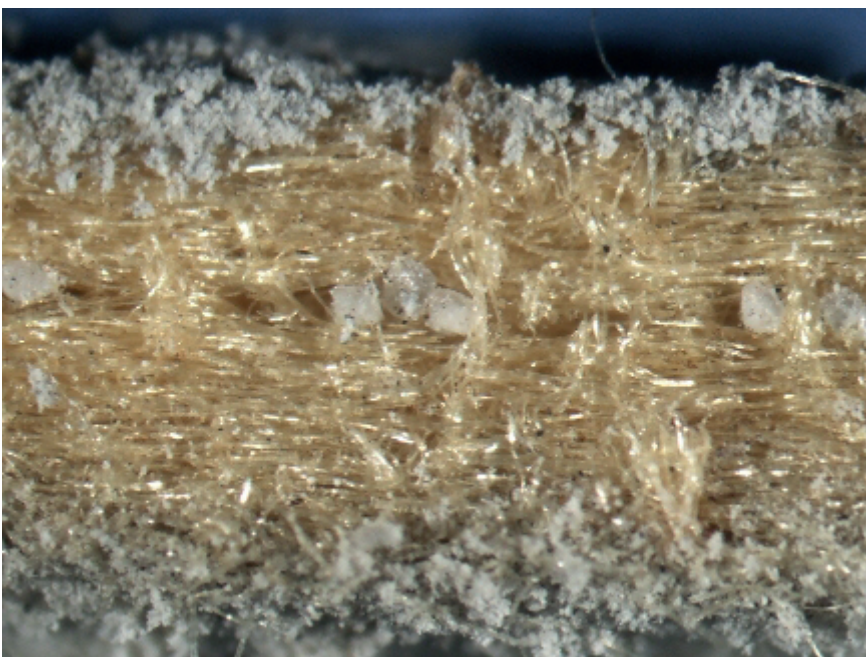
Fig. 4: Contamination from the clean gas side.

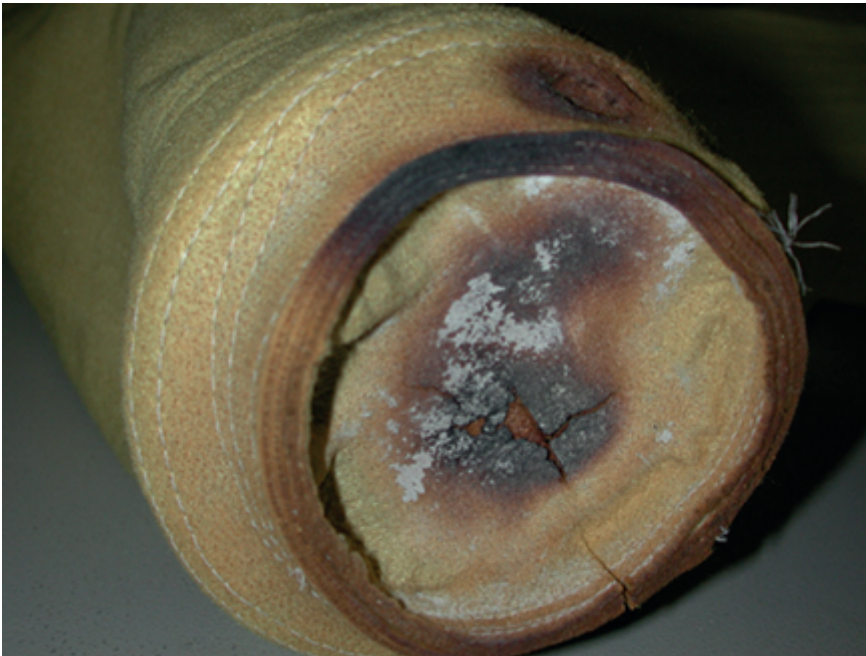
Fig. 5: Shrunken bag bottom as a result of high hopper dust levels.

Shrinkage or elongation - excessive temperature: Short time temperature peaks do not cause a high degree of chemical damage to fibre material but rather influence its dimensional stability. Depending on fibre material and load during operation shrinkage or elongation is typically experienced. A locally pronounced failure can be observed if high hopper levels result in locally high temperatures at the bag bottoms. Elongation due to peak temperatures above the material limit can result in folds and mechanical wear as shown later on.

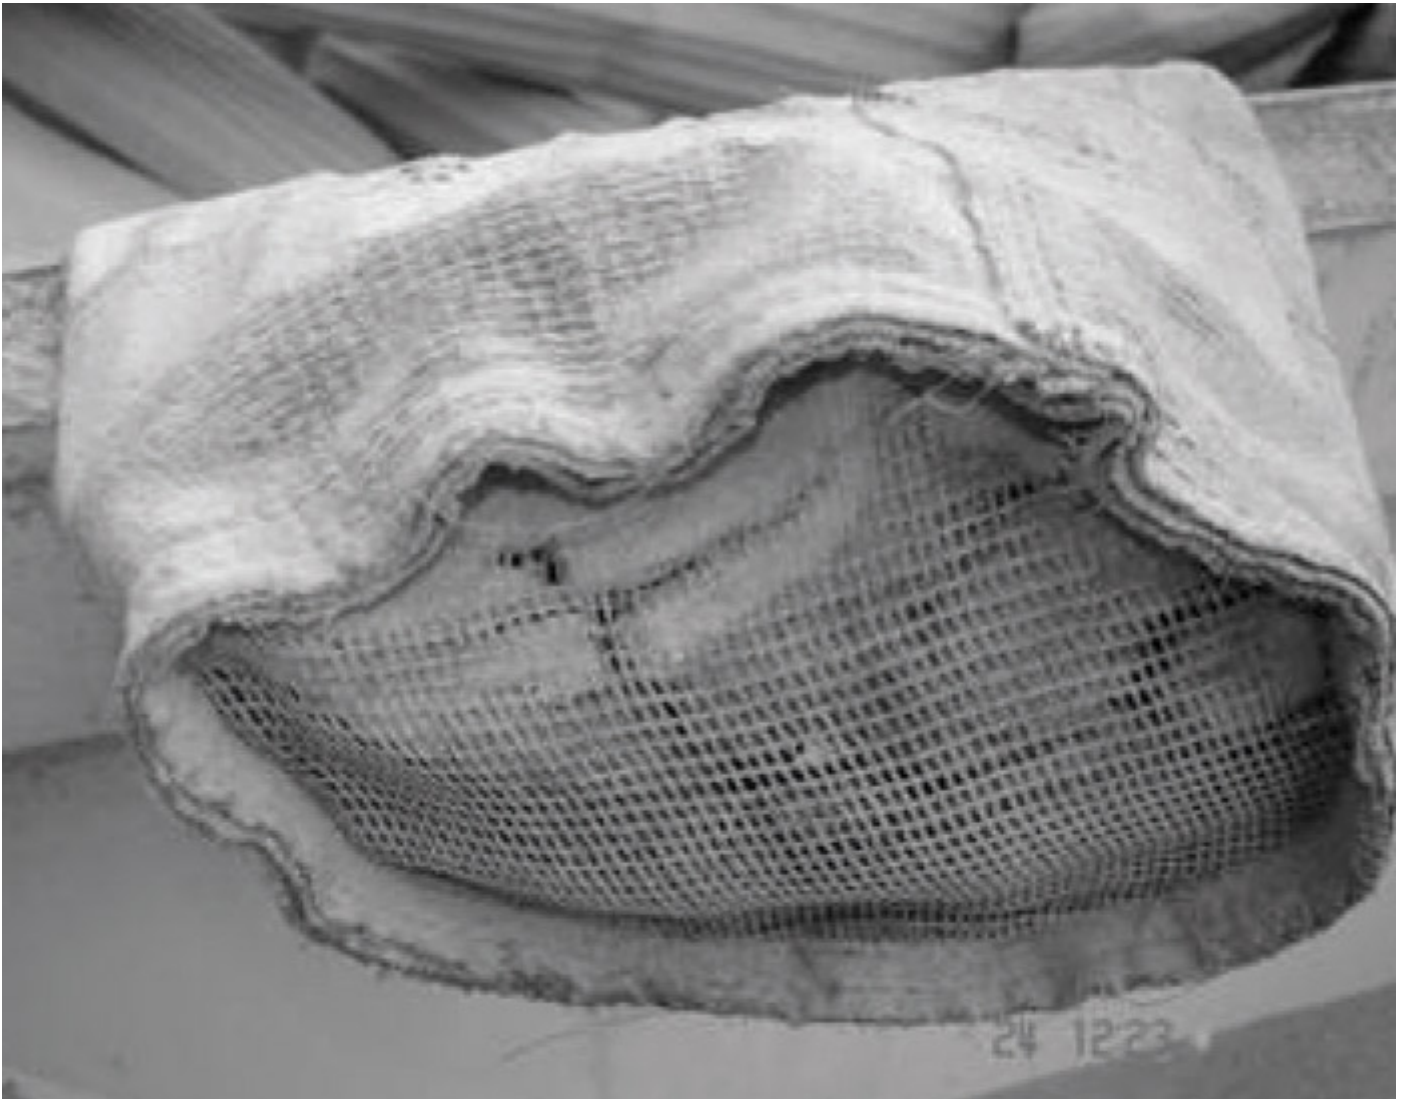
Fig. 6: Abrasion of the entire felt from the supporting scrim due to high local gas velocity.

(Excessive) mechanical wear: This may be due to abrasion from locally high gas velocities. Locally high gas velocity and re-entrainment of dust from the hopper is resulting in abrasion of the bag material. Even some bag materials show lower susceptibility against abrasion adaptations of the flow distribution are the only way for stable operation of the filter in this case. Abrasion from pulsing is often observed as secondary failure pattern when dust from the clean gas plenum is blown into the bags during pulsing. Abrasion starting from inside close to the bag top end is indication.

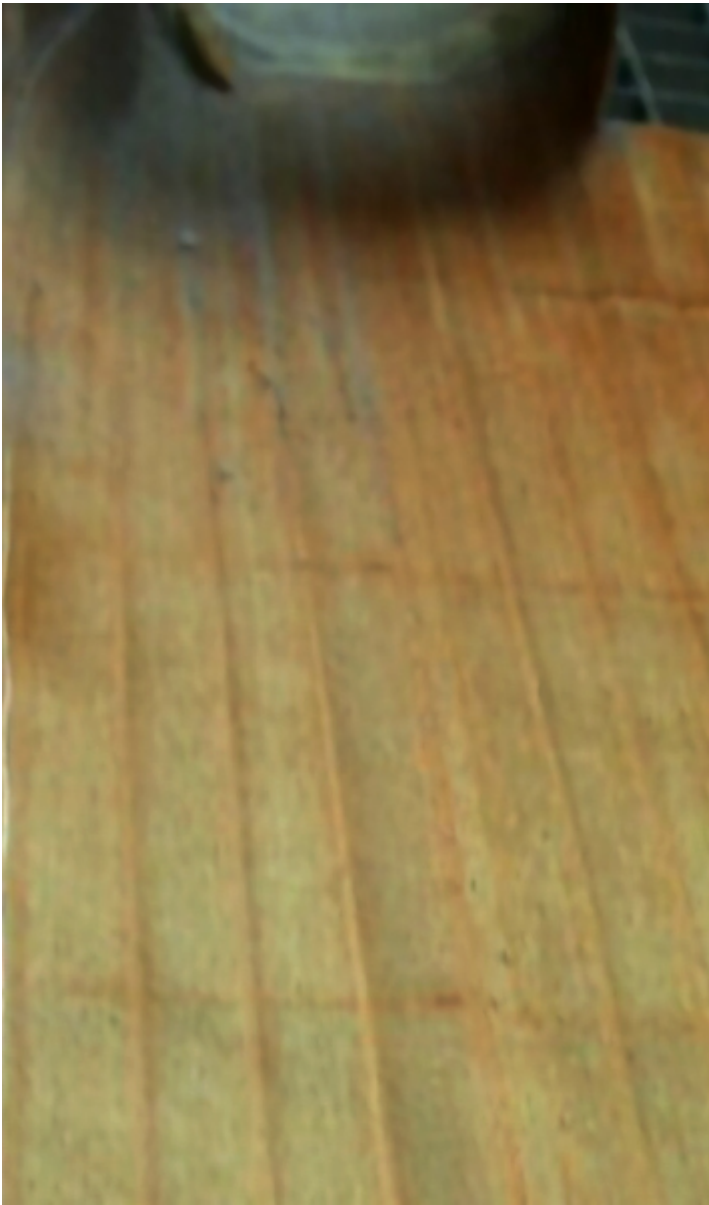
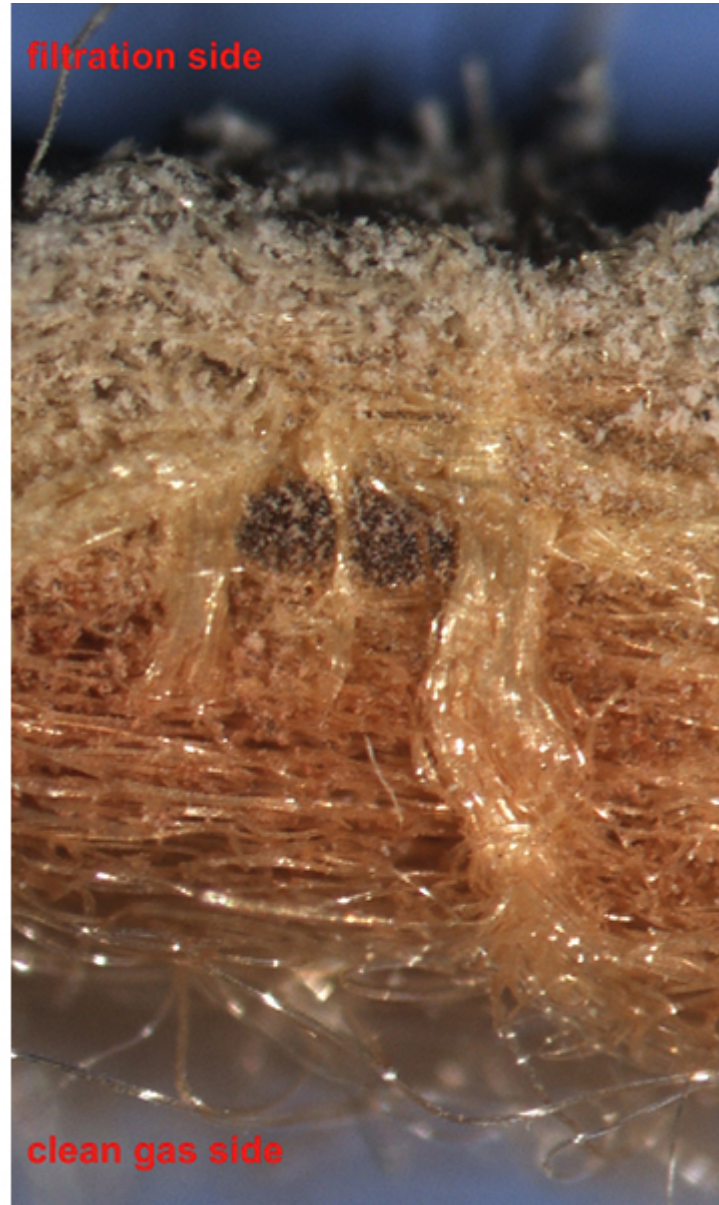
Fig. 7: Rust in the top section of a bag (left) and in a cross section through the felt (right).

Pronounced asymmetric appearance may indicate wrong adjusted cleaning valves/venturis. Red-brownish discoloration of the bag top section from rust is an indication for corrosion (e.g. as a result of condensation) as cause for abrasion from rust. Condensation may be the result of a cool-down below the (acid) dew point during pulsing, leakage due to improper sealing or insufficient insulation (Fig. 7) **Abrasion along cage wires:** Damage along cage wires is typically experienced when the cages are damaged or corroded, or after bag-to-bag or bag-to-wall contact due to misalignment of cages (Fig. 8). **Mechanical wear along folds:** Holes may also result from increased mechanical burden close to a longitudinal fold (e.g. oversized bag). Elongation in cross direction during operation has also to be considered for a misfit of bags on cages. (Fig. 9)

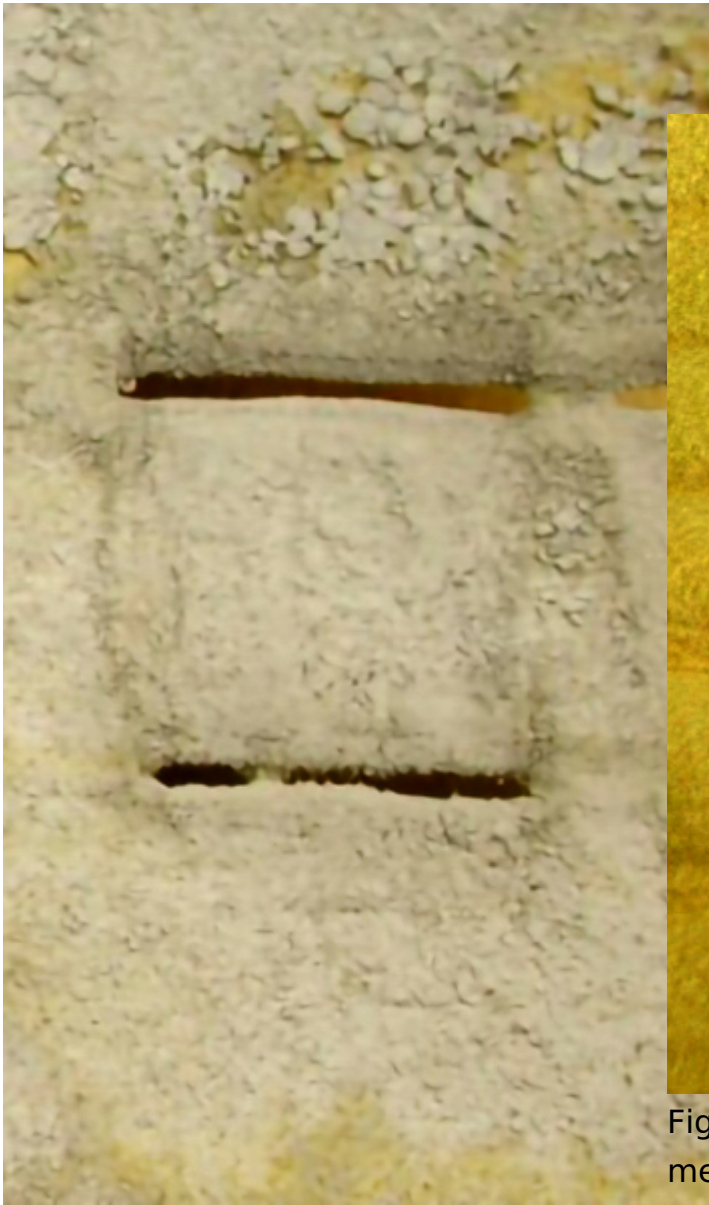
Fig. 8: Hole along cage wire uncleaned (left) and cleaned (right).

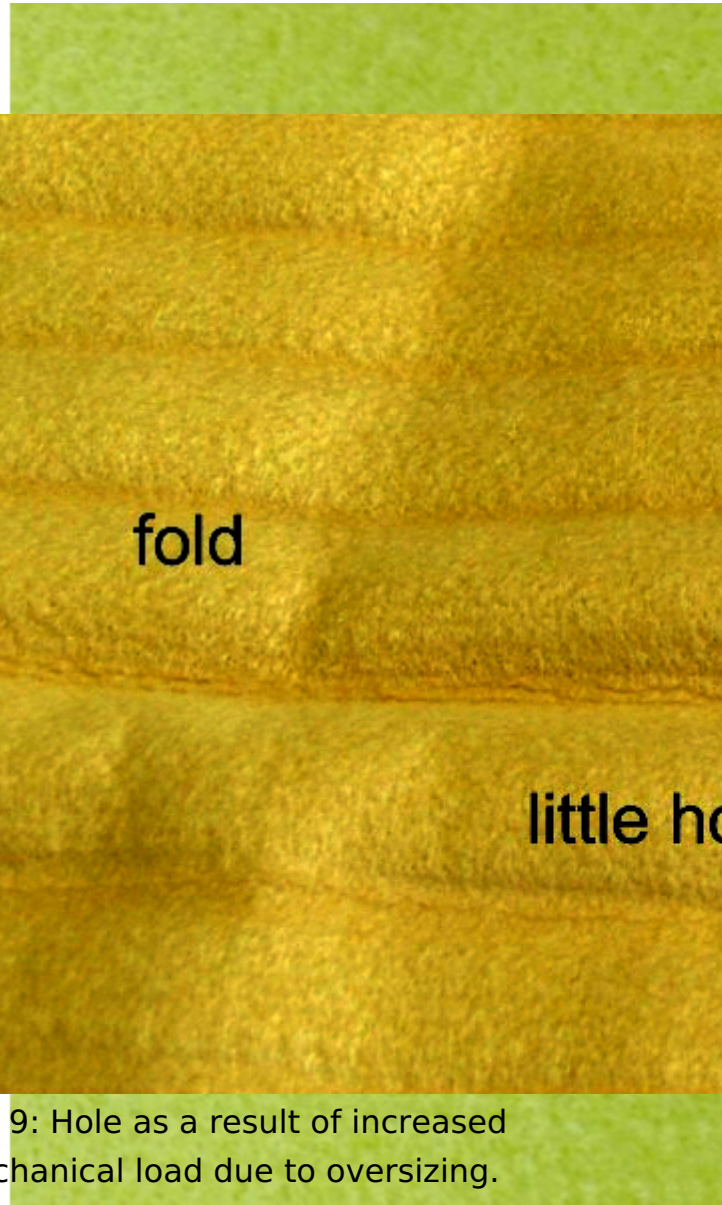
Fig. 9: Hole as a result of increased mechanical load due to oversizing.

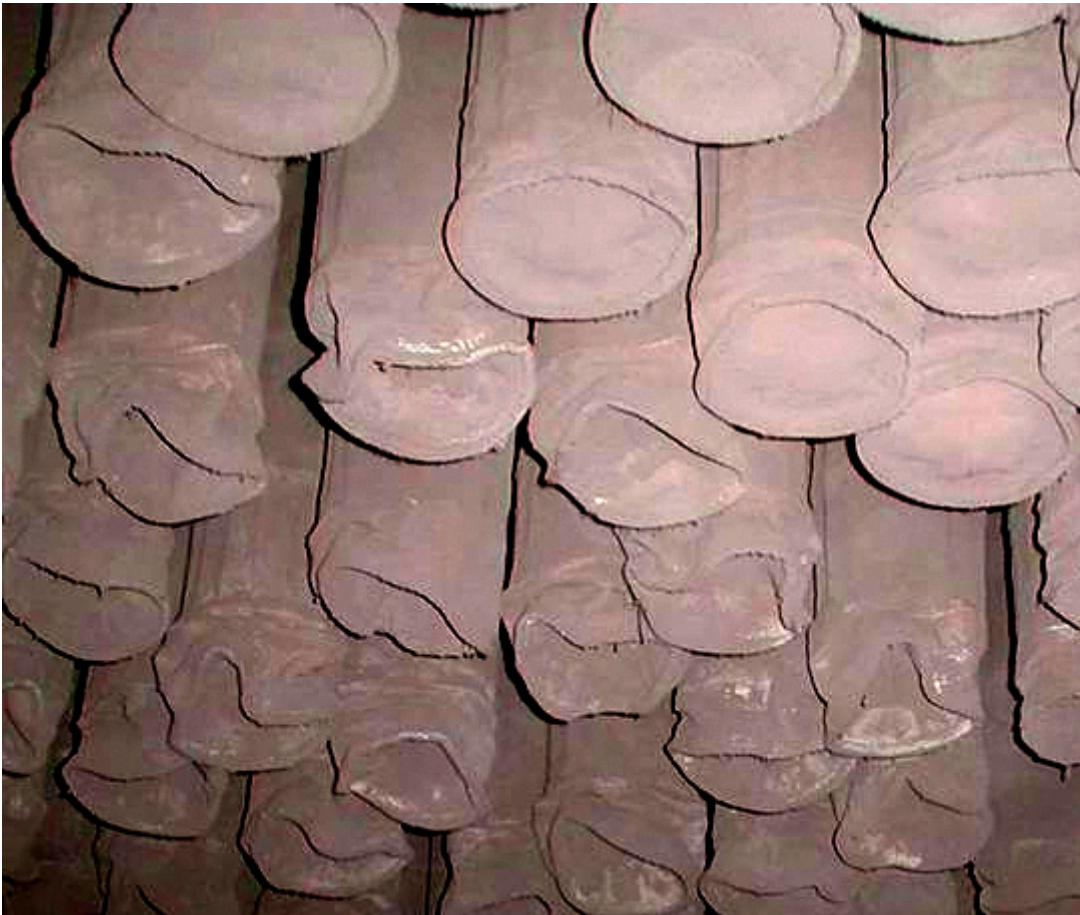
Fig. 10: Photograph from “Why bags fail”: View into a bag house. (Picture: ©Heimbach Filtration GmbH)

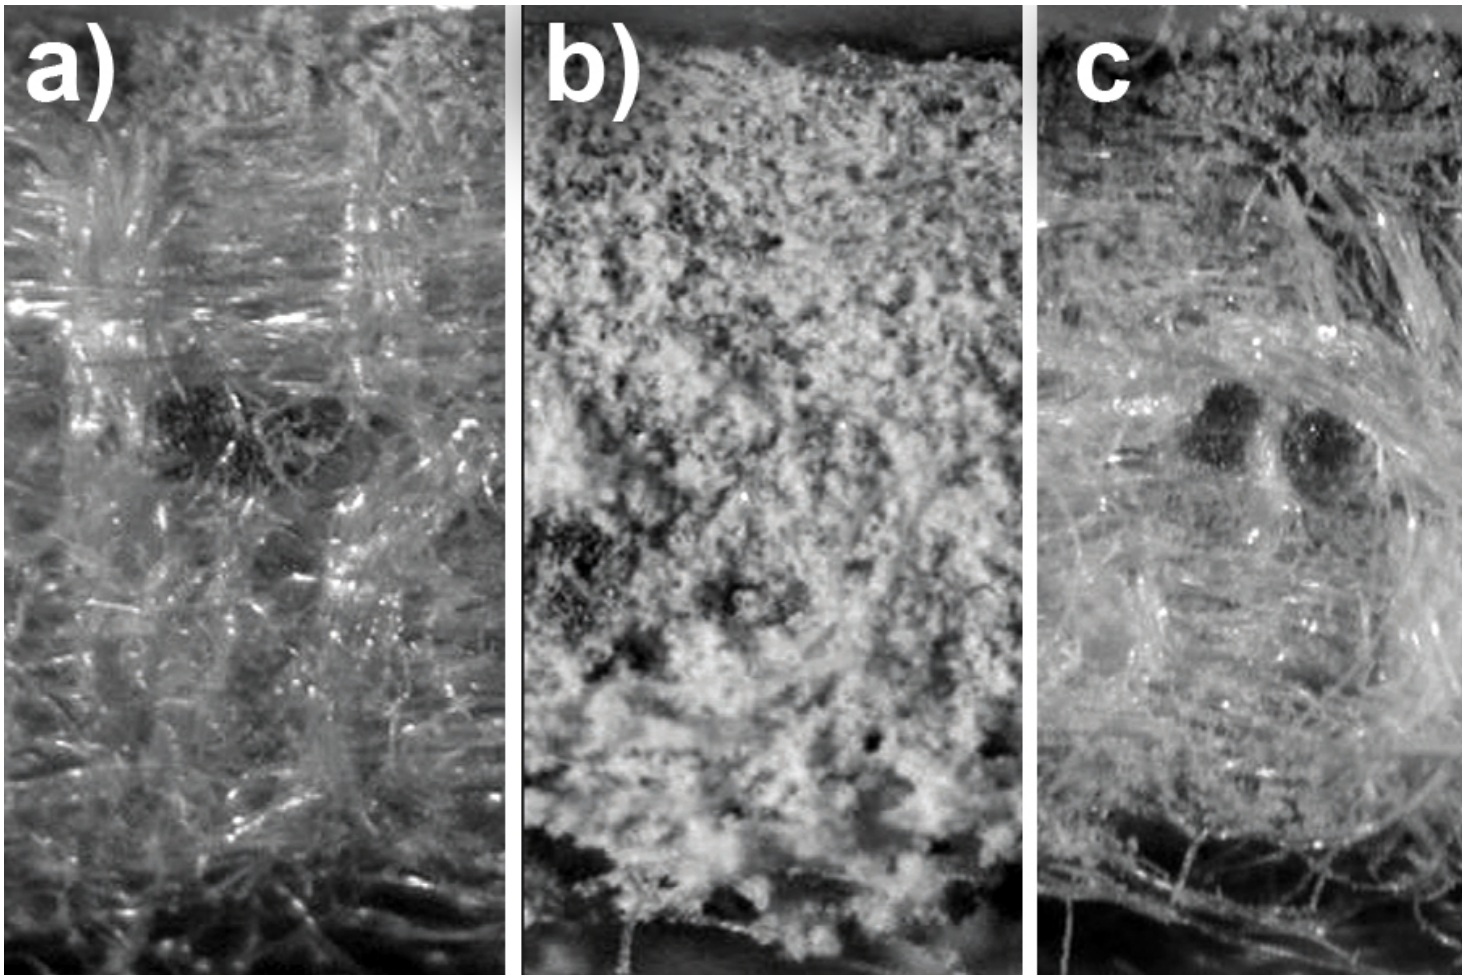
Typical Failure Pictures (Fig. 11)

Fig. 11: Comparison of different filter material constructions and examples for their failure: a) needle felt with good surface filtration, b) needle felt with dust penetration, c) membrane on needle felt, d) membrane on glass fabric.

Needle felt: Penetration of dust into the felt is typically resulting in increased pressure drop. Totally penetrated felts like displayed in the right picture show increased emissions. Needle felts which are constructed to meet the demands of a particular application can ensure high filtration efficiency on a long term. The bag life is typically limited by mechanical and chemical ageing of the fibre material.

Membrane on needle felt: After membrane damage dust accumulates behind the membrane, resulting in increased pressure drop. Increased cleaning pressure to release the membrane is a way to overcome acute problems with blocking, the needle felt has to overtake filtration afterwards.

Membrane on glass fabric: The open scrim does not favour clogging after membrane damage but rather penetration as it does not offer sufficient filtration efficiency for pulse jet applications.

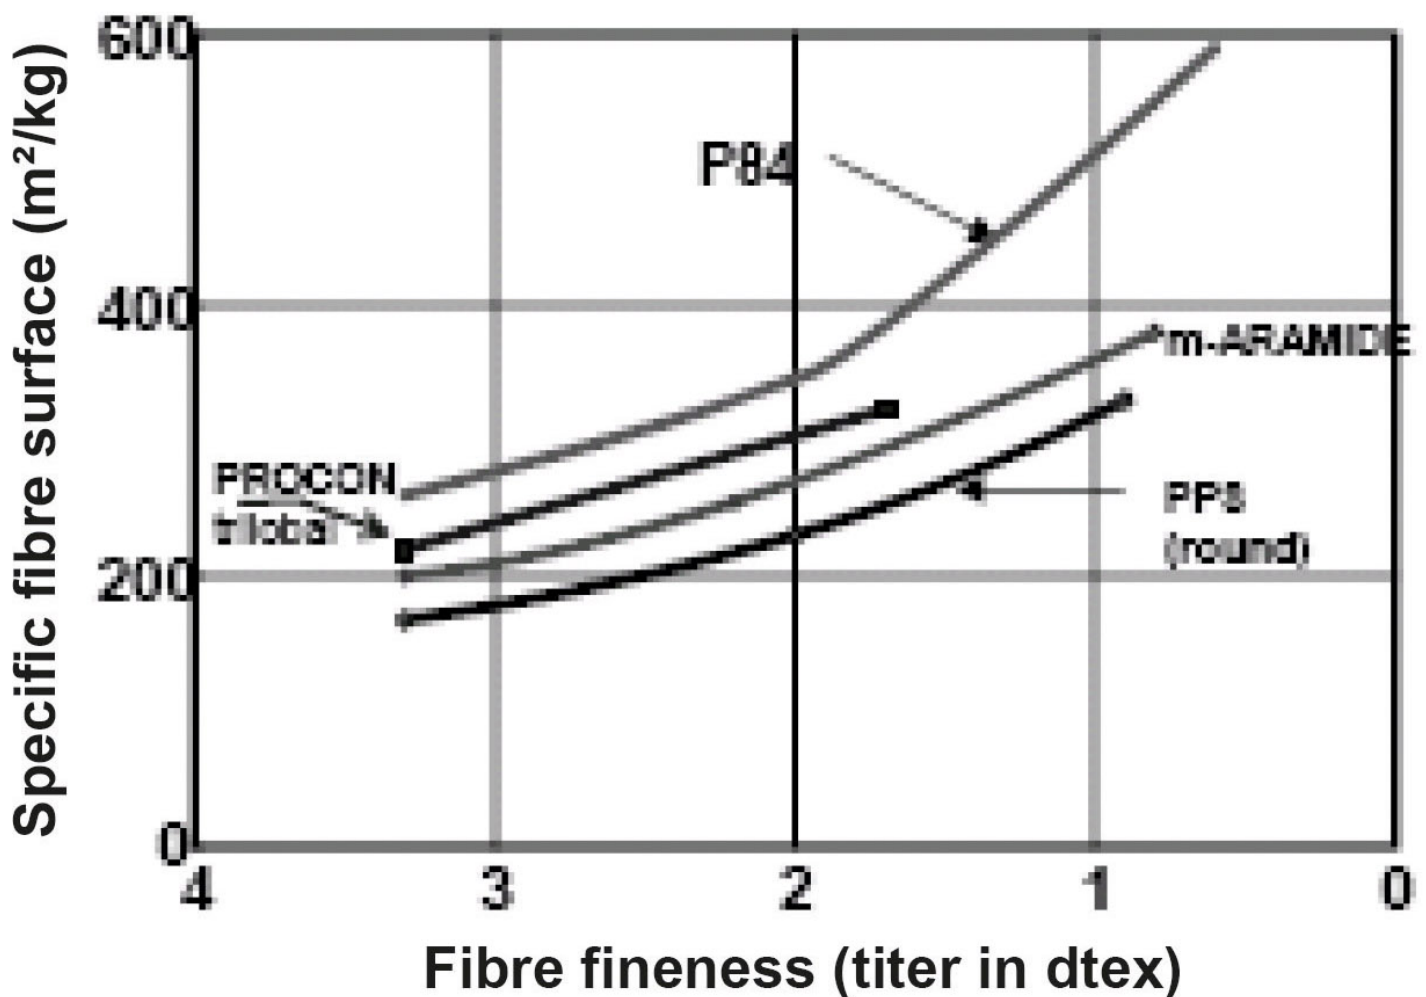
Fig. 12: Specific surface of different fibre materials.

One of the main challenges in today's filter construction is to improve the efficiency of the filter materials. There are different solutions to fulfill this task and to prevent dust from penetration into the felt. The implementation of fine fibres increases the fibre surface and decreases pore size. Blends of different fibre titres on the one hand make it possible to use finer fibres than processible on their own (during felt production) and on the other hand result in derived, narrow pore size distribution. The use of structured fibre cross section: trilobal and multilobal fibres increase the fibre surface (when the felt weight is kept constant). Fig. 12 displays the specific surface of different fibre materials depending on the fibre titer. In addition, low velocity areas exist between the lobes of the fibres where dust can be accumulated without an increase of the differential pressure drop.
