Anwenderbericht

Limestone in a Silo: OK - but out? Resolving Material Accumulation in Cement Plant Limestone Silo

[Published in bulk solids handling, Vol. 37 \(2017\) No. 1](#)

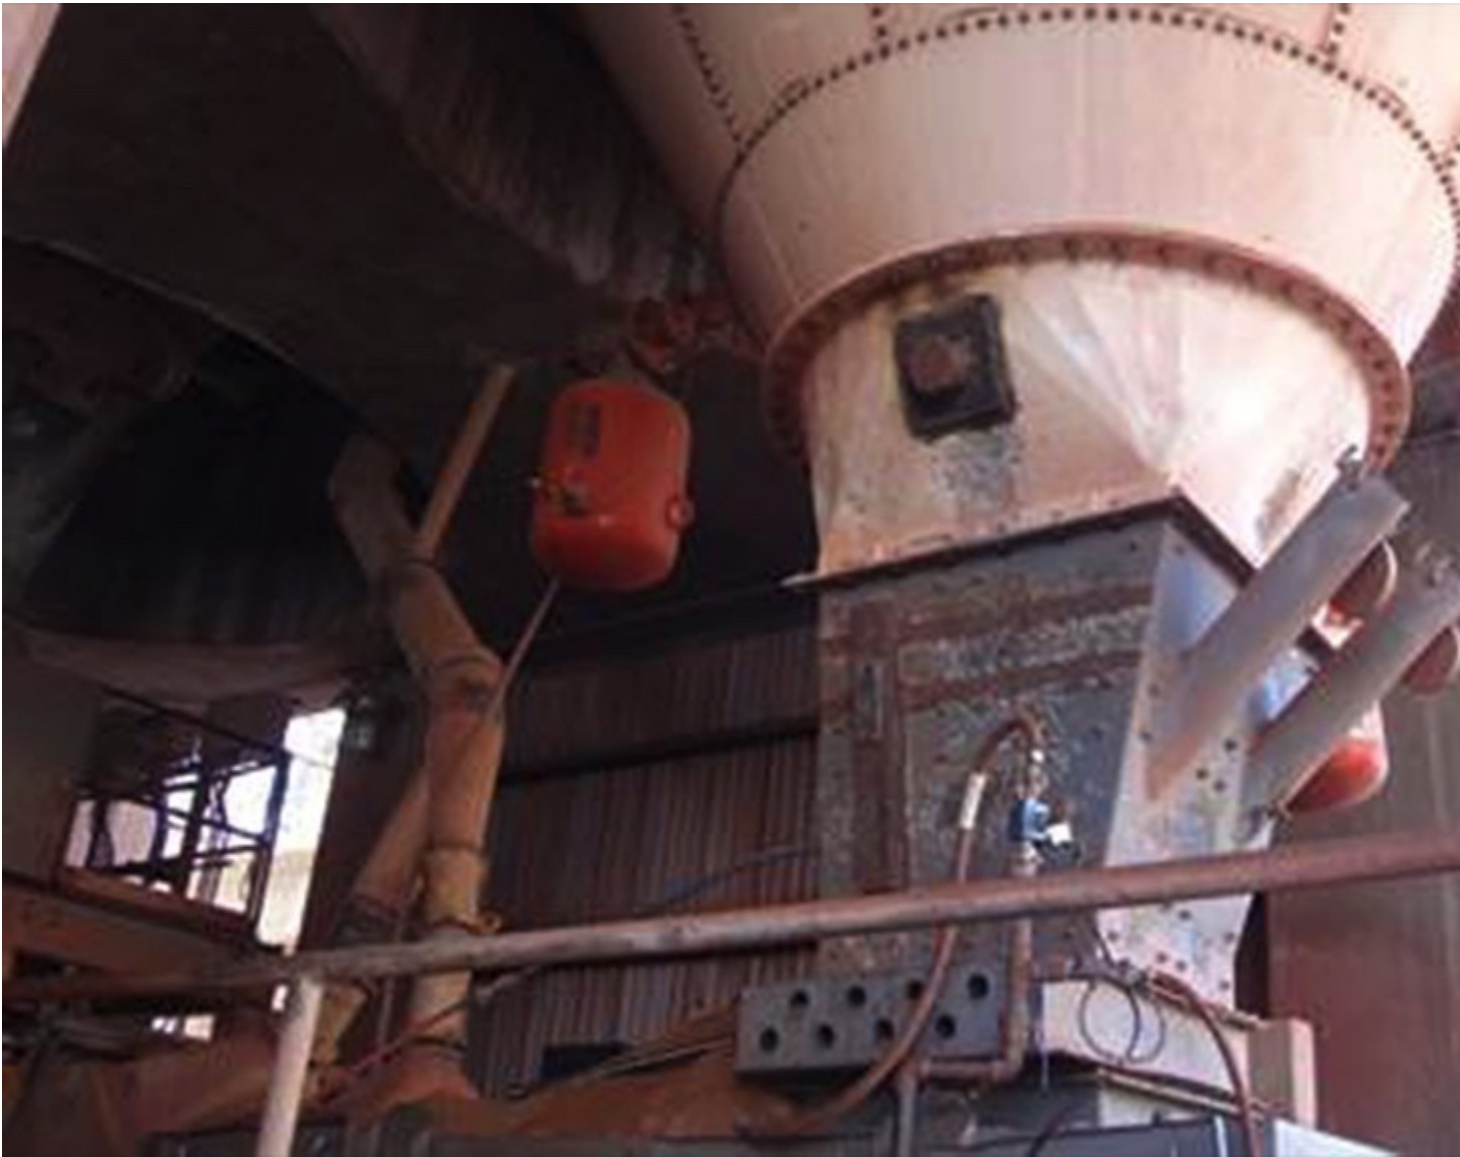
Martin XHV air cannons at Drake cement in their original perpendicular firing configuration (Pictures: © Martin Engineering)

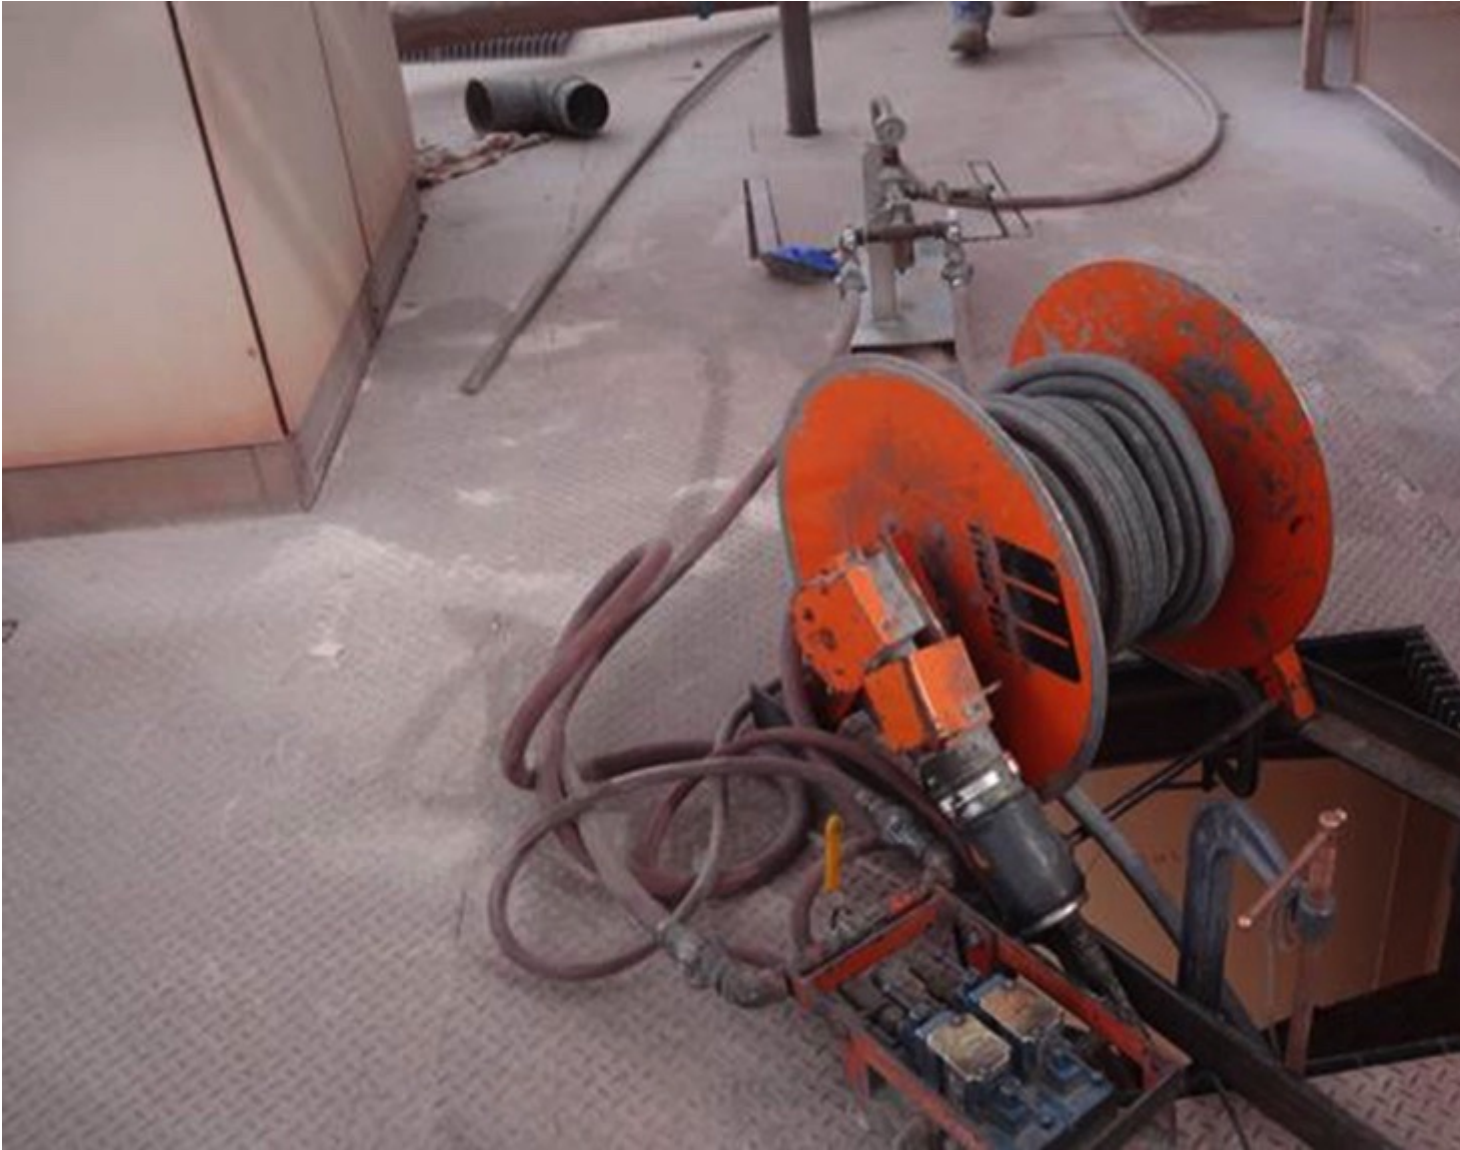
The remotely controlled heavy duty whip is set up above the manhole at the top of the silo.

The experienced two-man crew immediately set up a Martin heavy duty whip. Powered by compressed air, the device can be equipped with a variety of flails and cutting edges to knock down accumulated material without damaging the silo's walls or support structure. The coiled modular boom extends up to 28 ft (8.5 m) and can clean vessels as wide as 60 ft (18 m) in diameter and 225 ft (68.5 m) tall. Operating from the bottom of the silo up, the team completely cleaned out

the densely clogged silo in only 11 hours while the plant resumed production.

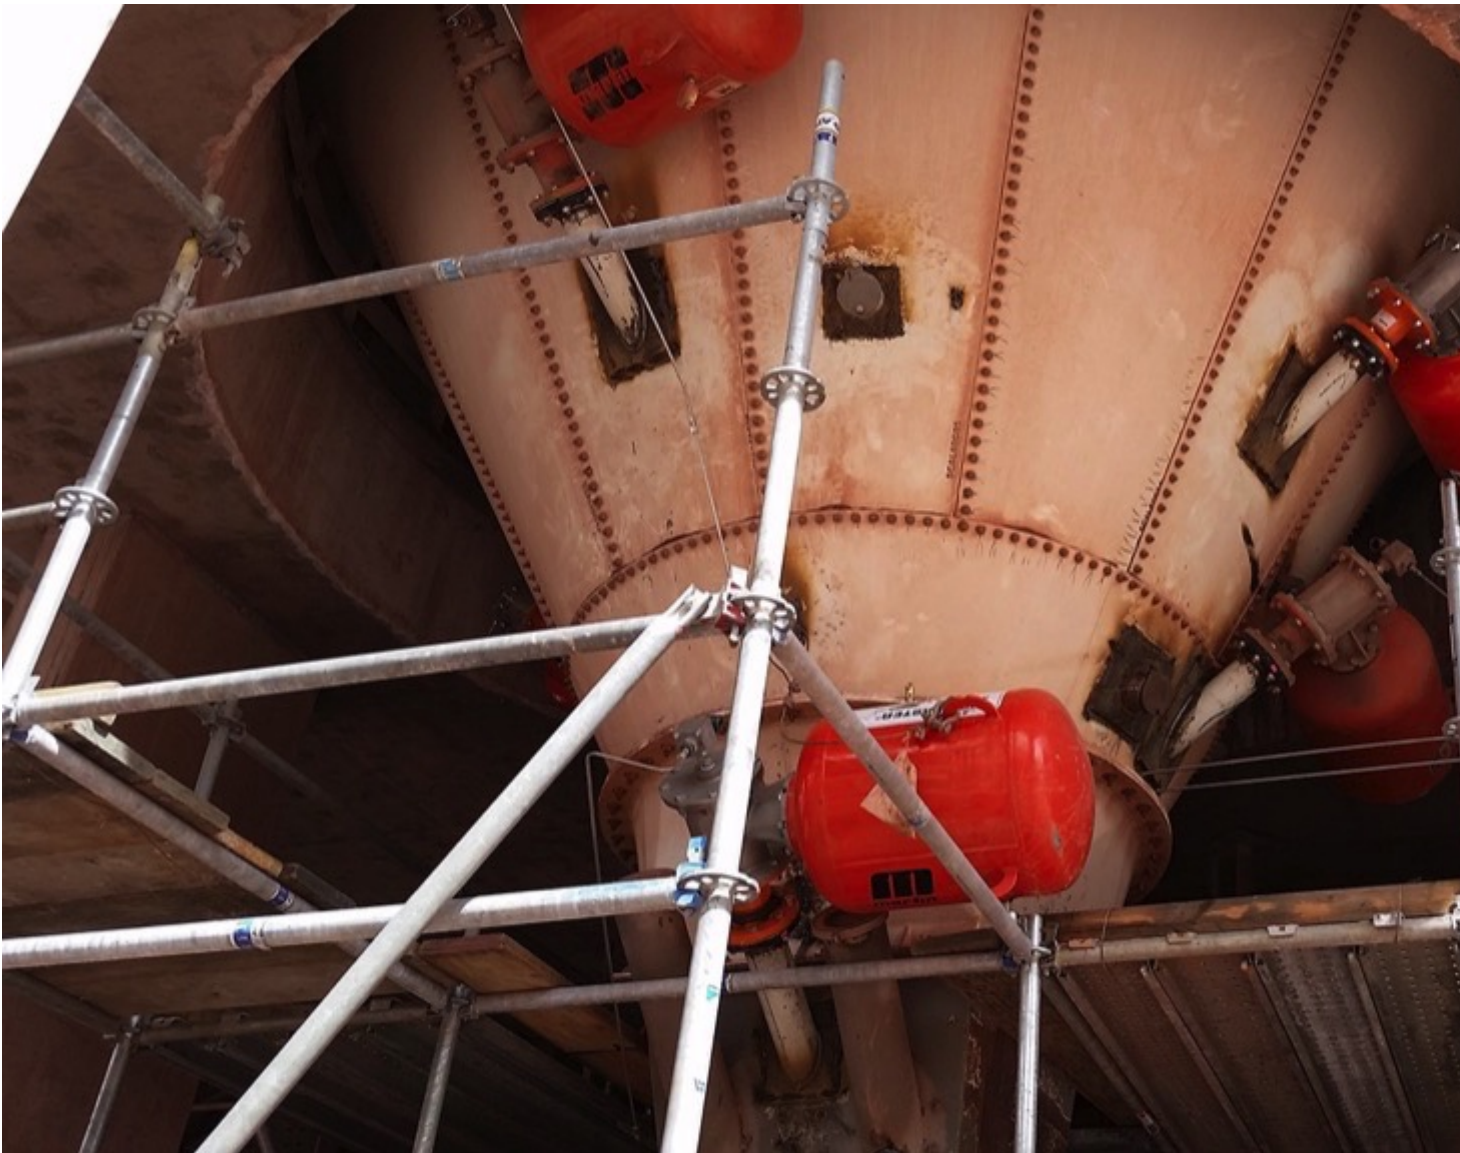
The lower silo cannons strategically placed around the 60° incline.

Rather than the two cannons at the bottom of the limestone silo firing across the cargo flow, five cannons were strategically placed around the vessel. Installed with a wide 4-in (101 mm) valve, three 70-liter (88 lb/40kg) Tornado air cannons were placed on the lower incline of the cone at a 30° downward angle against the

60° slope in the 6 and 12 o'clock positions (one side of the silo was inaccessible). In the 3 o'clock position, one air cannon was situated at the 2-ft-wide shaft, and another was added to the upper silo to aid in loosening material. The cannons deliver a strong pressurized blast of air down the wall of the silo, dislodging adhered material and introduces it back into the process flow. "This type of air cannon configuration has shown to be highly effective in promoting flow and preventing clogging," Brown pointed out. "It has the benefit of directing the air cannon's blast to dislodge the material, delivering a more powerful shot on accumulation that's stuck to the vessel wall." A programmable logic control (PLC) system centrally placed in the facility coordinates and monitors the timing and firing sequence of each unit at all locations, including the limestone silo. This made expanding the system easier, since the cannons use a positive-acting valve that is triggered by a solenoid panel set a safe and convenient distance - up to 200 ft (61 m) - from the cannons. Connected to the plant's compressed air system, the improved air path of the Tornado fills the reservoir 3-4 times faster than typical designs. The positive-acting valve opens in response to a surge of air sent by the solenoid, amplifying the discharge force by 20% and reducing the chance of misfires. During the wet winter and monsoon months, the cannons were activated approximately every hour, but throughout the rest of the year the system has a firing sequence of only 4-5 times per day. "We also added a layer of protection that the silo didn't have before by installing an automated weight sensor," Venegas explained. "If the silo exceeds 40 t of downward pressure, logistical software detects the buildup and fires the cannons. This sequence can also be manually activated at the weigh feeder, the solenoid panel or in the control room."
