Whitepaper

Static Electricity Hazards - Dust Cloud Ignition caused by Static Electricity

[Published in bulk solids handling, Vol. 37 \(2017\) No. 4](#)

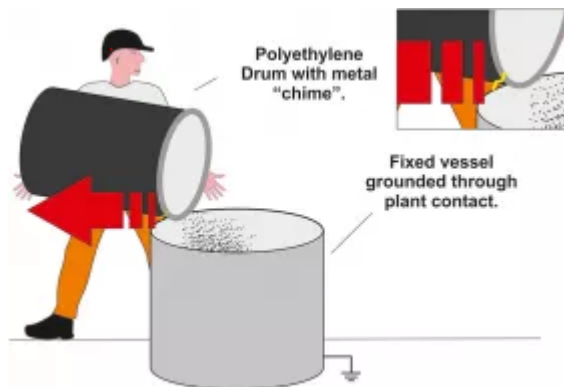
It was postulated that the accumulation of electrostatic charge on the chime resulted in a static spark discharge from the chime as it came into close proximity with the vessel when the drum was removed. The vessel was grounded through its own fixed connection to the plant.

The situation in the plastic processing plant, when the powder cloud ignited.

The first place to start is to determine why electrostatic charge was “permitted” to accumulate on the chime. In this case electrostatic charge accumulated on the chime because the chime was electrically isolated from a true earth ground. Had the chime been connected to the grounded process vessel, charge would not have accumulated on the chime. Excess electrostatic charges would simply have found their way to earth. So in accordance with industry guidelines like NFPA 77 and IEC 60079-32-1, the isolated metal component should have had a connection to a verified ground (in this case the process vessel) with a resistance of 10 ohms or less.

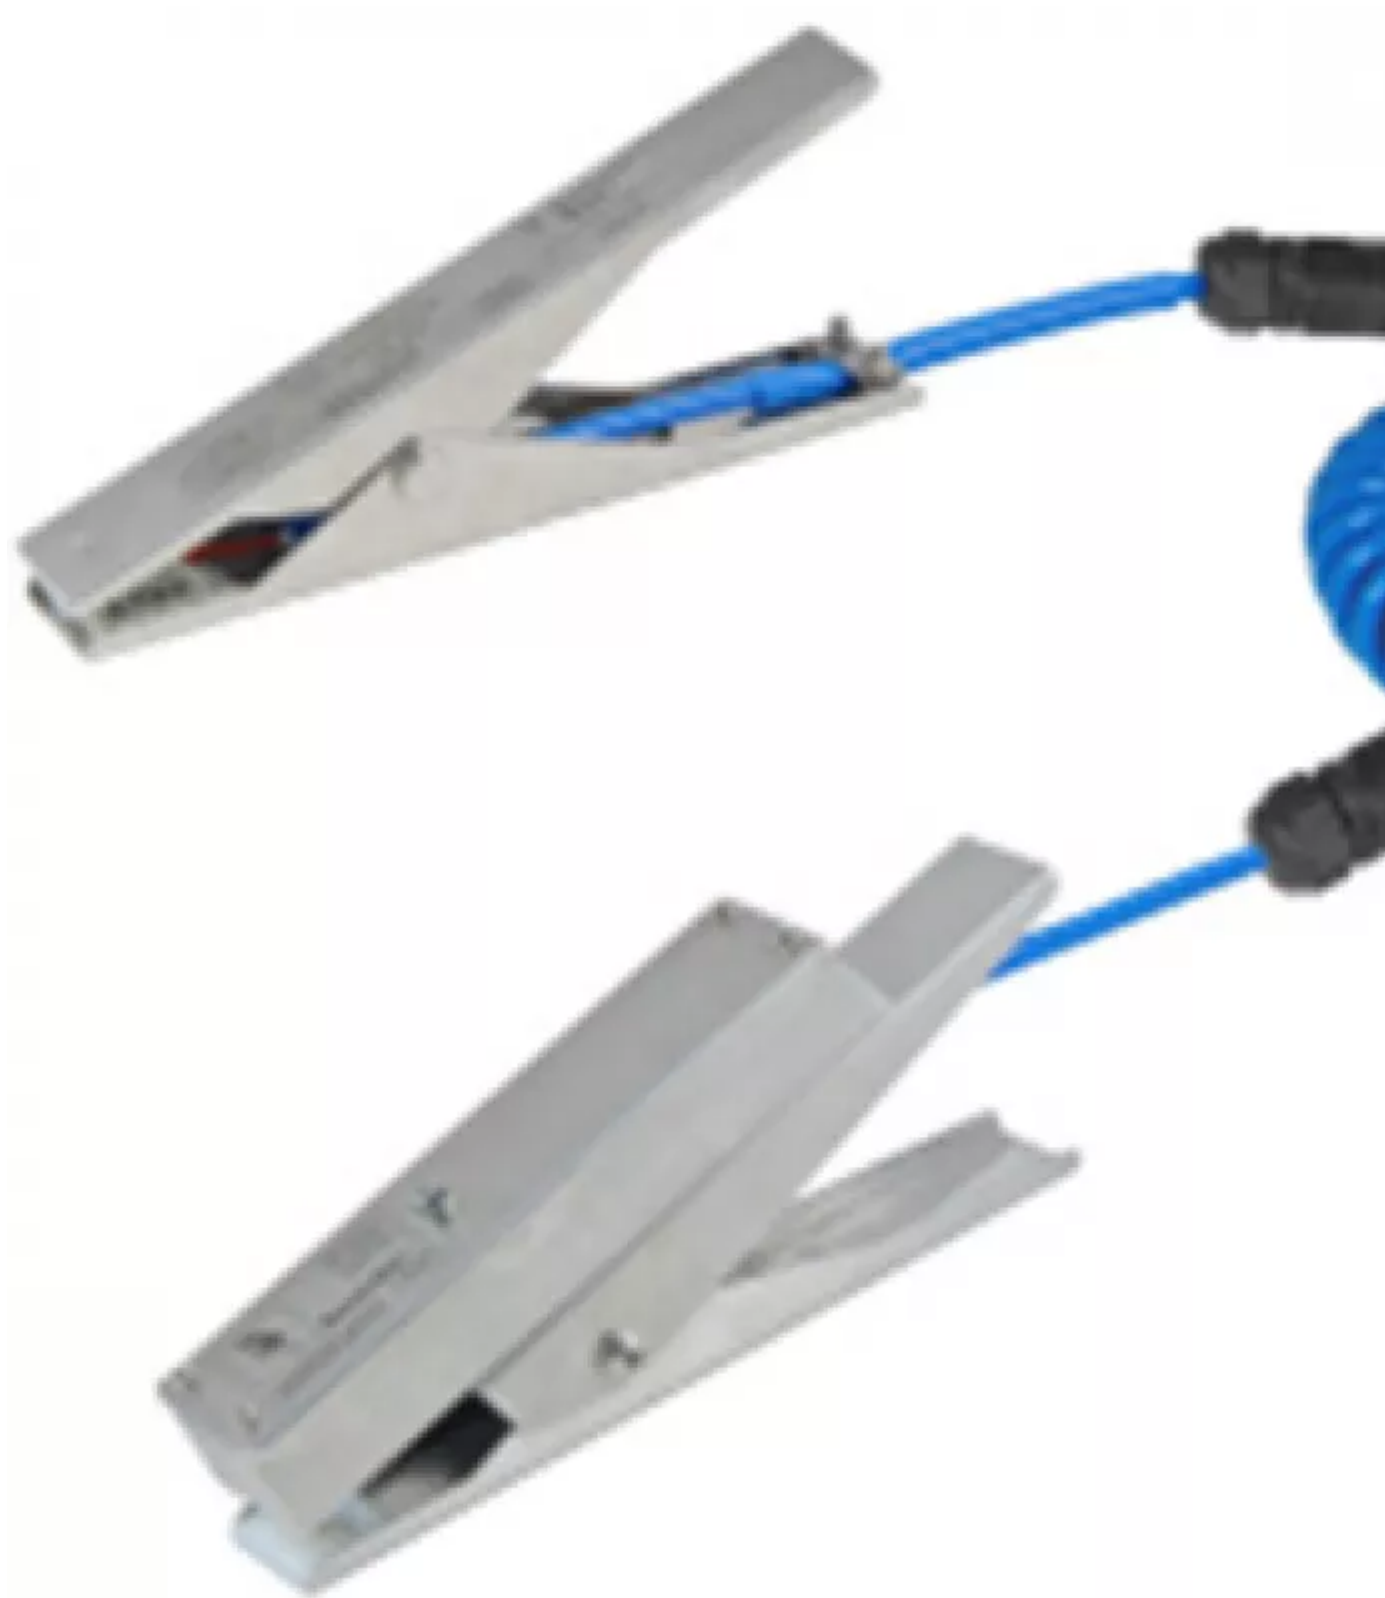
A clamp mounted LED indicates when a connection resistance of 10 ohms or less is met.

Devices like the ones highlighted in the pictures above can be used to connect the drum to the grounded process vessel. At minimum a grounding clamp with FM/ATEX approvals, like the example in the picture on the right, should be specified so that any physical impedances like paint coatings and product

deposits are fully penetrated to make contact with the base metal. The picture on the left shows a device that will inform the operator when a connection resistance of 10 ohms or less between a metal drum and the process vessel has been achieved. This is indicated via a pulsing green LED mounted in the grounding clamp that provides the operator with a simple GO / NO GO instruction to tip the powder into the process vessel.
