Case Study

## **Air Cannon's Ambiance too hot! Innovative Air Cannon Positioning at Clinker Cooler for easier Maintenance**

[Published in bulk solids handling, Vol. 37 \(2017\) No. 4](#)

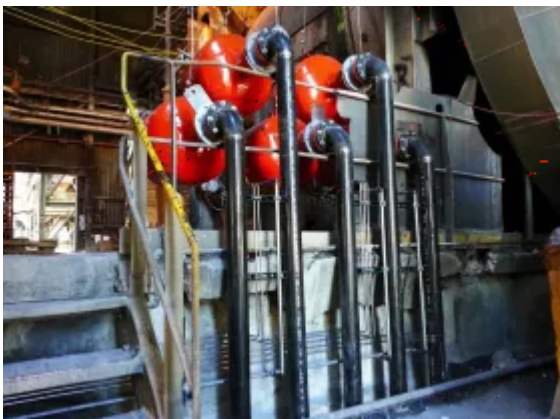
11.5 mm pipes lead down to holes drilled into the concrete floor, then continue under the subfloor.

Technicians installed five 150 l Martin Hurricane Air Cannons, lifting the units away from the discharge area and up several meters to a preexisting platform. Located well away from the hot wall and the kiln’s discharge zone, the cannons can be serviced without having workers wear the special high-temperature equipment.

Connected to the existing compressed air system, the Hurricanes supply more force output with less air consumption at half the size of other designs. Each unit

fires a shot of air up to 120 PSI (8.27 BAR) from a pressurized tank through the long pipes and spreads the airstream across the area of buildup.

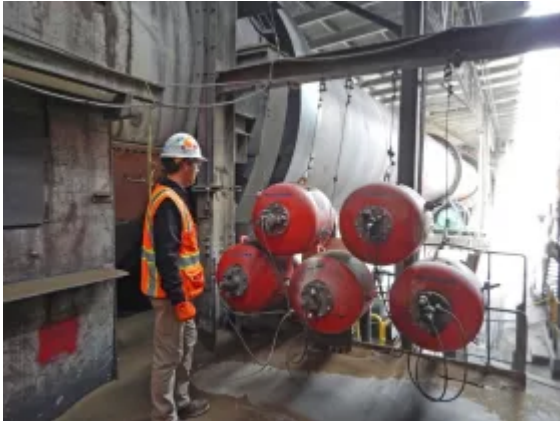
Valves face outward for convenient maintenance, requiring no tank removal to service them.

The Hurricane's valve faces outward, opposite the pipe end, and is serviced without removing the cannon tank. A single technician simply detaches the air and solenoid connections, removes the 8 bolts from the valve assembly and slides it out for inspection and maintenance.

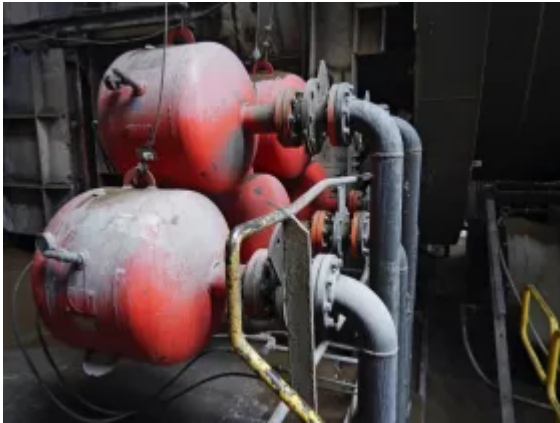
After five years of service, the cannons continue to operate at a high level of reliability.

“After five years of constant operation, the results have been better than we ever expected,” said Schutt. “Since the installation, we have had a significant reduction in downtime due to accumulation.”

The lack of heat exposure has reduced the impact on the equipment itself, increasing the life of the valves and the tank. Setting the tanks in an easily accessible and safe area means that workers can inspect the equipment more often and perform maintenance on a single cannon without downtime.
