White Paper

Avoiding the Rip off - A Guide to Chevron Conveyor Belts

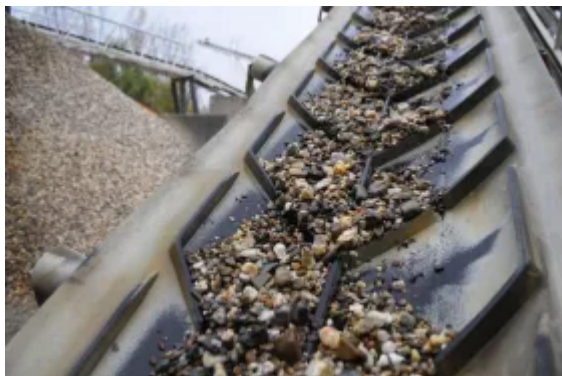
Fig. 5: Chevron belts with a single homogenous structure are stronger and longer-lasting by far.
