White Paper

Wearing thin - Causes and Solutions for Conveyor Belts that have to be replaced prematurely due to Surface Wear

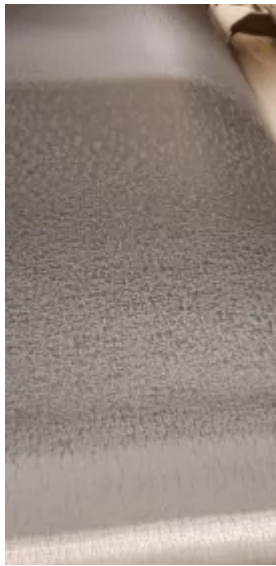
Close up of ozone cracked belt.

There is absolutely no question that ALL rubber conveyor belts should be fully resistant to the damaging effects of ozone and ultra violet light. This is because ozone becomes a pollutant at ground level. Exposure increases the acidity of carbon black surfaces and causes reactions to take place within the molecular structure of the rubber. This has several consequences such as surface cracking and a marked decrease in the tensile strength of the rubber. Likewise, ultraviolet light from sunlight and artificial (fluorescent) lighting also accelerates deterioration. This is because it produces photochemical reactions that promote the oxidation of the surface of the rubber resulting in a loss in mechanical strength. In both cases, this kind of degradation causes the covers of the belt to wear out even faster than it should.

Rubber belts that are not fully resistant to ozone and UV can start to show signs of degradation even before they have been fitted to a conveyor simply by being exposed to the open air and daylight. Sadly, despite its crucial importance in terms of operational lifetime, ozone and UV resistance is very rarely, if ever, mentioned by traders or manufacturers. This is almost certainly because the anti-ozonants that need to be used during the mixing process of the rubber compounds are relatively costly. Building that 'avoidable' cost in would immediately make the belt less competitive on price. My advice is to always make ozone & UV resistance a required part of the specification when selecting any rubber conveyor belt.

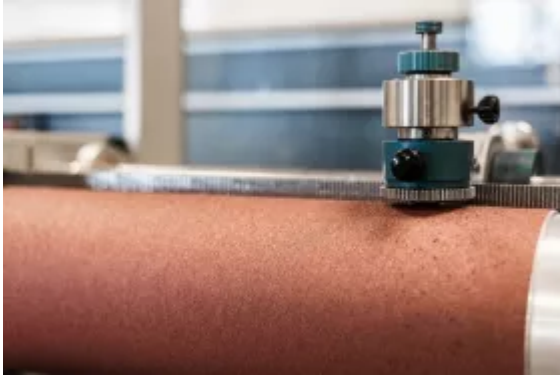
ISO 4649 / DIN 53516 abrasion testing.

The test method for abrasion (ISO 4649 / DIN 53516) is actually quite simple. Abrasion resistance is measured by moving a test piece of rubber across the surface of an abrasive sheet mounted on a revolving drum. It is expressed as volume loss in cubic millimeters, for instance 150 mm³. The most important thing to remember when comparing abrasion test results (or promises!) is that higher figures represent a greater loss of surface rubber which means that there is a lower resistance to abrasion. Conversely, the lower the figure the better the wear resistance.
