Case Study

## **State of the Art Hazard Monitoring for State of the Art Flour Mill**

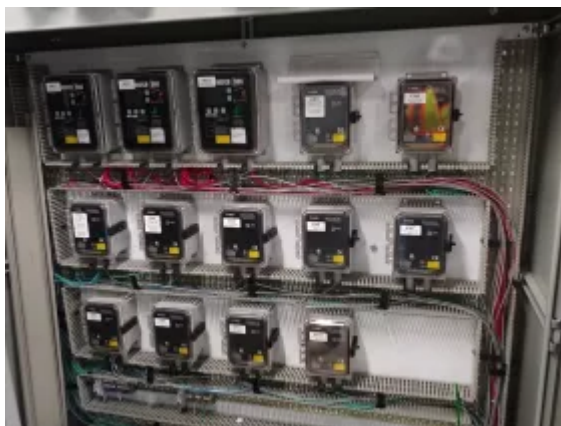
Panel of IE-Nodes

4B's newest hazard monitoring system, the Industrial Ethernet Node (IE-Node) was the perfect fit. It features EtherNet/IP communications that work directly with the customer's Allen Bradley PLC without any gateways while being approved for Class II, Division 1 Group E, F & G hazardous dust environments. It provides inputs for continuous bearing temperature sensors, belt alignment sensors, and speed sensors.

The customer selected the IE-Nodes because they are technologically superior to other options on the market and improve the flexibility of installation all at an attractive price. The IE-Nodes each have 10 inputs and can be expanded to 16 to provide even more flexibility in applications where the site needed additional sensors. All of the sensors can be fully tested with 4B's Speedmaster and ADB Tester and the system has the unique ability to have multiple speed inputs for the PLC to monitor the speed ratio on equipment operating with VFDs.

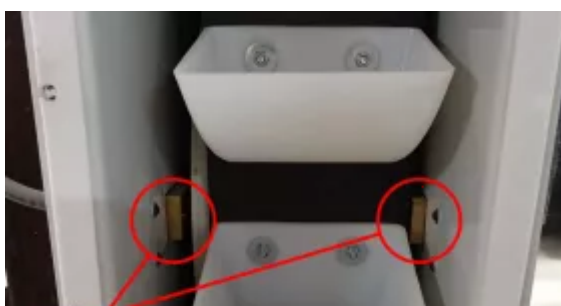
## Brass Rub Blocks installed

The customer selected NTC Adjustable Depth Bearing (ADB) temperature sensors, 2" x 4" rectangular brass rub blocks with stainless steel hinged inspection doors for belt misalignment, and whirligigs with 4-20 mA Milli-Speed sensors for monitoring belt slippage. 4B provided training for both the end user and installer to highlight the best practices for wiring and maintaining the system.
