White Paper

Don't get tired repairing Tyres - OTR Tire Repair: A Look behind the Scenes

[Published in bulk solids handling, Vol. 34 \(2014\) No. 5](#)

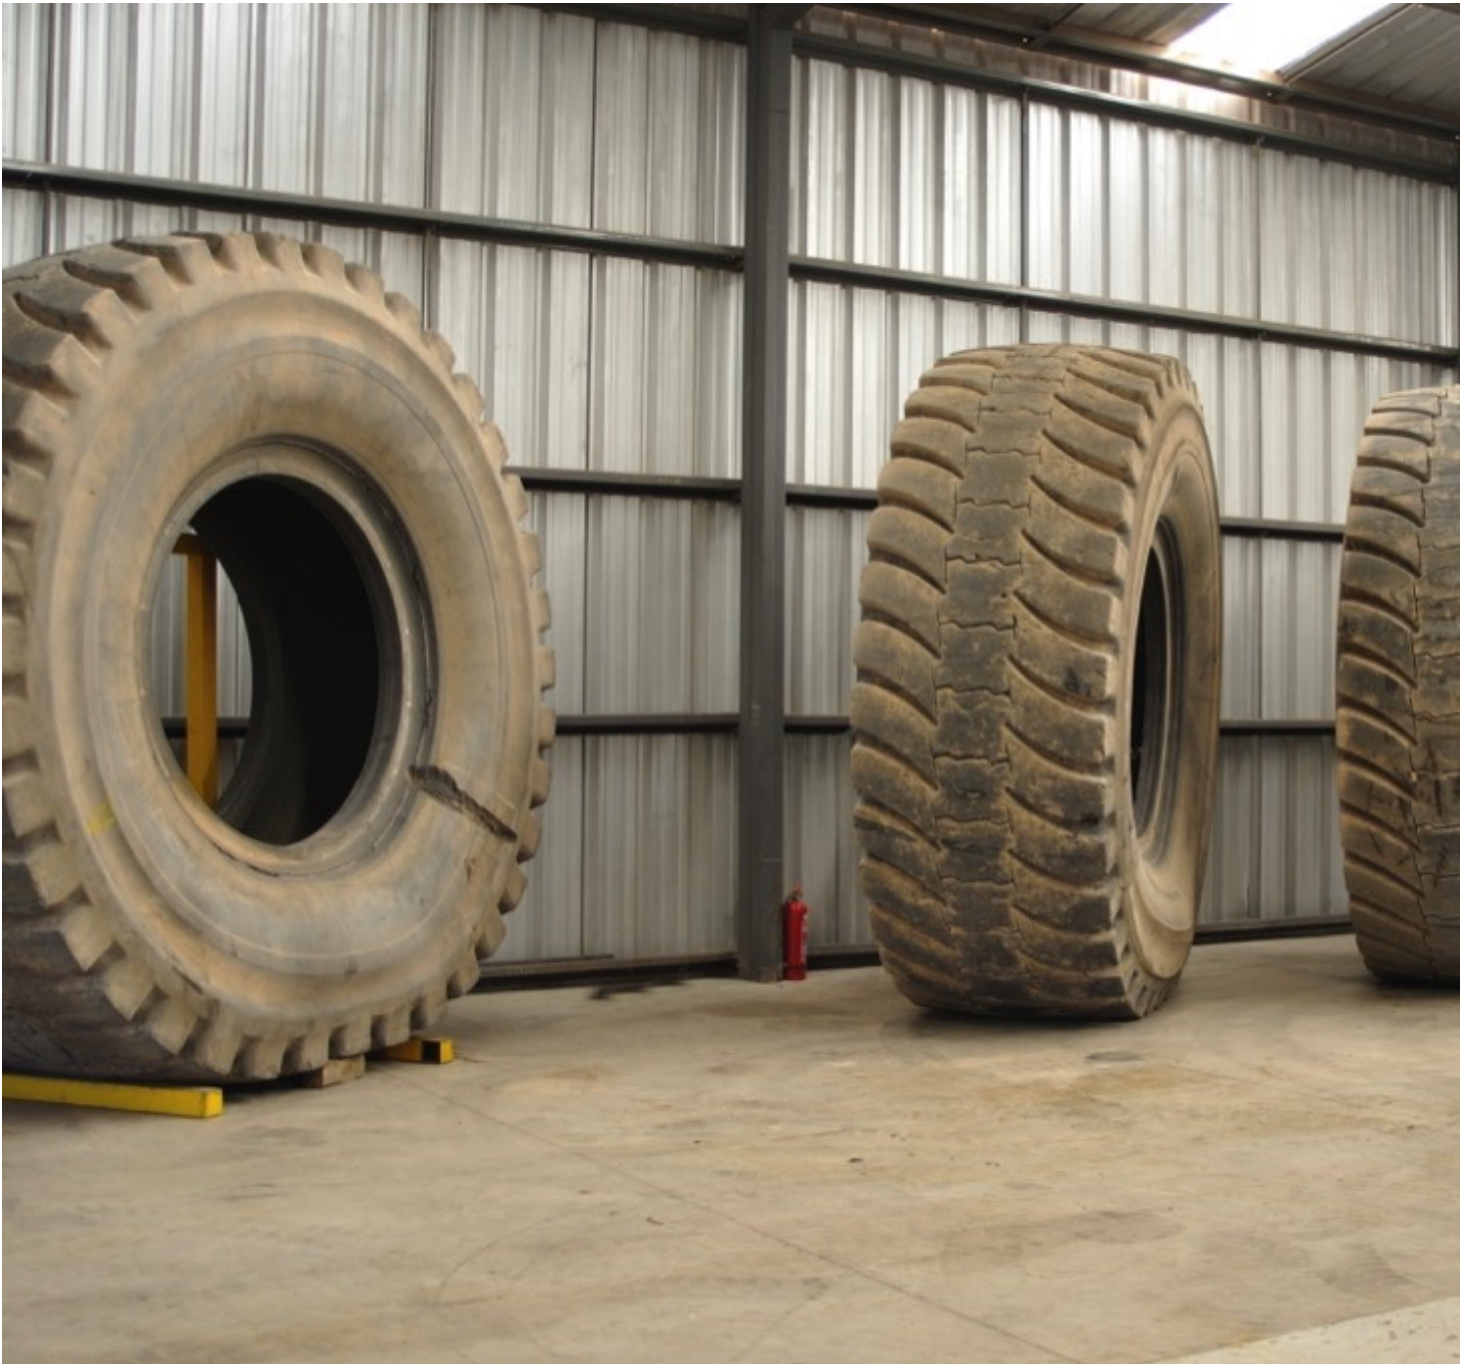
Tyres in the OTR workshop waiting for repair. (Pictures: © Rema Tip Top)

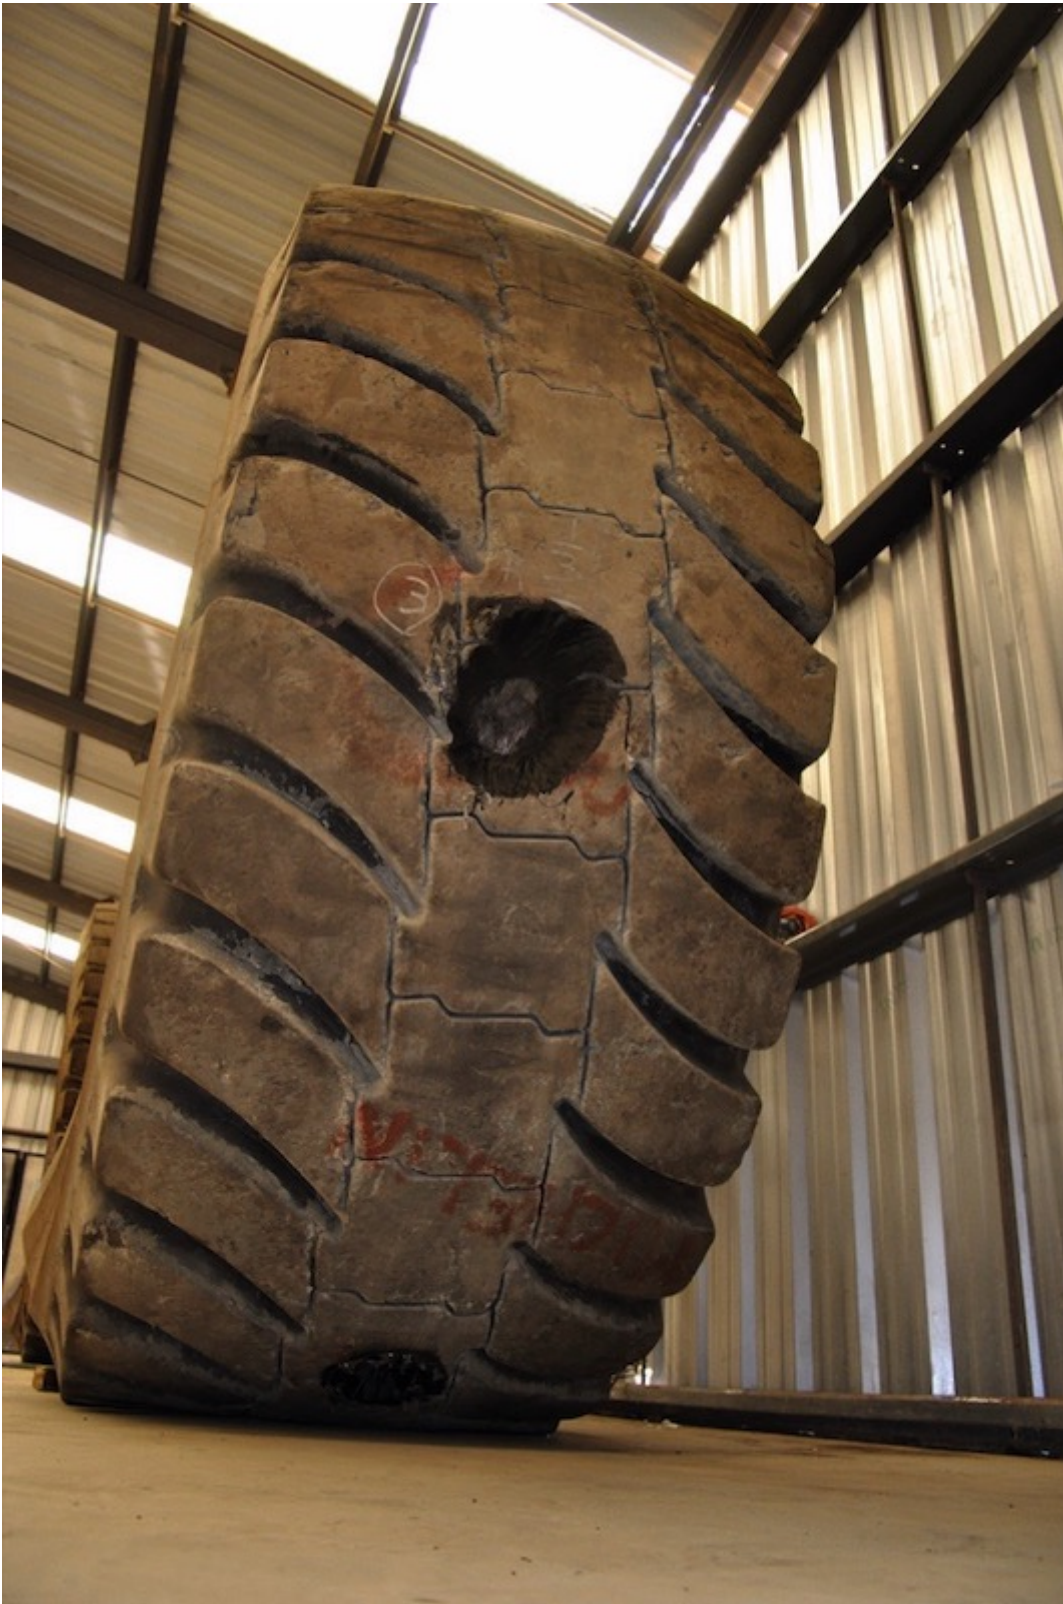
Damage on a 63-inch-tyre prepared for repair in the OTR-workshop.

Damage can generally occur at three different places on the tire – the tread, the tire shoulder and the sidewall. Much of the damage to OTR tires is due to penetration by stones or rock splinters, something that cannot be avoided in spite of taking good care of the road surface. Fist-sized stones that become jammed in the profile work their way through the tread with every revolution, even though the tread may be up to 140 mm thick. When the stone penetrates the carcass it causes a gradual loss of air (slow puncture) that can lead to total destruction of the tire if not noticed. Loss of air is also a certain indication of damage when sidewall or tire shoulder cracks are found. To prevent irreparable damage to the tire, the tires have special sensors fitted that given an early visual and acoustic indication of loss of air or temperatures that are too high.

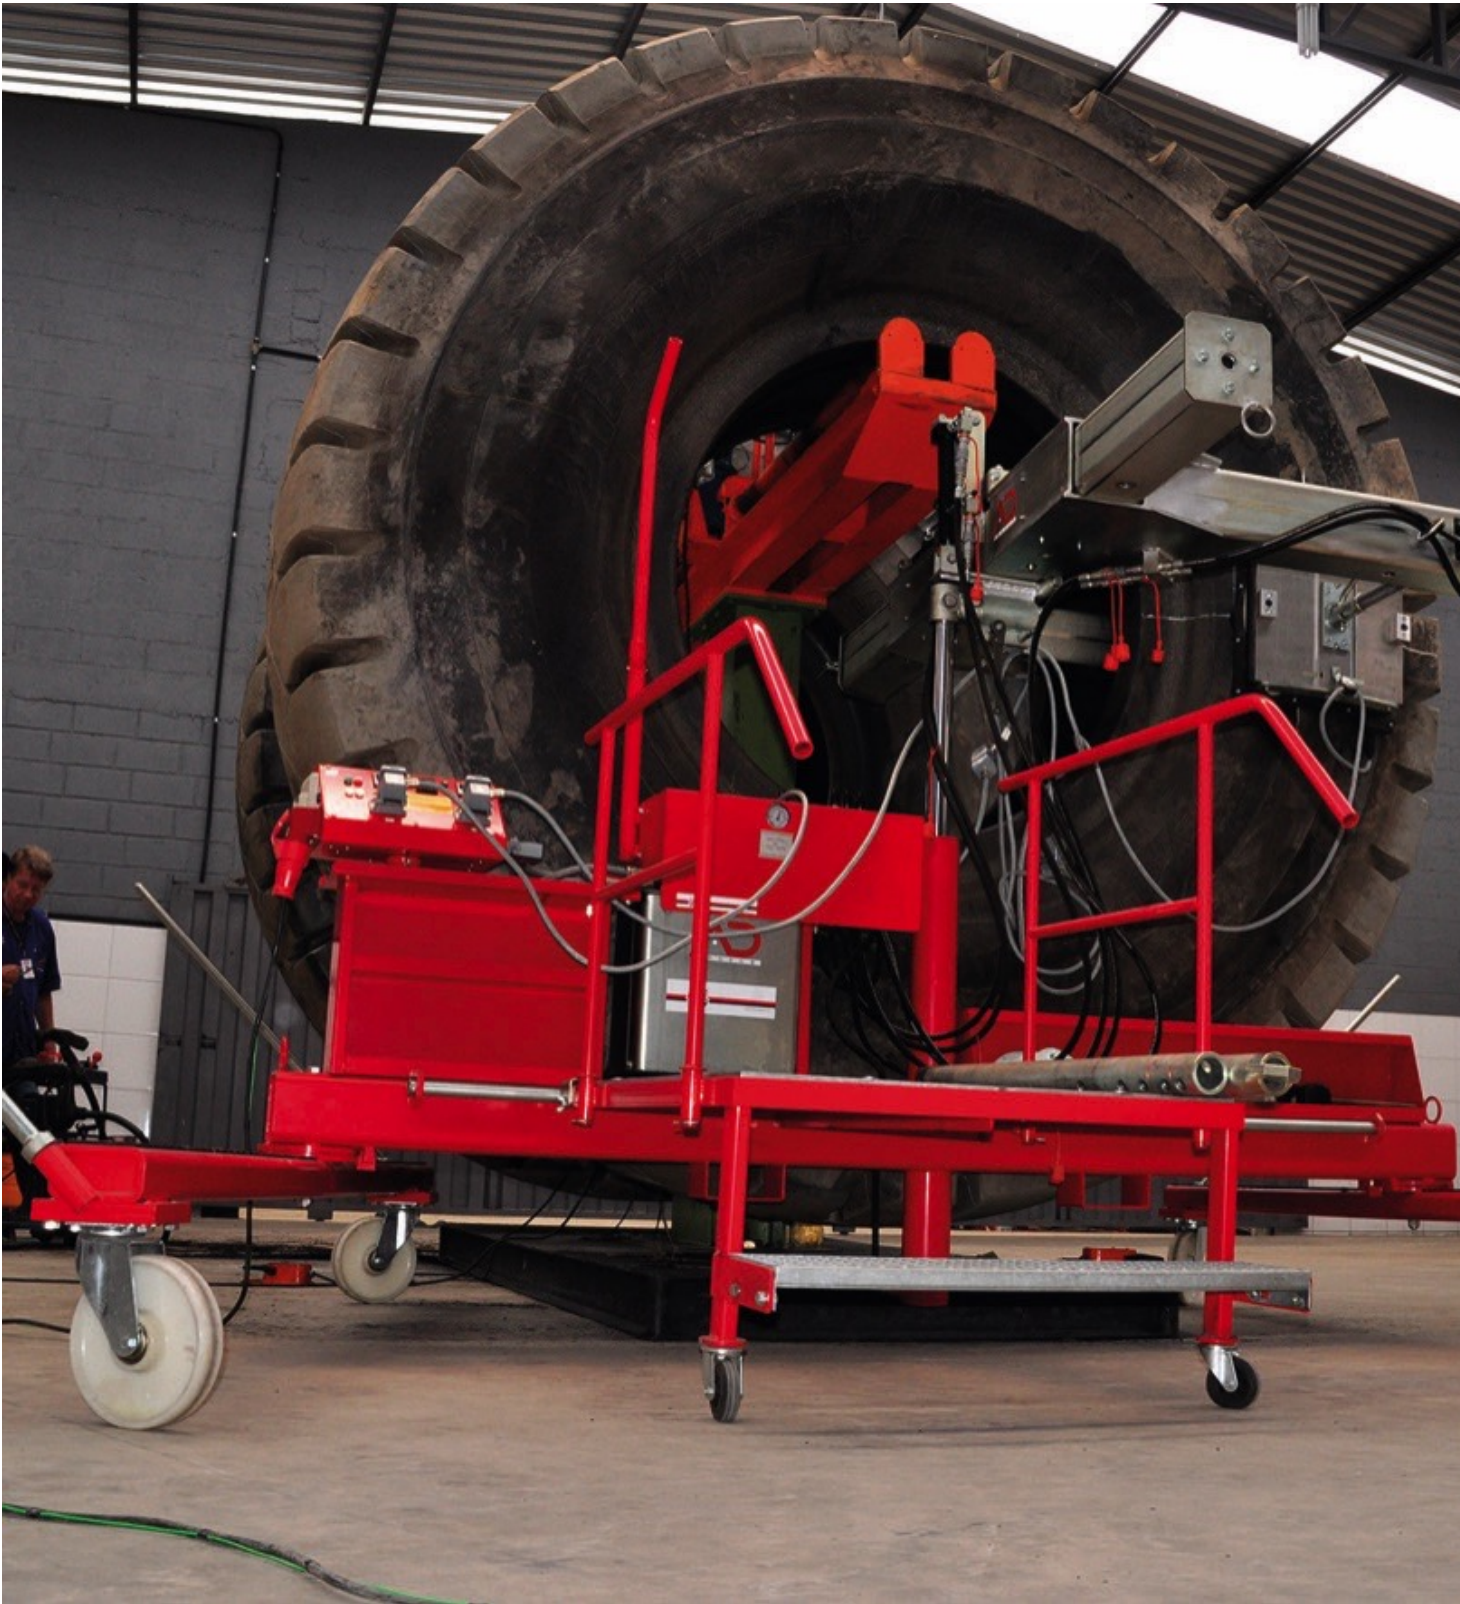
Positioning of the tyre sidewall for the Thermoprocess system.

In the first phase, the damaged tire is cleaned, thoroughly inspected and the degree of damage measured. Loose rubber parts or any damaged carcass wires are removed. The damaged area is roughened and the reinforcement patch placed in position. The damaged area is then filled with MTR repair rubber. If the extent of damage to an OTR tire is great, up to 12 kg of filler may be

necessary. This is followed by the process of vulcanization in which the filled rubber mixture is vulcanized in a skive. Two different processes are possible: the 1-way or the 2-way system, each having its own advantages and disadvantages. The advantage of the 1-way process is the fast repair time because the damaged area and the strengthening patch are vulcanized in one working step.

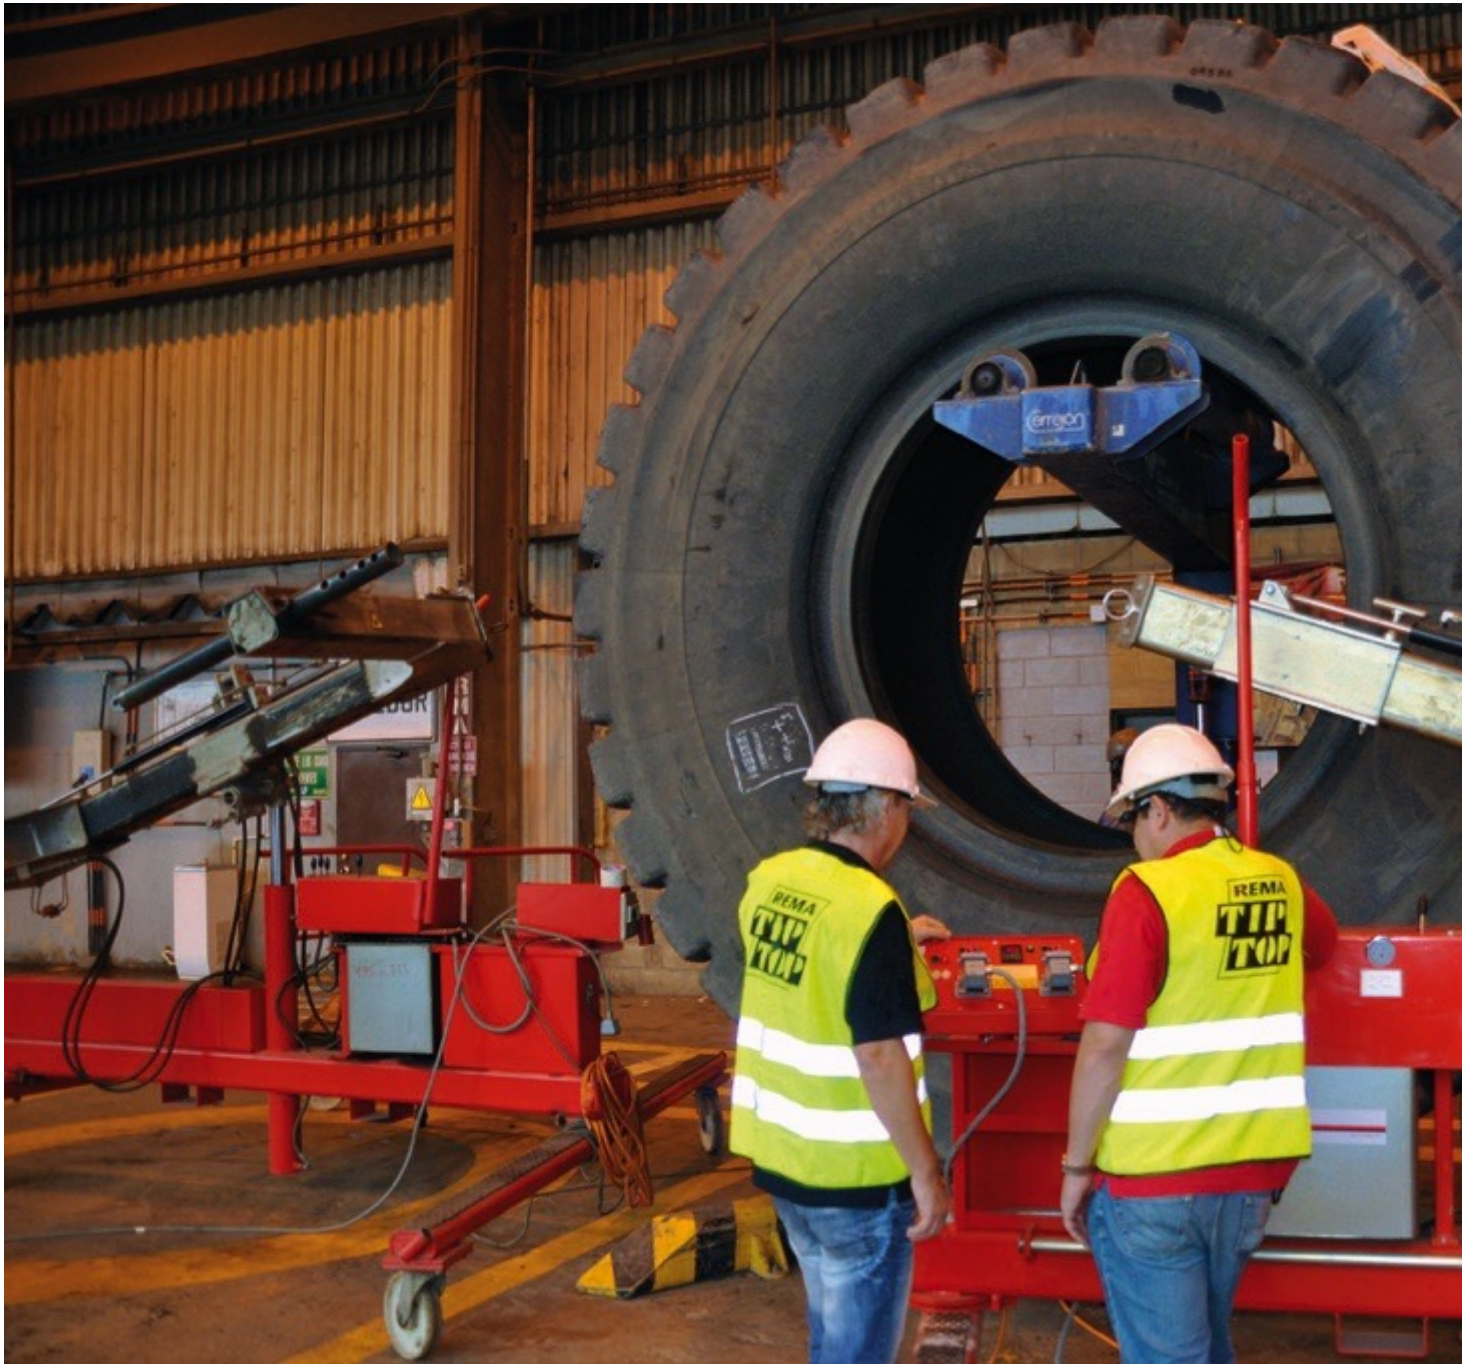
The vulcanizing system in place, also within the tyre.

For a tire with sidewall damage this means, for example, that it can again be used after 10 to 12 hours of vulcanization and a 2 to 3 hours cooling-off period. In the 2-way system, in contrast, only the damaged area undergoes hot vulcanization. The reinforcement patch is subsequently cold vulcanized. This process takes

longer but is particularly kind to the tire since the heat is only applied to the damaged area. A considerable difference between both processes is, however, the price of the equipment required. The large heating autoclaves and vulcanizing equipment necessary for the 1-way system are considerably more expensive than machines such as Rema Tip Top's Thermopress used in the 2-way vulcanization process. But what counts most is the final result – and that is equally good for both systems.

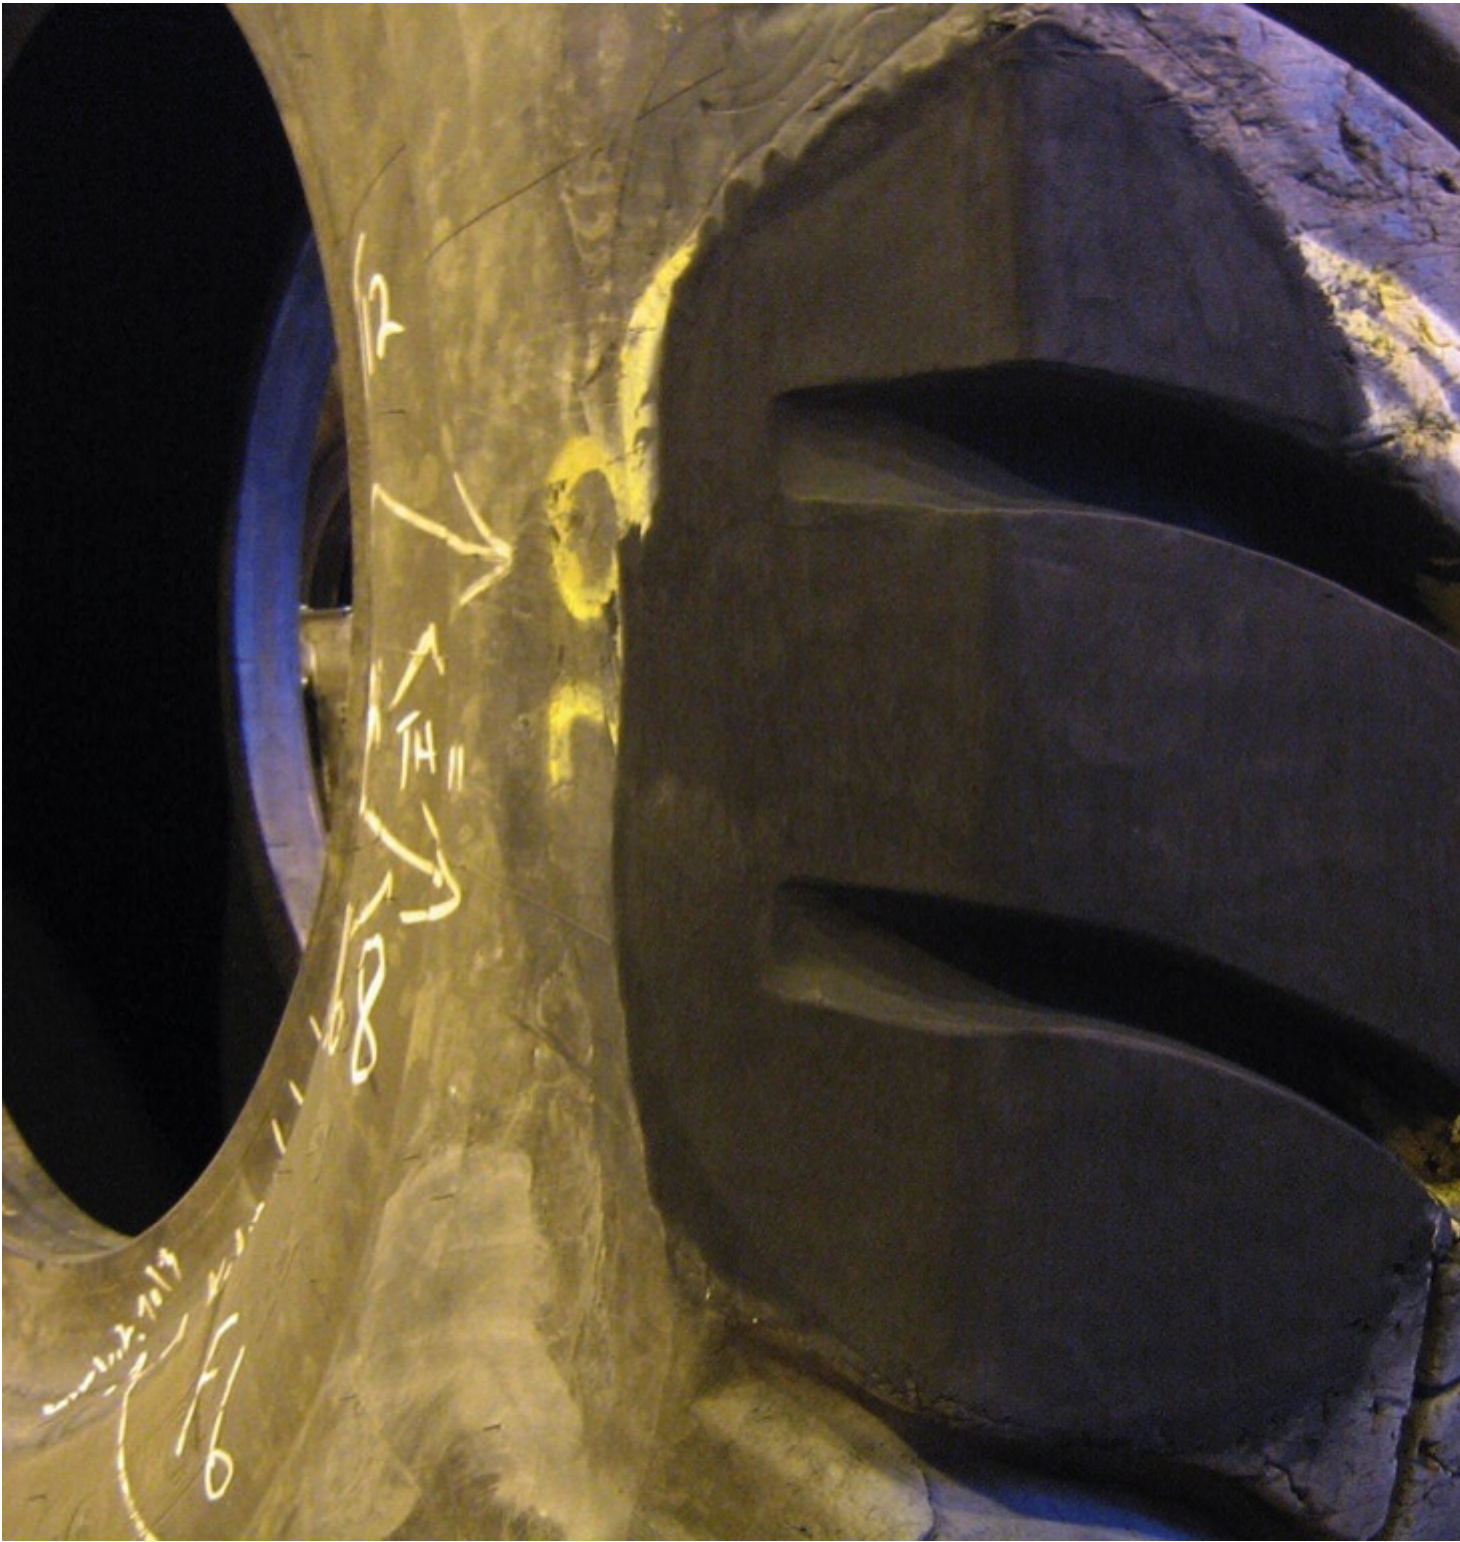
The final result: 63-inch OTR Tyre after repair.

As outlined before, the quality of the tire repair is independent of the chosen process. What is decisive is the complete OTR tire repair system together with its compatible consumables such as reinforcement patches, repair rubber, vulcanizing solutions and tools used for the repair. Rema Tip Top experts regularly visit OTR tire repair workshops throughout the world in order to obtain first-hand information on damage, the work required and the needs of the
