Technical Article

Bag House Operation Problems: Failure Patterns, Problem Identification and Solutions

[Published in bulk solids handling, Vol. 34 \(2014\) No. 2](#)

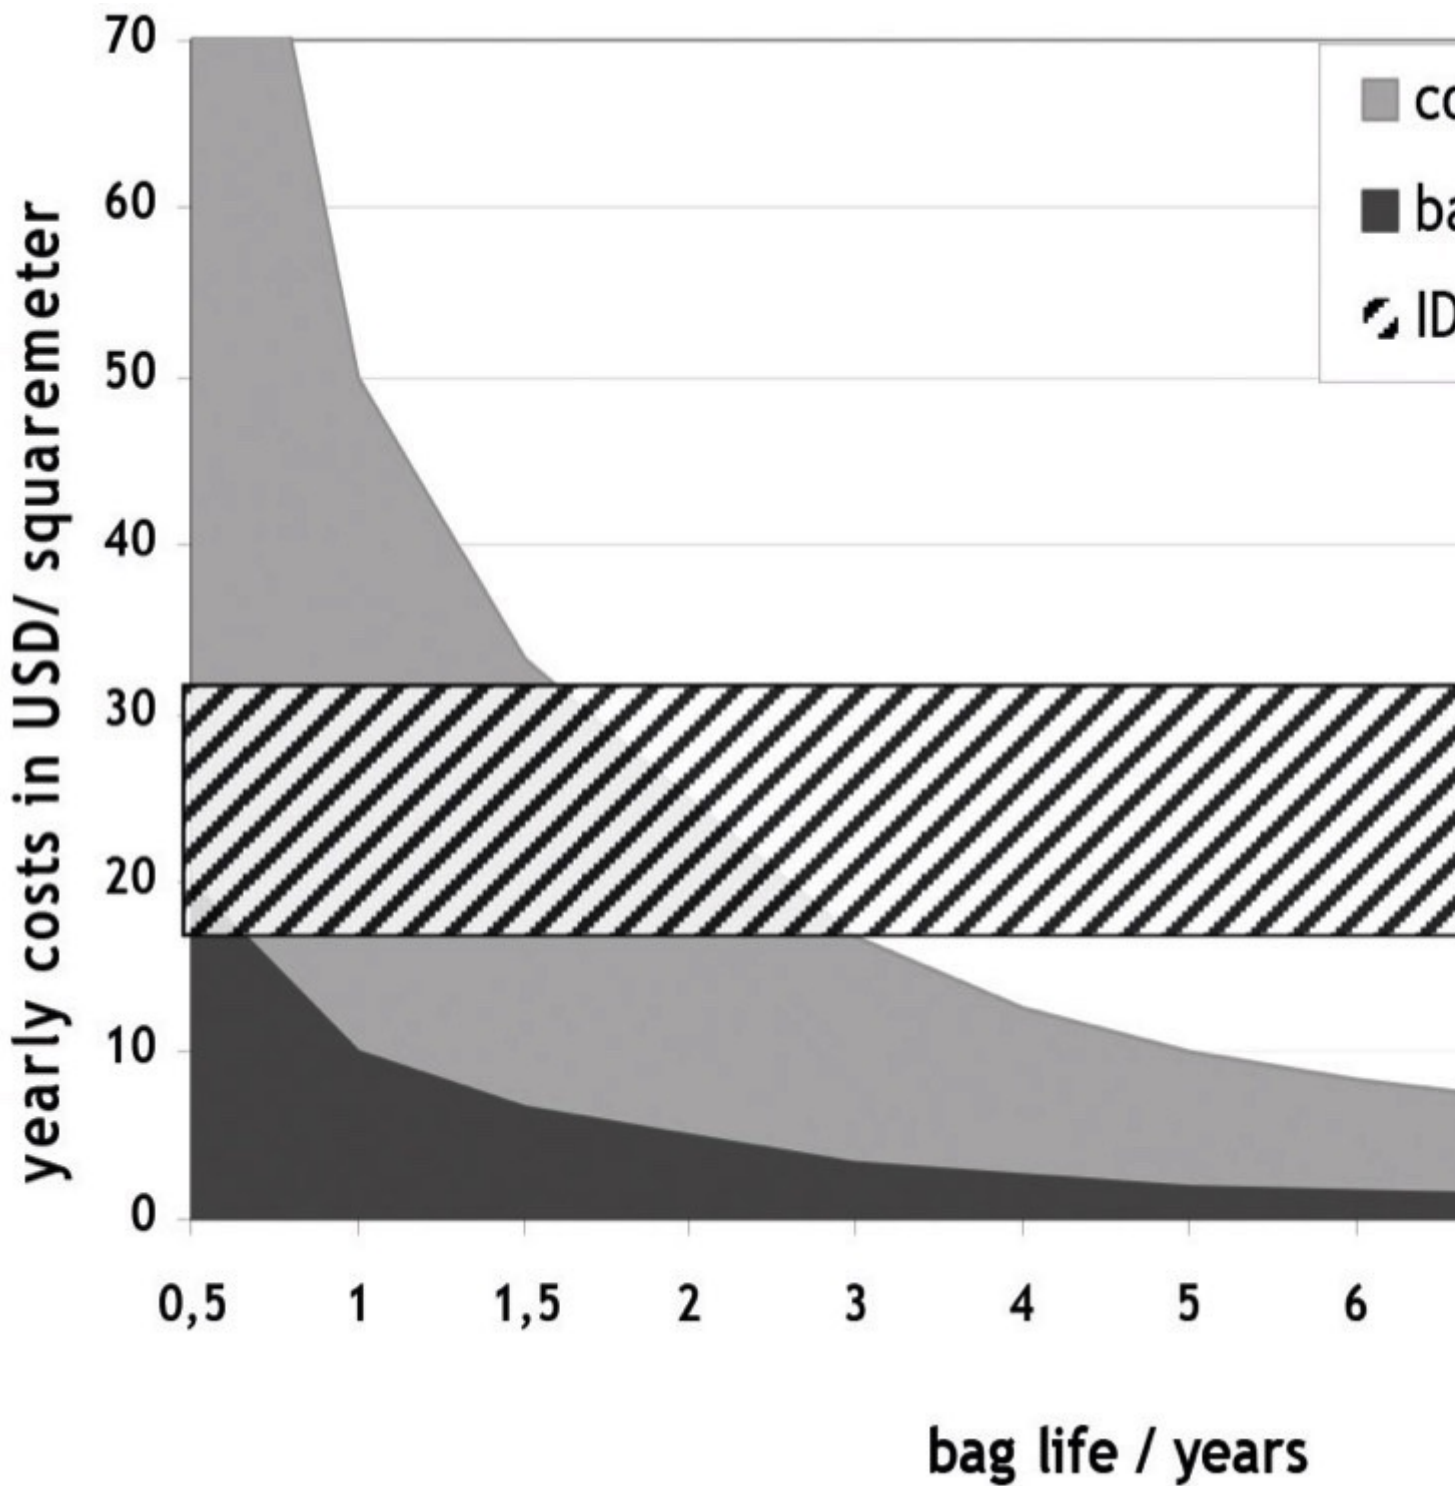
Fig 2: Major bag house operating/maintenance costs.

The operation of a bag house results in expenses for fan power, pressurised air and bag material as well as cost for manpower and the loss of production during maintenance. Bag costs are typically the most obvious and therefore best evaluated cost factor as it is a big investment at the start-up and at the time of complete replacement. In fact it is typically just number 2 after the fan power. With its effect on all other operating costs the choice of bags has to be made properly, including the evaluation of its effect on other costs. In Fig. 2 the operating costs for a bag house are displayed, split in cost for new bags, bag change and disposal and ID fan power. Major differences and therefore a wide range of each single cost factor has to be considered for different applications and bag house layout.

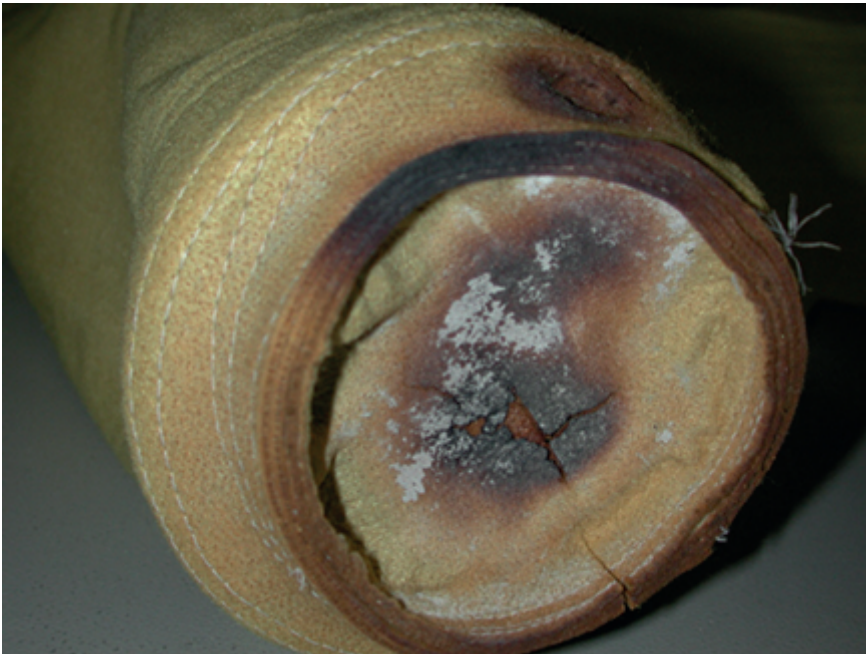
Fig. 5: Shrunk bag bottom as a result of high hopper dust levels.

Shrinkage or elongation - excessive temperature: Short time temperature peaks do not cause a high degree of chemical damage to fibre material but rather influence its dimensional stability. Depending on fibre material and load during operation shrinkage or elongation is typically experienced. A locally pronounced failure can be observed if high hopper levels result in locally high temperatures at the bag bottoms. Elongation due to peak temperatures above the material limit can result in folds and mechanical wear as shown later on.

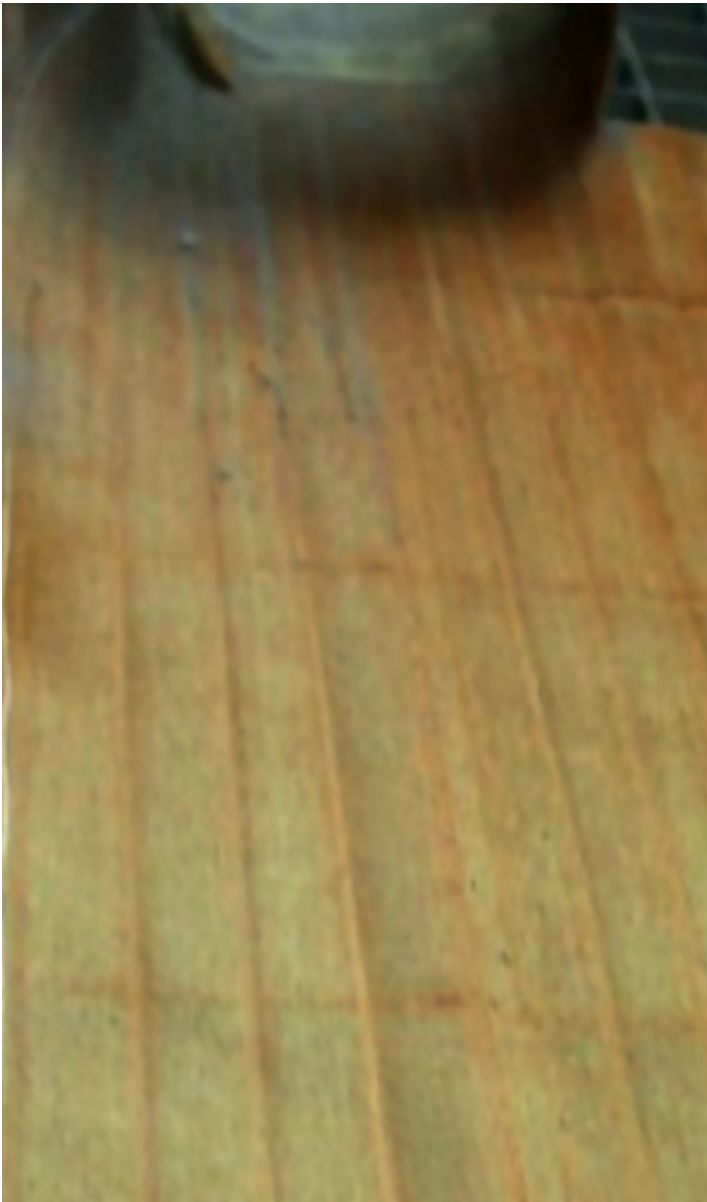
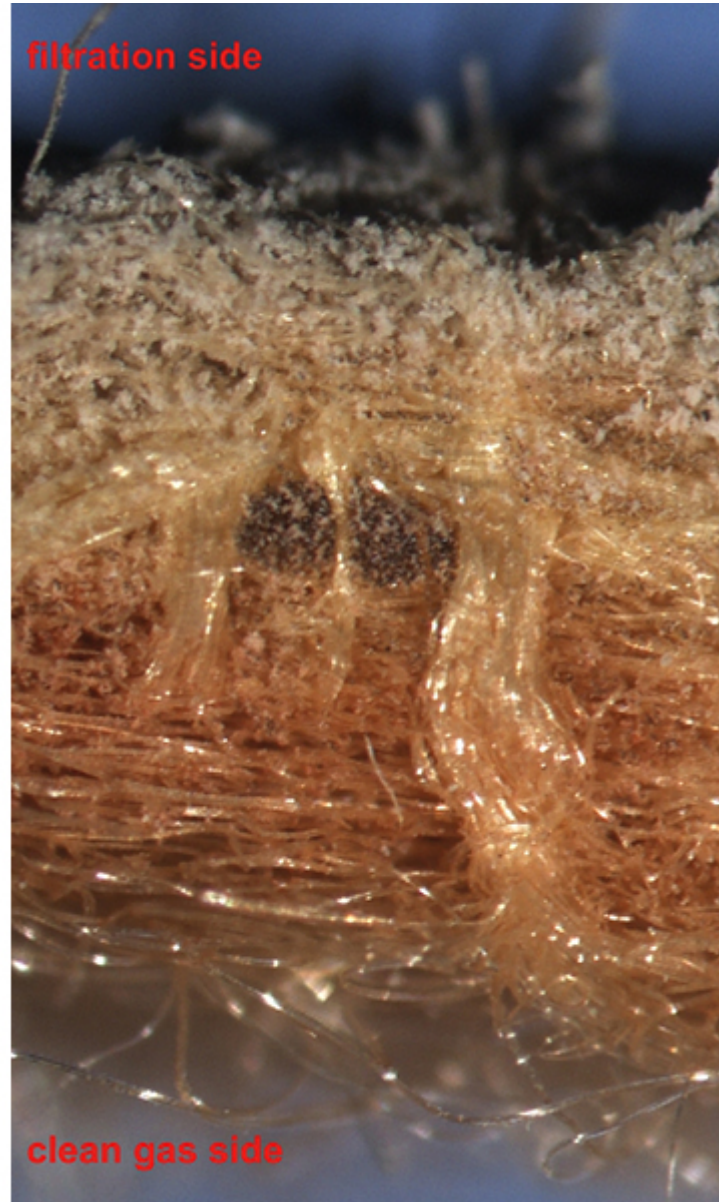
Fig. 7: Rust in the top section of a bag (left) and in a cross section through the felt (right).

Pronounced asymmetric appearance may indicate wrong adjusted cleaning valves/venturis. Red-brownish discoloration of the bag top section from rust is an indication for corrosion (e.g. as a result of condensation) as cause for abrasion from rust. Condensation may be the result of a cool-down below the (acid) dew point during pulsing, leakage due to improper sealing or insufficient insulation (Fig. 7) **Abrasion along cage wires:** Damage along cage wires is typically experienced when the cages are damaged or corroded, or after bag-to-bag or bag-to-wall contact due to misalignment of cages (Fig. 8). **Mechanical wear along folds:** Holes may also result from increased mechanical burden close to a longitudinal fold (e.g. oversized bag). Elongation in cross direction during operation has also to be considered for a misfit of bags on cages. (Fig. 9)
