White Paper

Kinder Australia: Transfer Point Optimisation Key to measurable Productivity Improvements

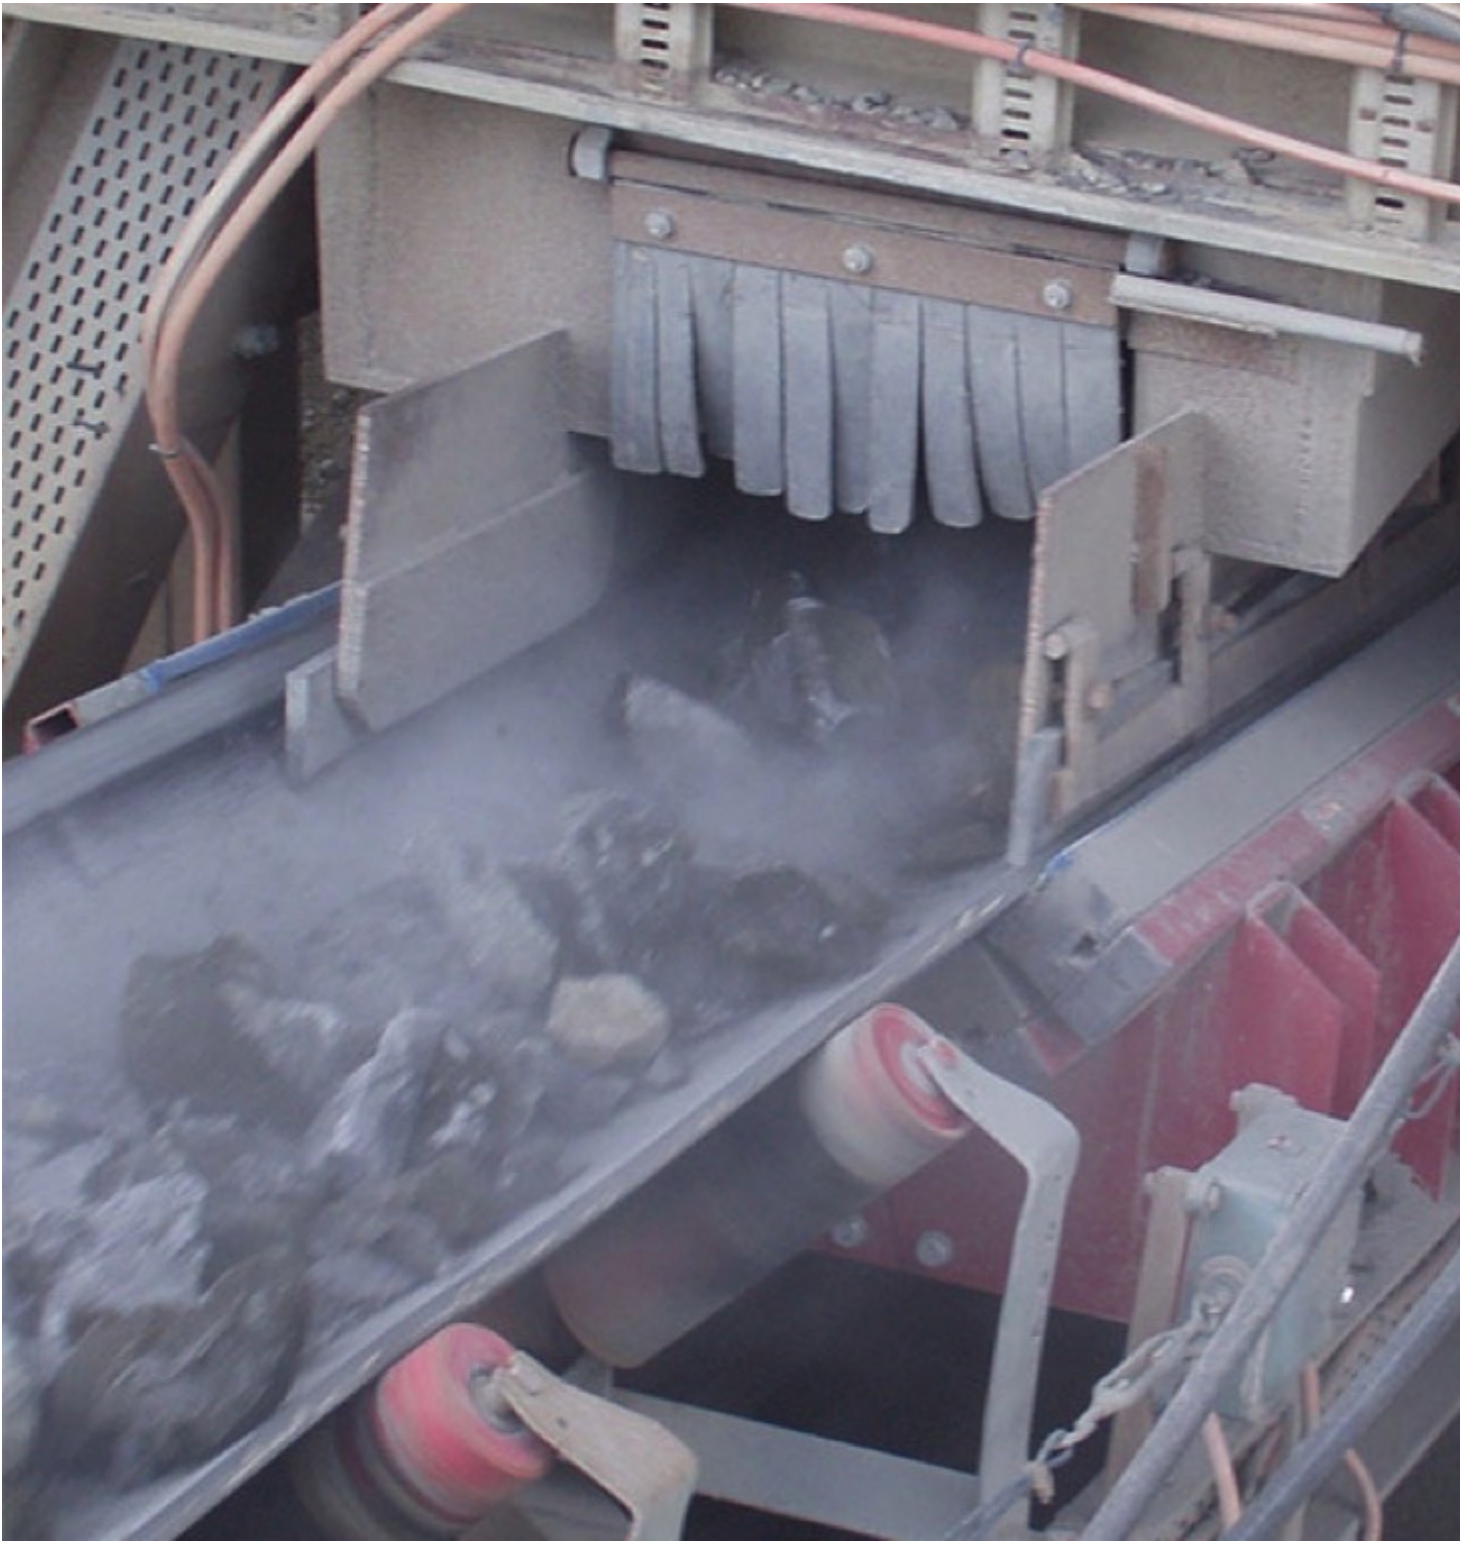
K-Impact Belt Support System.

With a 2.5 metre, vertical impact drop height from the cone crusher and material lump size of minus 60 mm provided evidence the conveyed material was pooling. This was due to the material not moving in the direction of the conveyor belt. A combination of conveyor belt sag and inconsistent conveyor idler profile gave way to ineffective skirting system, this inefficiency further aggravated dust emissions and ongoing spillage challenges at the quarry. “The quarry maintenance team

followed Kinder Australia's recommendation to overhaul the conveyor system by fabricating a new tail section and install K-Impact Belt Support, K-Sure[®] Belt Support System and K-Ultra Dual[®] Seal Skirting System", says Mr Kinder. Mr Kinder also highlighted "K-Impact Belt Support modular system installation was very successful in stabilising the load at the transfer point which in turn improved material containment, additional maintenance and labour costs were also averted". It's well regarded that transfer points are instrumental for conveyor belt systems running efficiently, integral to this is incorporating an exceptionally designed and executed transfer chute. "The key to measuring efficiency of transfer points involves the requirement for maintenance teams to continually monitor and assess the conveyor system both before and after the load transfer point and make any necessary adjustments", says Mr Kinder. Kinder Australia has over time developed an excellent reputation and established a proven history of designing transfer points and engineering solutions that resolves our customers' most challenging bulk materials handling problems effectively. Not to mention creating opportunities for further productivity gains, through extension of production assets, minimising shutdowns and labour resources.

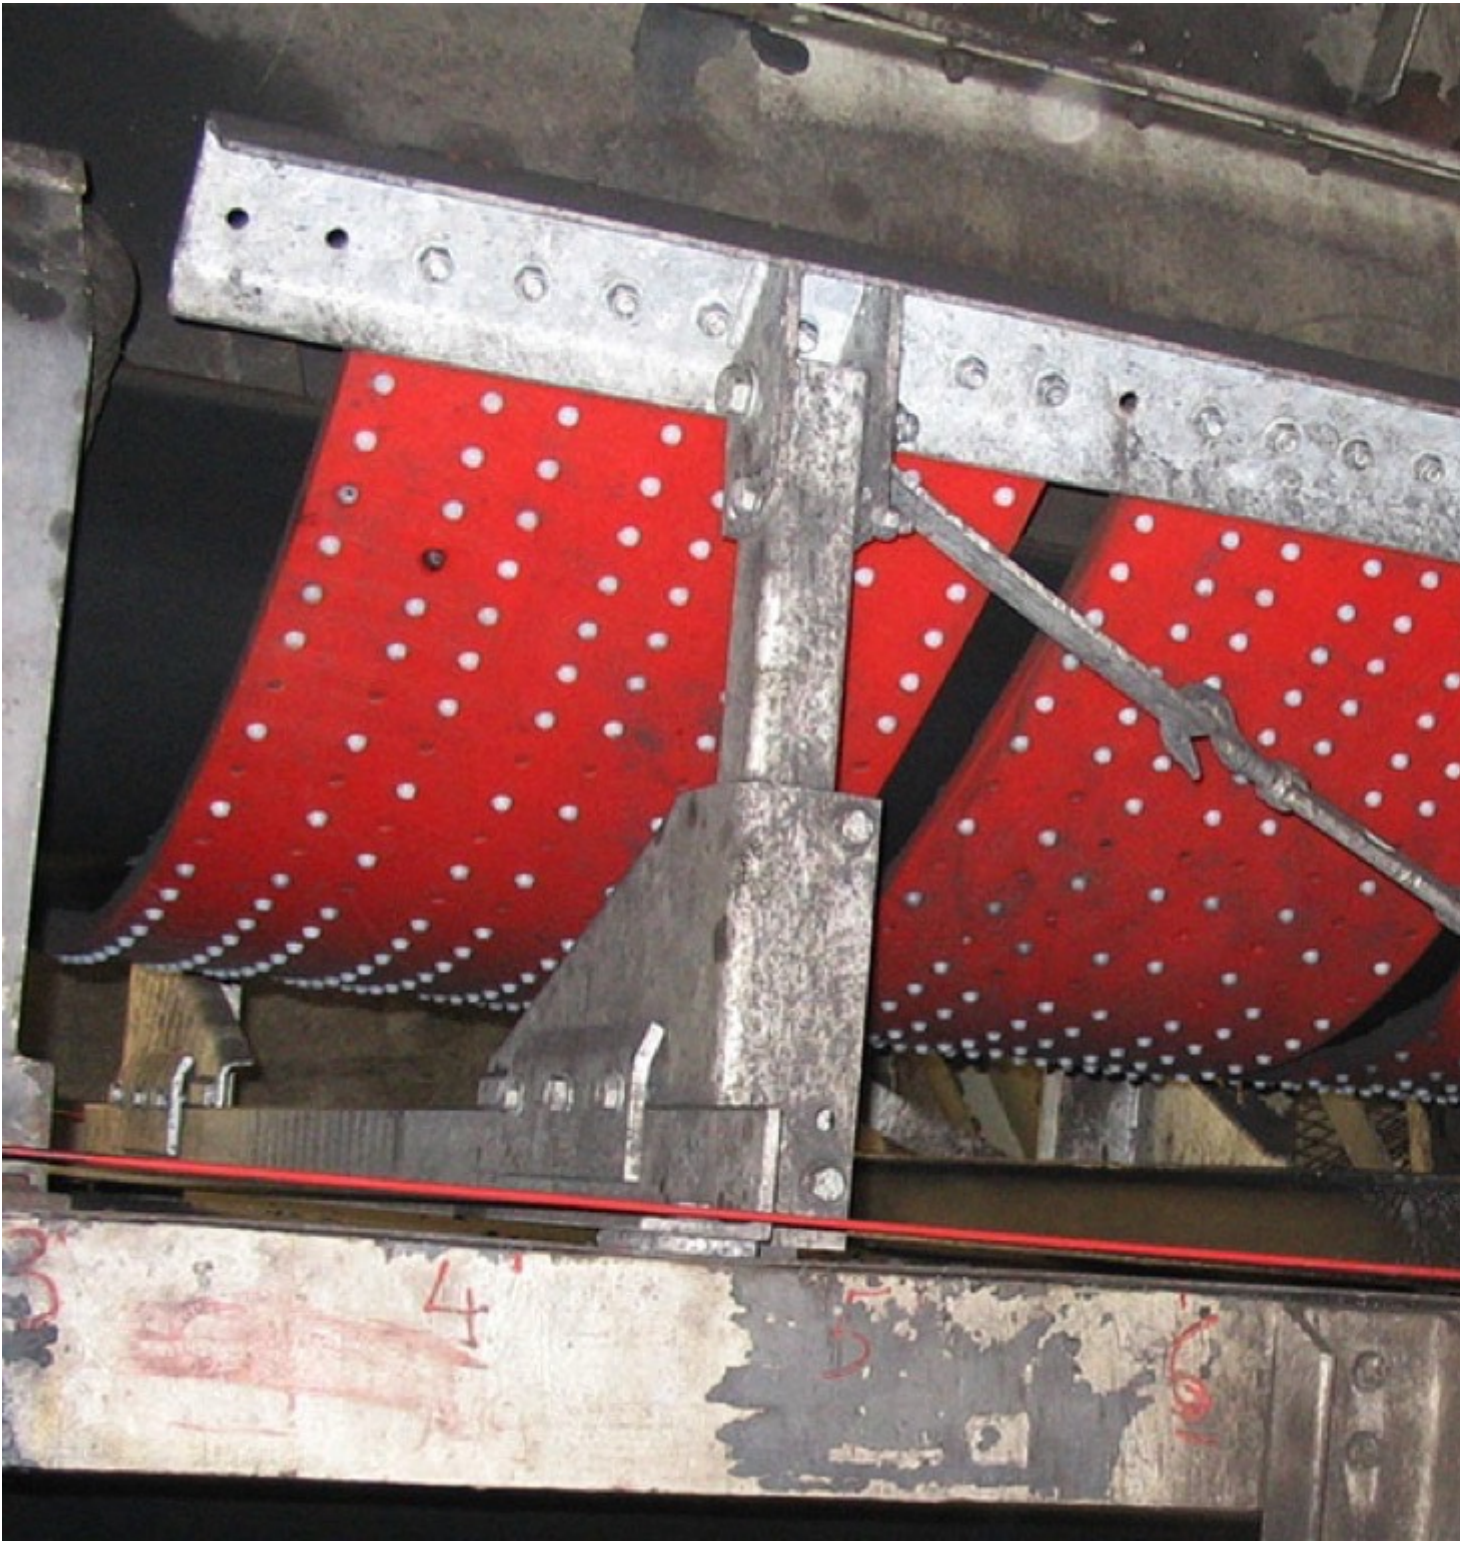
Kinder Australia recently added the K-Flexal Elastic Belt Support System to their product line up.

Recent additions to Kinder Australia's product line up include K-Dynamic Belt Support and K-Flexal[®] Elastic Belt Support System, both expertly engineered and designed to allow better absorption of energy and provide an even weight dispersion of the conveyed bulk material. Additional cost advantages are also realised, such as improved wear life of the conveyor belt and components and
